**COASTAL PHOTOGRAPH BY THE ILLINOIS
DEPARTMENT OF NATURAL RESOURCES**

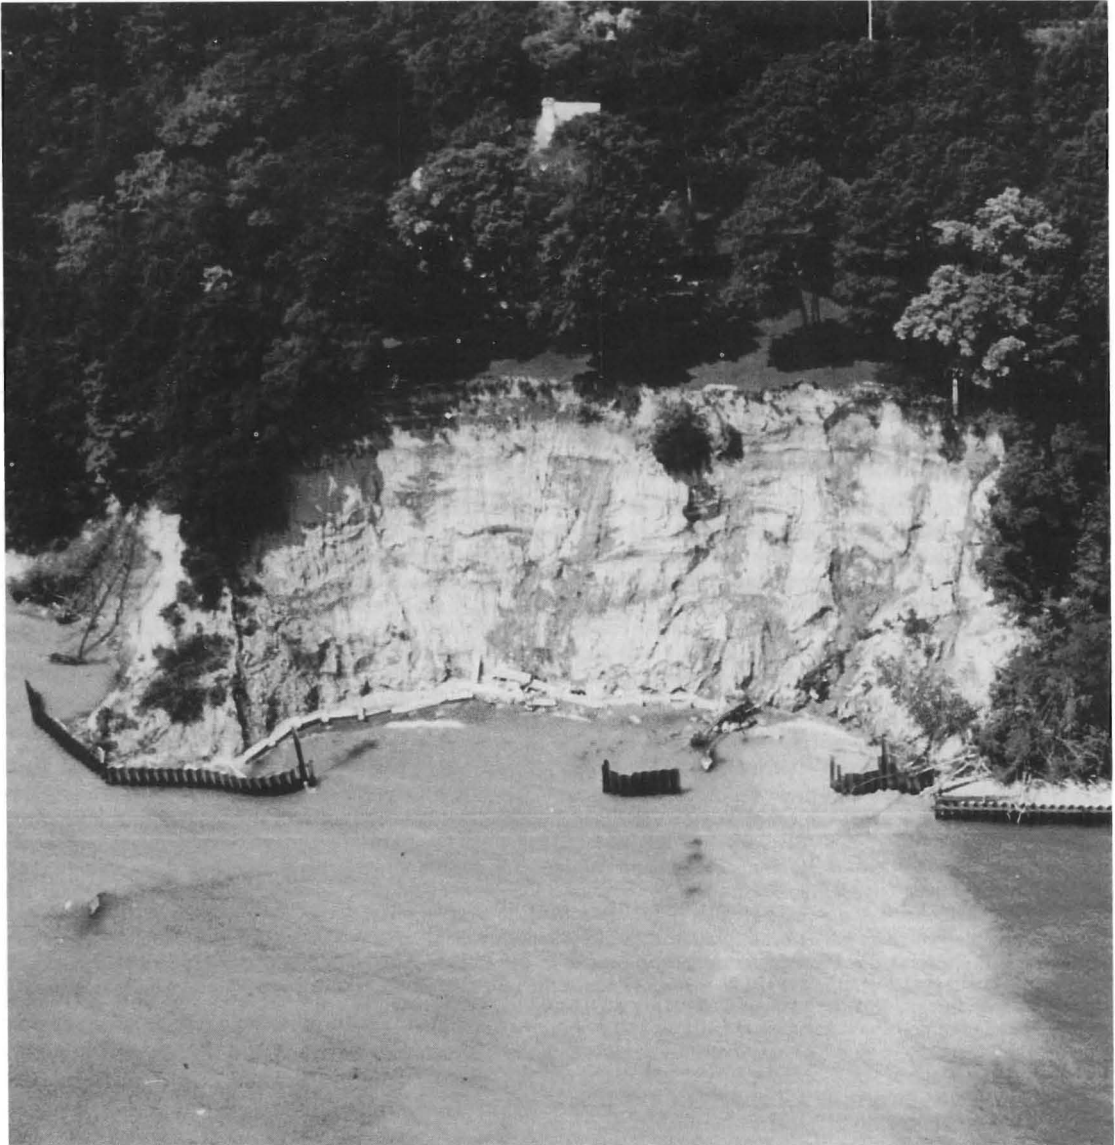
PHOTO52. Lake Michigan shore at Lake Bluff, Illinois. The bulkhead shown here failed in 1969 or 1970. All recession behind the structure occurred between 1970 and 1974. On the right, where the bulkhead has been maintained, the bluff has remained vegetated and stable. The houses on the top of the bluff are less than 50 feet from the bluff edge. Note the submerged groins and debris. The photo was taken in August 1974 when the lake level 580.7 IGLD. Unstable sand, silt, clay, and brown silty till compose more than the upper half of the scarp. Homogenous gray till composes approximately the lower half.
