## TECHNICAL COMMUNICATION

## Property Damage Mitigation Lessons from Hurricane Opal: The Florida Panhandle Coast, October 4, 1995

Craig A. Webb, David M. Bush and Robert S. Young

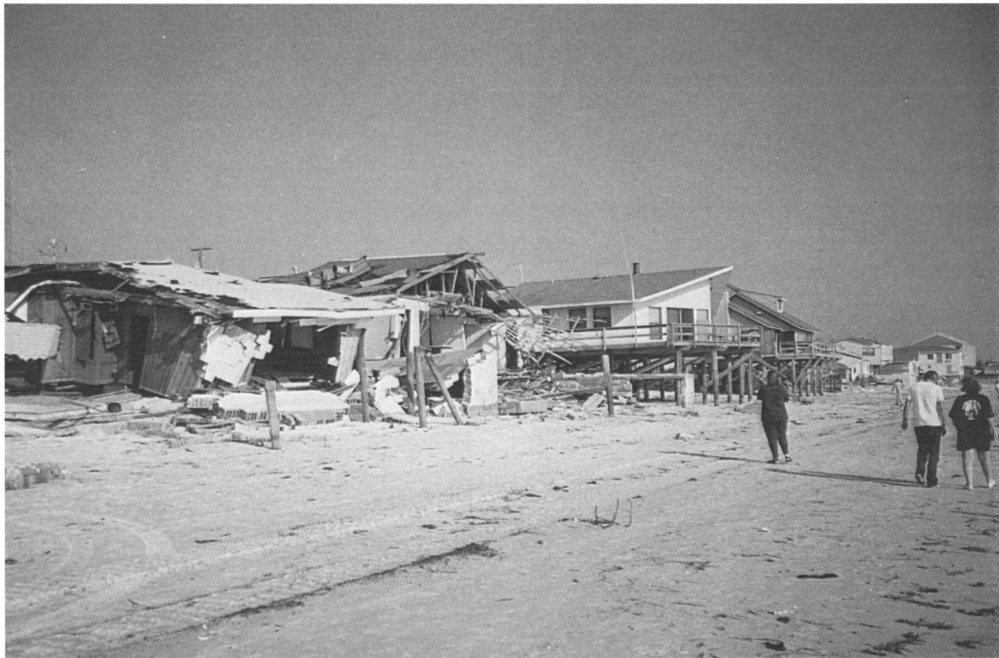
Structures built at grade suffered significantly more damage than those built on pilings. Building on pilings or (preferably) at higher elevations doesn't guarantee that no damage will be incurred, but it was observed that during this storm, those houses with more elevation, even just the sev-

Figure 2. The importance of building above grade is shown by these four single family homes in Mexico Beach. The two on the left were built at grade and completely destroyed by storm surge, while the two on the right are elevated on pilings and suffered no structural damage.

eral meters offered by pilings, fared much better than those built at grade. We should add an important note. If your house is on pilings and those of your neighbors are not, your home is still at risk as those neighboring structures may very well be floated off their foundations and into your house during the storm.

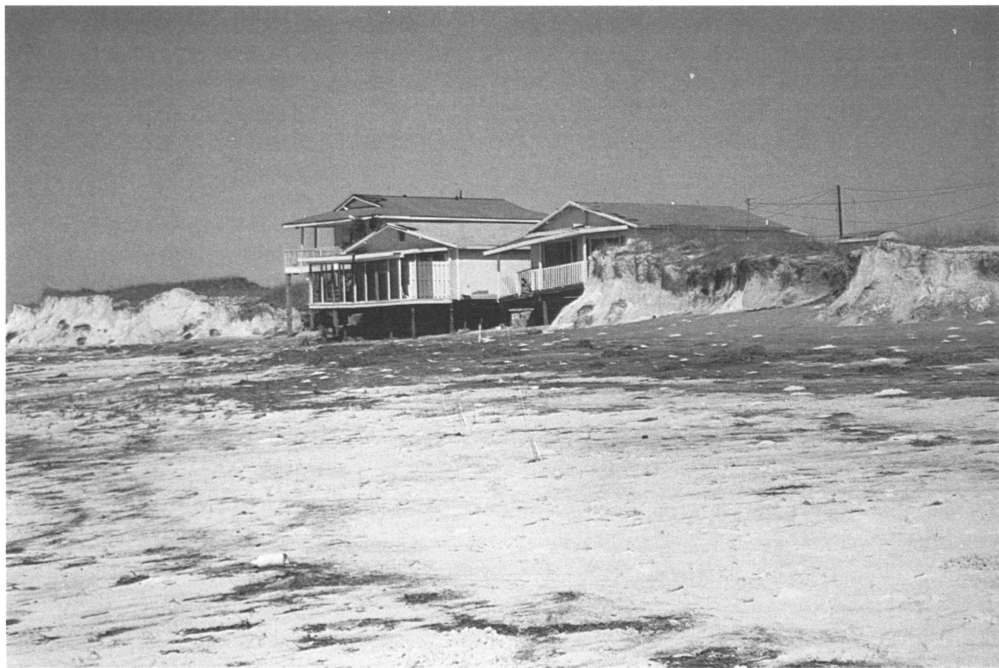
Figure 3. These houses west of Hollywood Beach illustrate the impact of removing dunes. Despite being elevated slightly and set back approximately 60 m from the shore, prior dune removal resulted in some structural damage to these single family homes during Opal. Had the houses been built behind the dune, damage would have likely been minimal.

All along the impact area dunes were destroyed. However, structures with pre-storm dunes received less damage than structures where the dunes had been entirely or partially removed during construction. Dune restoration should now be an early focus for future mitigation of storm damage in the impact area.

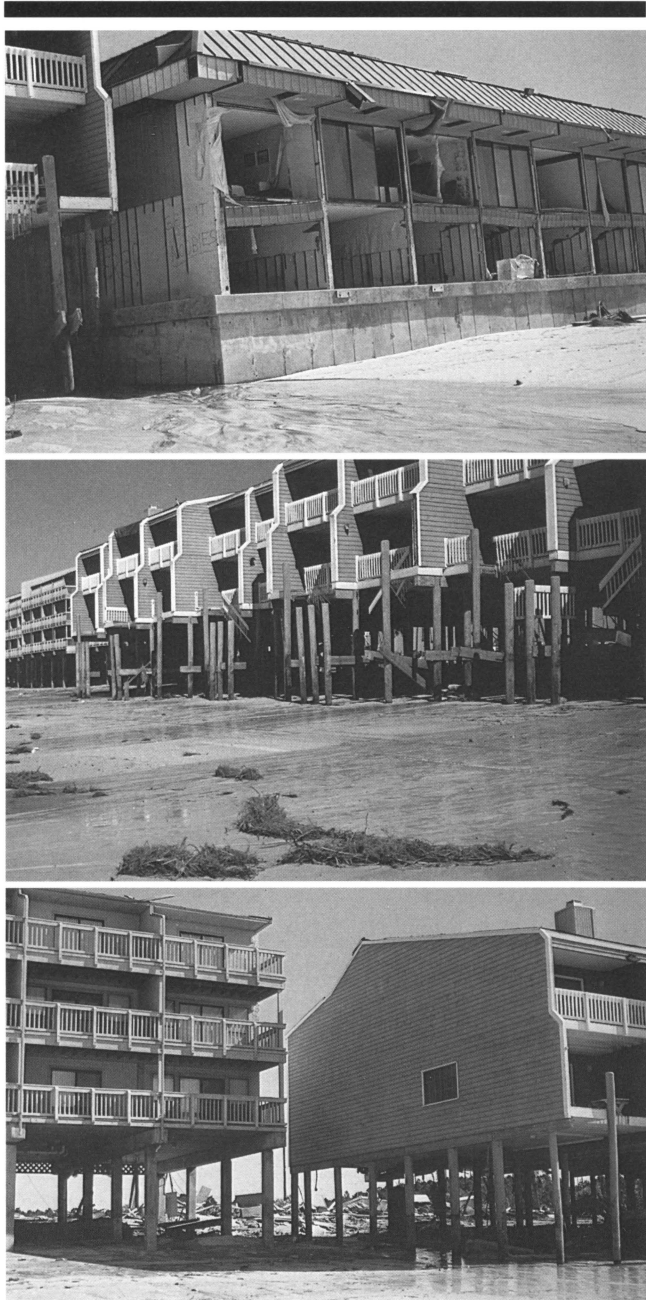
Figure 4. Three adjacent buildings in Hollywood Beach provide a basis to compare the damage mitigation capabilities of seawalls, building above grade, and building setback. Elevation and setback provided greater protection than seawalls. 4A. This building is at grade and is farthest seaward of the three. The seawall protected the structure from being undermined, but did not prevent both floors from being completely destroyed by wave action. 4B. Built approximately 3 m above pre-storm grade and set back slightly landward of the structure in Figure 4A, this building suffered minor wave damage to the first floor. The water and waves that destroyed the structure in Figure 4A passed under this building. 4C. This building (left) is set back approximately 12 m further landward and is elevated slightly higher than the structure in Figure 4B. It received no structural wave damage.

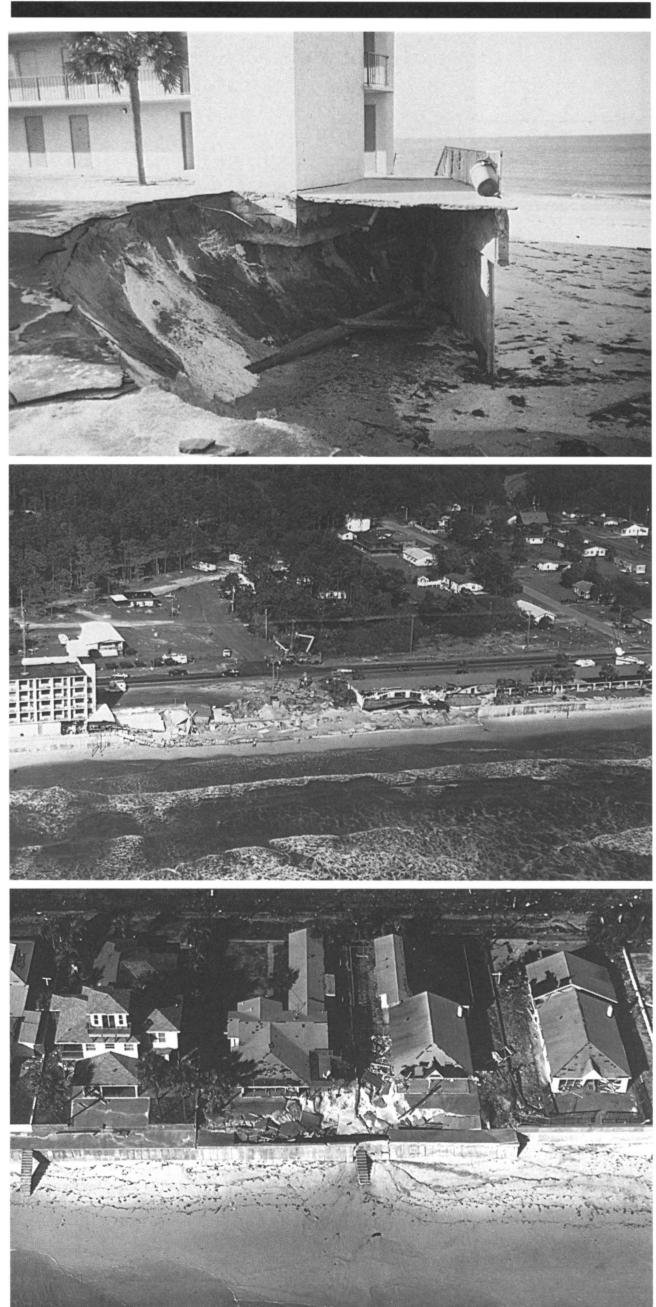
Figure 5. Seawalls prevented significant damage to many structures. However, failure of seawalls was not uncommon, indicating they may not be the best or most assured method of reducing damage. Three main types of failures were observed. 5A. End around failures of seawalls, like this one in Mexico Beach, resulted from erosive "flanking" of the seawall. 5B. This seawall in Mexico Beach did little to protect the structures behind it. The wall fell seaward, indicating overloading of the structure from behind. Loading by rain water, wave washover and insufficient drainage led to failure of the tiebacks. 5C. Seawalls can also be undermined, as shown by this Panama City Beach example. Scouring at the base of the seawall removed material from behind the wall, resulting in the wall falling landward, characteristic for this type of failure.

Seawalls, like natural dunes protected many structures from significant damage. However, failure of seawalls was not uncommon, indicating that they are certainly not fool-proof. Three main types of failures were observed: (1) end-around failures resulting from erosive "flanking" of the seawall; (2) seaward toppling of the seawall by overloading from behind by rain water, wave washover, and insufficient drainage leading to failure of the tiebacks; and (3) undermining by erosive scouring at the base of the seawall which removes material from behind the wall resulting in the characteristic landward fall of the wall.

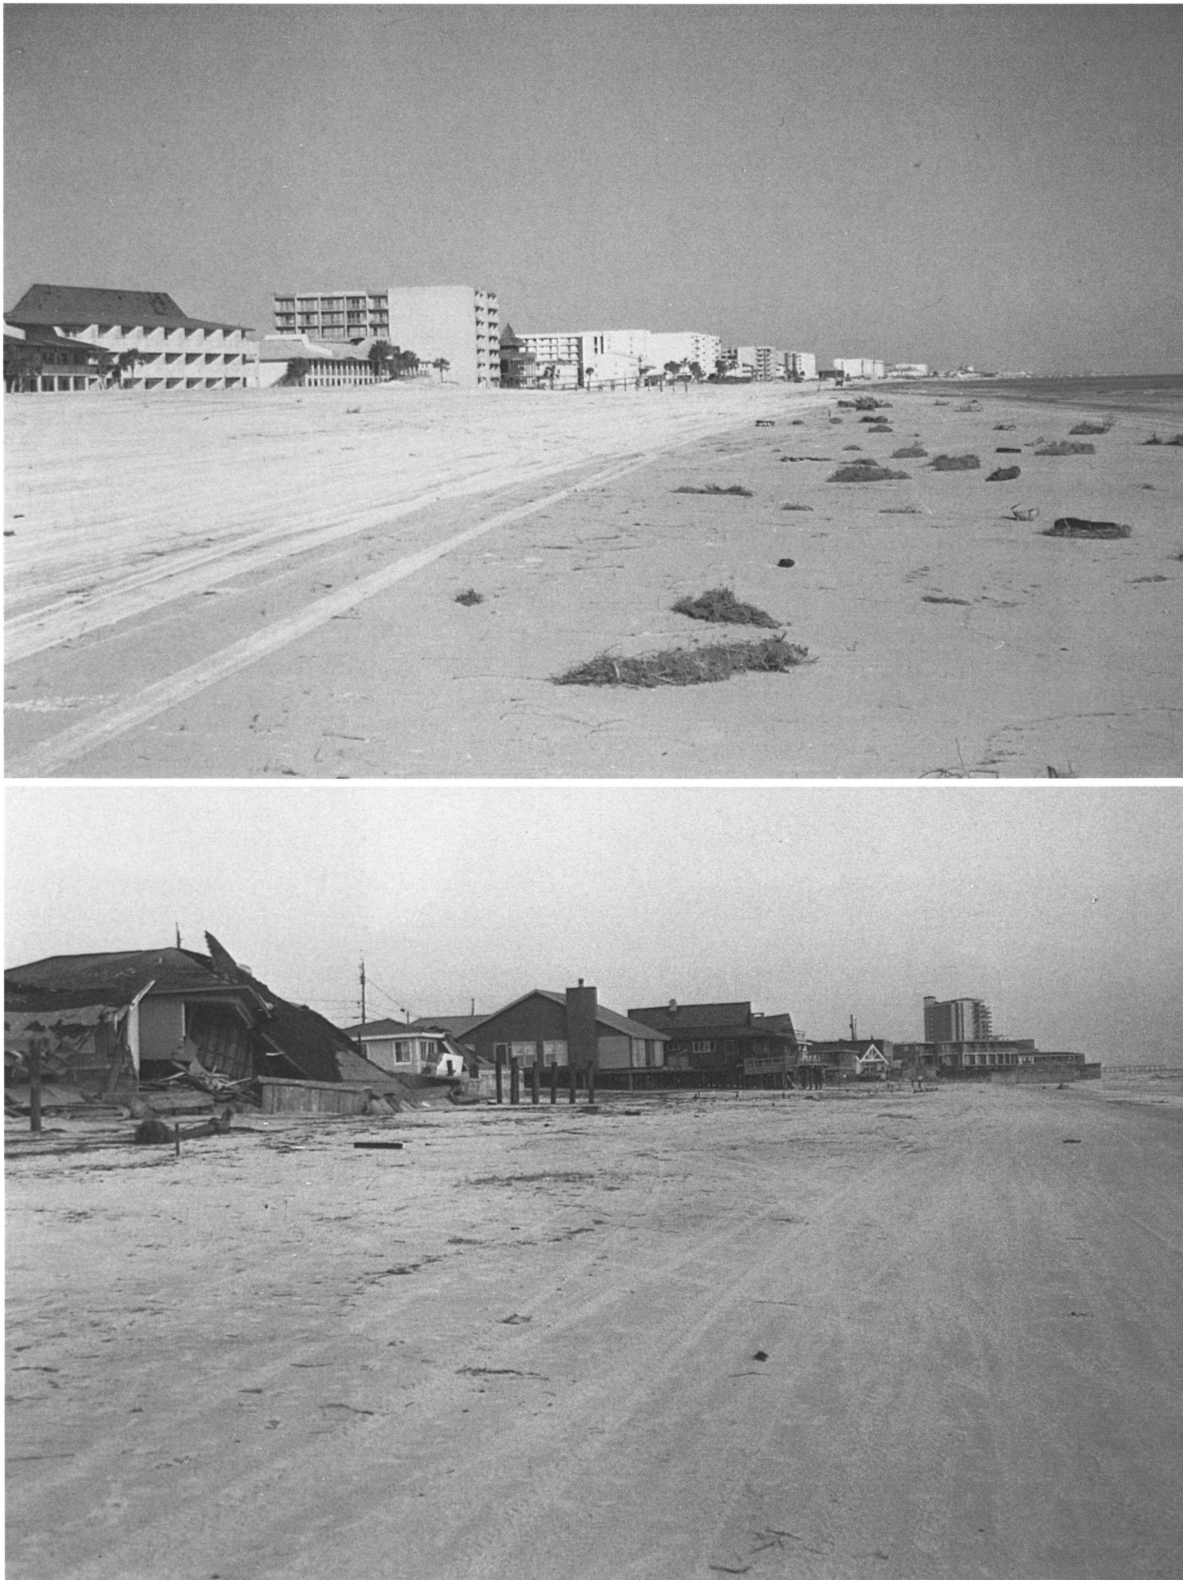
Figure 6. A. This picture from Fort Walton Beach shows the wide and flat post-storm beach. Most of the area was overwashed, leaving inland sand deposits up to 1m thick. The wide pre-storm beach and high dunes helped to reduce damage here. The large setback and immediate emplacement of overwash sand back on the beach will help mitigate against future storms. 6B. The wide, flat post-storm beach in Panama City Beach leaves all structures at a higher risk of damage by future storms. Mitigating some future damage to the single family structures in the foreground however, can be as simple as constructing an artificial dune. The seawalled structures in the background have few if any mitigation options.

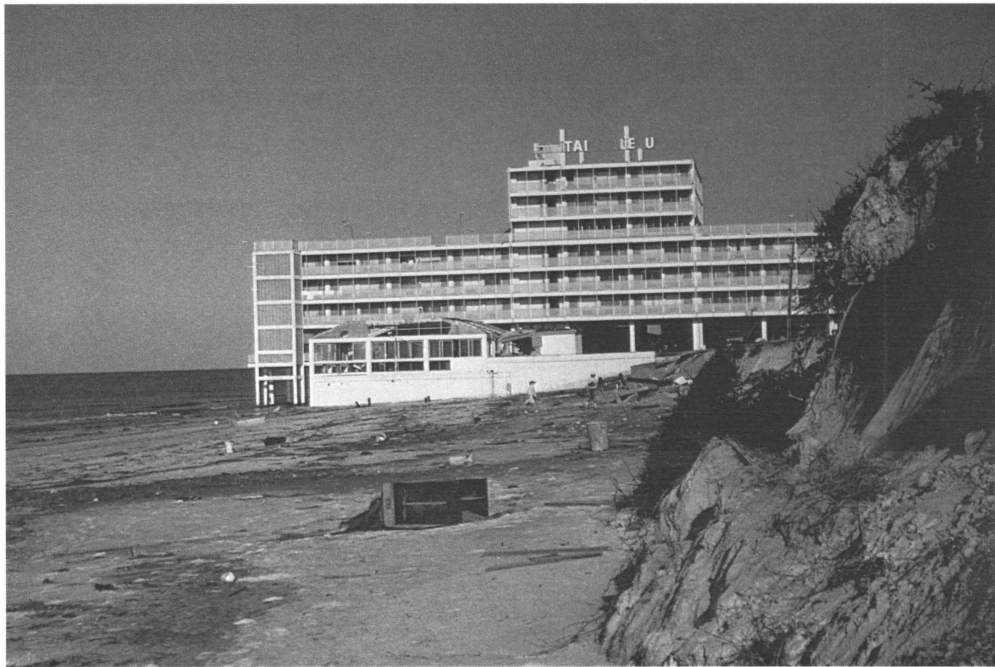
Figure 7. Erosion along Panama City Beach seriously damaged the hotel in the background. Nearly the entire structure is now seaward of the 3 m dune, with part of the building in the surf zone itself. The structure is now extremely vulnerable to even a small storm. Prevention of future damage to this structure would most likely be attempted with beach replenishment but would be only a temporary solution to the problem.

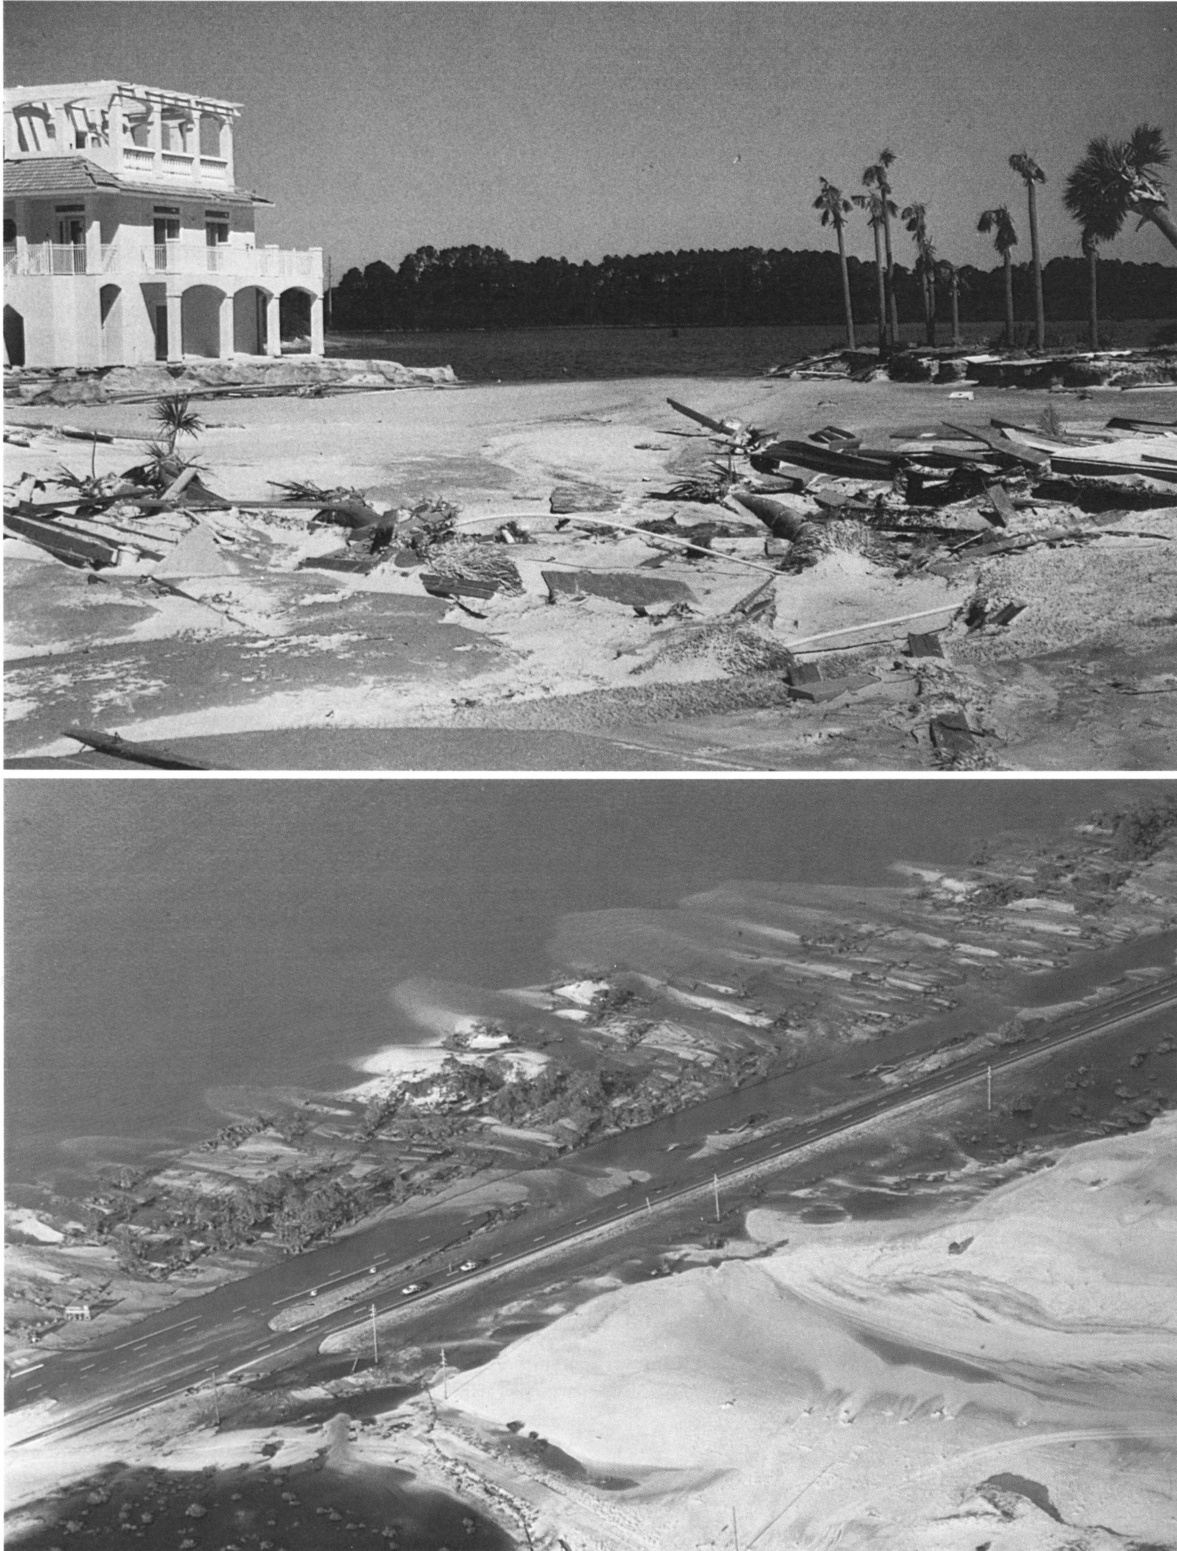
Figure 8. Storm surge flood scour occurred in many areas. By their nature, these areas are prone to repeat flooding and should be noted for future development restrictions. 8A. Channelized overflow of this area near Destin resulted in intense storm surge flood scour. 8B. In Fort Walton Beach, overflow scoured away Florida Route 98 and deposited washover fans in the lagoon.
