Another Look at the Impact of Hurricane Hugo on the Shelf and Coastal Resources of Puerto Rico, U.S.A.

RODRIGUEZ, R.W., WEBB, R.M.T., and BUSH, D.M., 1994. Another look at the impact of Hurricane Hugo on the shelf and coastal resources of Puerto Rico, U.S.A. *Journal of Coastal Research*, 10(2), 278-296. Fort Lauderdale (Florida), ISSN 0749-0208.

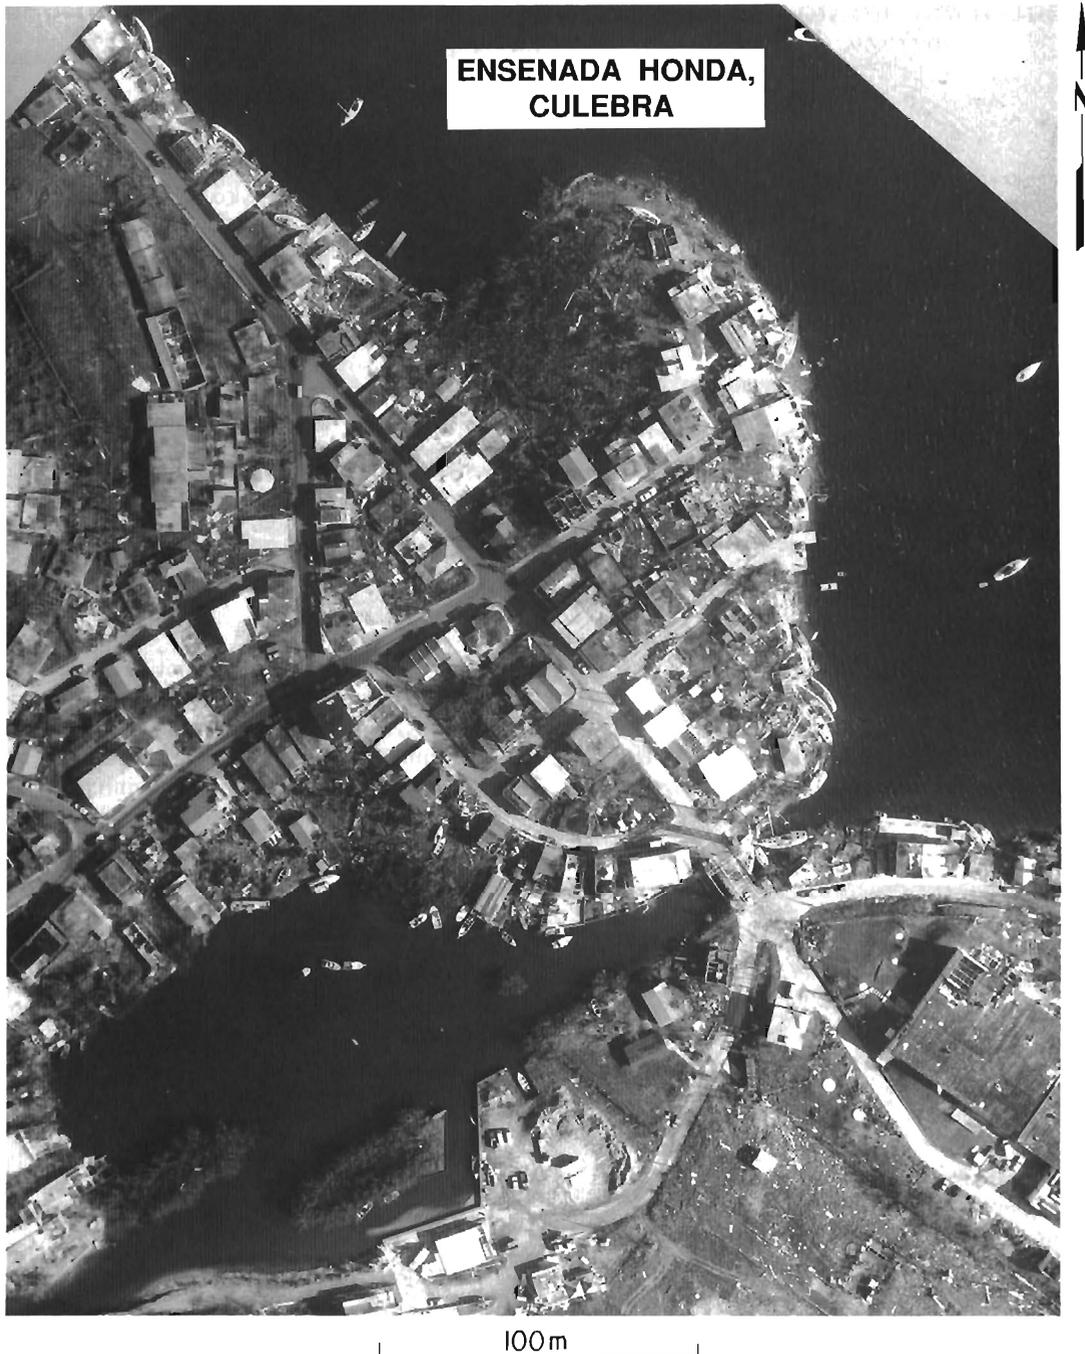
Figure 3. Aerial photograph of Ensenada Honda, Culebra, Puerto Rico taken on October, 1989. Strong winds combined with the storm surge jammed four sailboats under the bridge. Approximately 100 vessels out of 300 that took shelter in the "hurricane proof" harbor were sunk.

the development and infrastructure of eastern Puerto Rico. Over 80 percent of wooden structures were destroyed in Culebra and Vieques (FEMA, 1989). Thirty-thousand people were left homeless and property damage exceeded \$1 billion. Thousands of boats were destroyed. Boat owners as far away as San Juan and St. Thomas took their vessels to Ensenada Honda, a legendary "hurricane-proof" bay at Culebra (Figure 1). Sustained southerly winds of 193 km/hr (121 mph) with gusts to 240 km/hr (150 mph) (GOLDEN, 1990) created a wave setup in Ensenada Honda estimated at greater than 4 m. Vessels 20 m and longer in length were carried up and over the coastal road with several sailboats ending up wedged under a bridge (Figure 3).

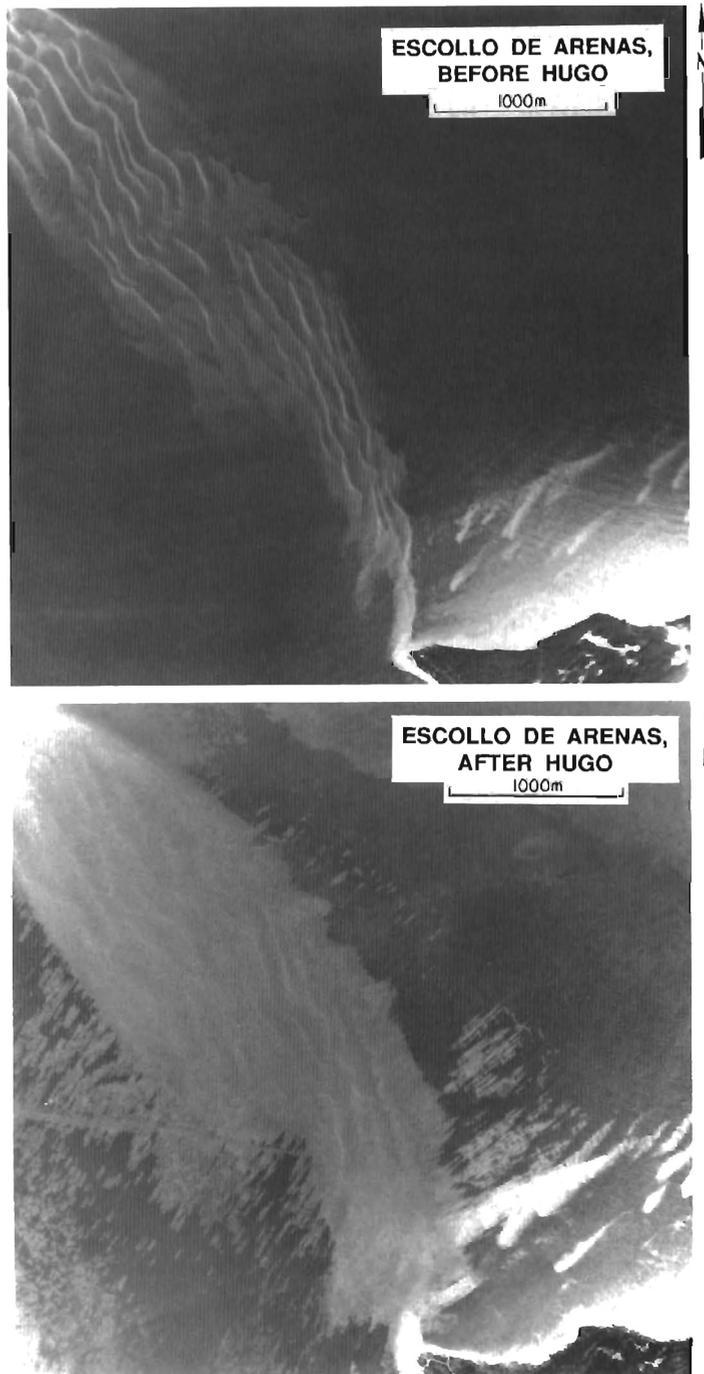
Figure 5. Aerial view of the Escollo de Arenas before and after Hugo. (Upper) Before Hugo. Note the well-developed bedforms on the surface of the sand deposit. The area of the deposit is approximately 3 km². (Lower) After Hugo. Hugo smoothed the characteristic bedforms of the surface of the deposit, dispersing sand over the adjacent sea floor. Seagrass beds to the east and west of the Escollo were buried. The resulting sand apron and large "blowout" areas of grass removal increased the area of exposed sand by 60%.

Tidal currents with velocities that commonly exceed 140 cm/s maintain a wide variety of bedforms on the surface of the shoal (RODRIGUEZ, 1979). Sandwaves having wavelengths on the order of 100 m and amplitudes of 2 to 3 m are the most common bedform. Hurricane Hugo smoothed these bedforms and dispersed the sediment over the adjacent sea floor (Figure 5) increasing the areal extent of the shoal by 60%. Most of the redistribution occurred along the eastern margin

of the Escollo, burying over 1 km² of seagrass beds. The algal plains along the western margin were also severely affected by the formation of large northeast trending "blowouts" or areas of deep scouring of the seagrass meadows. Vibracores taken three months after Hugo showed 5 to 10 cm of sand deposited on the seagrass beds (Figure 6). These results coupled with aerial photo-interpretation suggest an unrecoverable loss of between 10 and 20 × 10⁵ m³ cubic meters of sand from the Escollo (worth more than \$2,000,000 at current market prices). The loss is considered unrecoverable from a commercial standpoint because the sand was deposited as a thin layer on top of a muddy substrate typical of seagrass bed

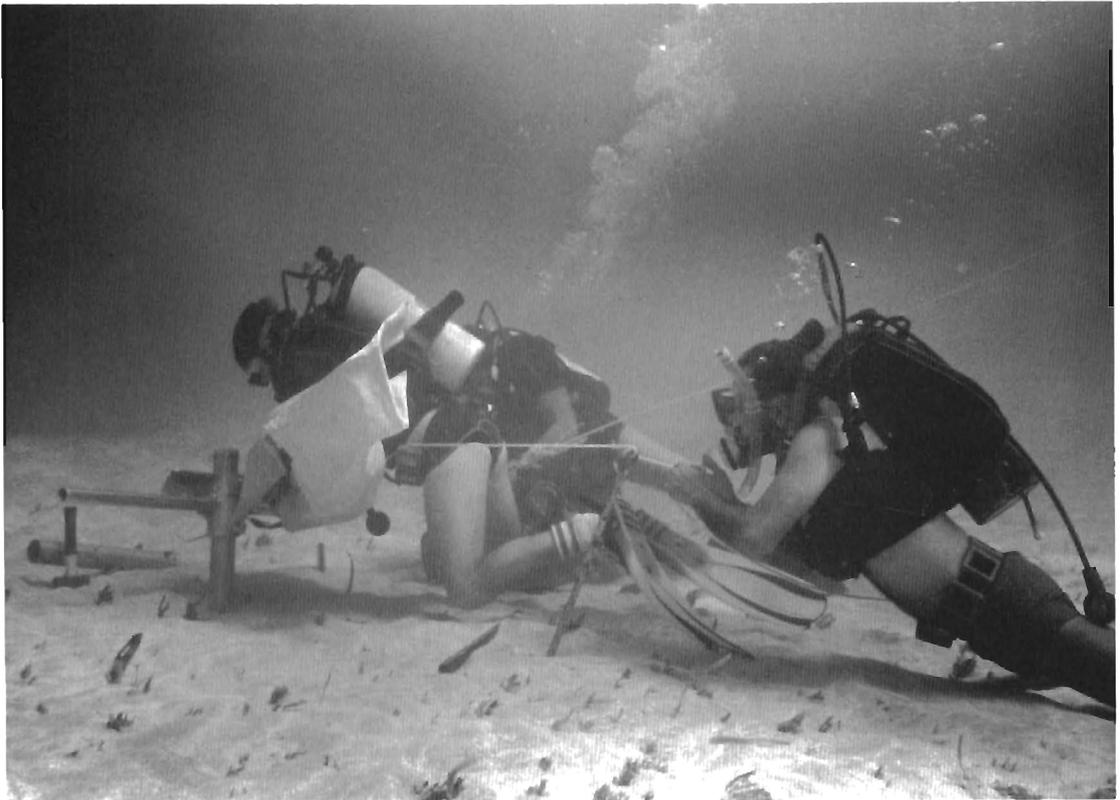
Figure 6. Underwater photograph showing sand covering seagrass beds on the fringes of the Escollo de Arenas.

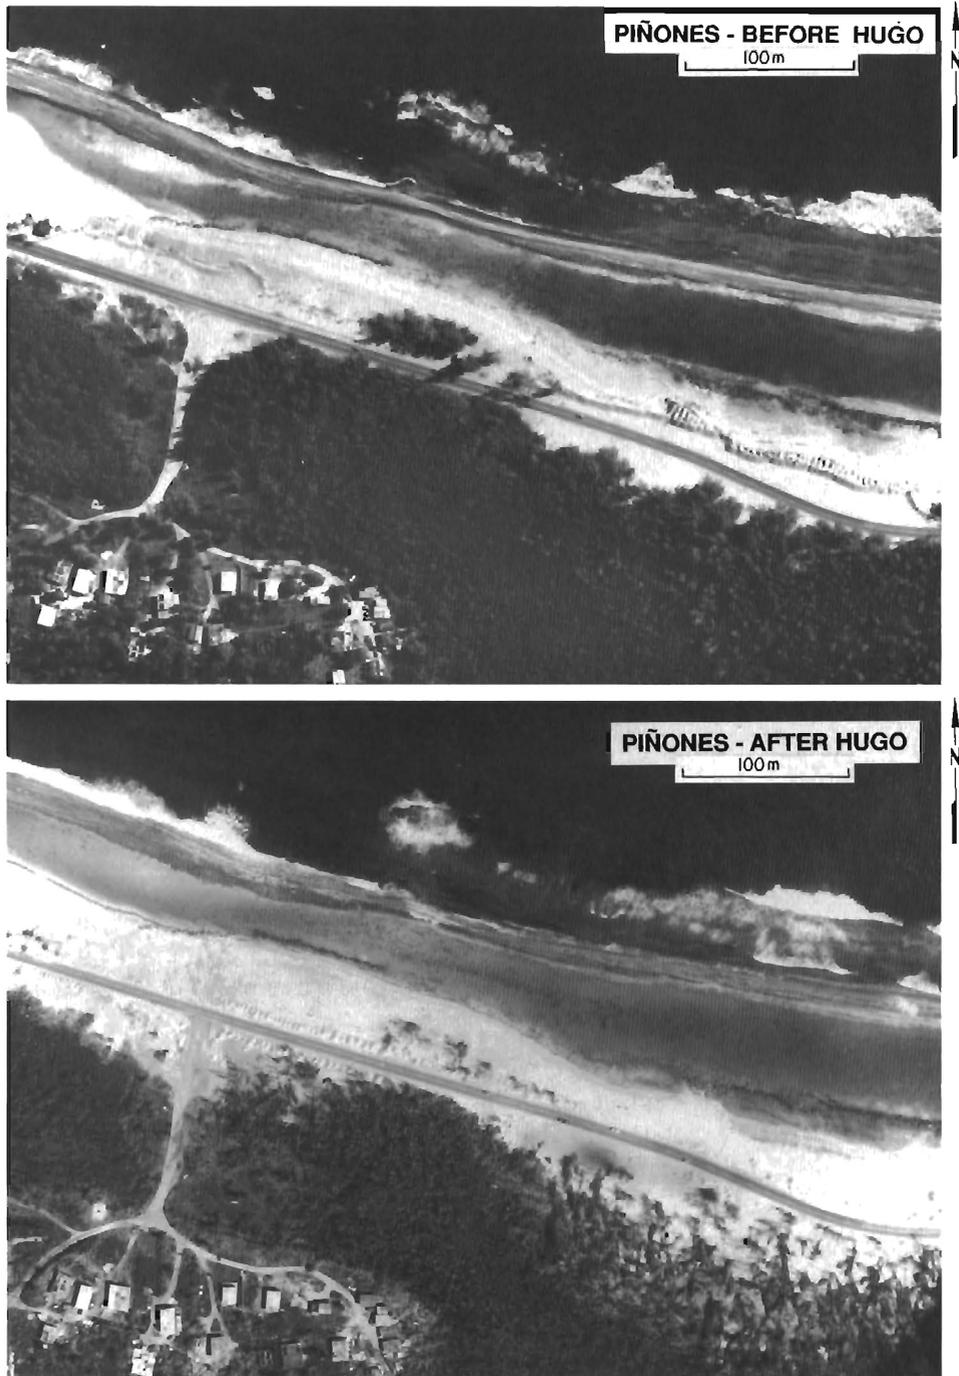
Figure 8. Aerial view of heavily overwashed section of Piñones. See Figure 1 for location. (Upper) Before Hugo. The artificial dune discussed in the text was located in the right half of the photograph. (Lower) After Hugo (October 1989). More than 40,000 m² of sand overwashed across the road effectively removing the material from the active beach system. Whereas vegetation worked to restrict the extent of the overwash, roads perpendicular to shore acted as conduits, allowing the overwash to penetrate several hundred meters inland in places.

Long-time residents of the Piñones sector state that overwash has been common in the area following removal of a massive dune system bordering the north side of highway 187 for fill in the 1950's. Without the protection of the dunes, even moderate energy waves have the potential to ov-

erwash the road and deposit the sand in the mangroves of Torrecilla Lagoon. In 1986, the U.S. Army Corps of Engineers constructed a 56,000 m³ artificial dune along a 300 m section of the road in order to mitigate the problem. The project cost approximately \$300,000. In 1987, an extratropical storm generated swells that impacted the Piñones area, eroding a large portion of the artificial dune. Hugo completed its total destruction, carrying the remaining material landward. A total of over 500,000 m³ of sand was overwashed along the entire 1 km stretch of shoreline of coastal compartment 1 (BUSH, 1991). The thickness of the deposit exceeded 1 meter along several kilometers of Highway 187. In the aftermath of Hugo, the Puerto Rico Department of Natural Resources used heavy equipment to return 46,000 m³ of the overwashed sand back to the active beach system. Whereas vegetation worked to restrict the landward extent of the overwash penetration, roads

perpendicular to shore acted as conduits, allowing the overwash to penetrate several hundred meters inland in places (Figure 8).

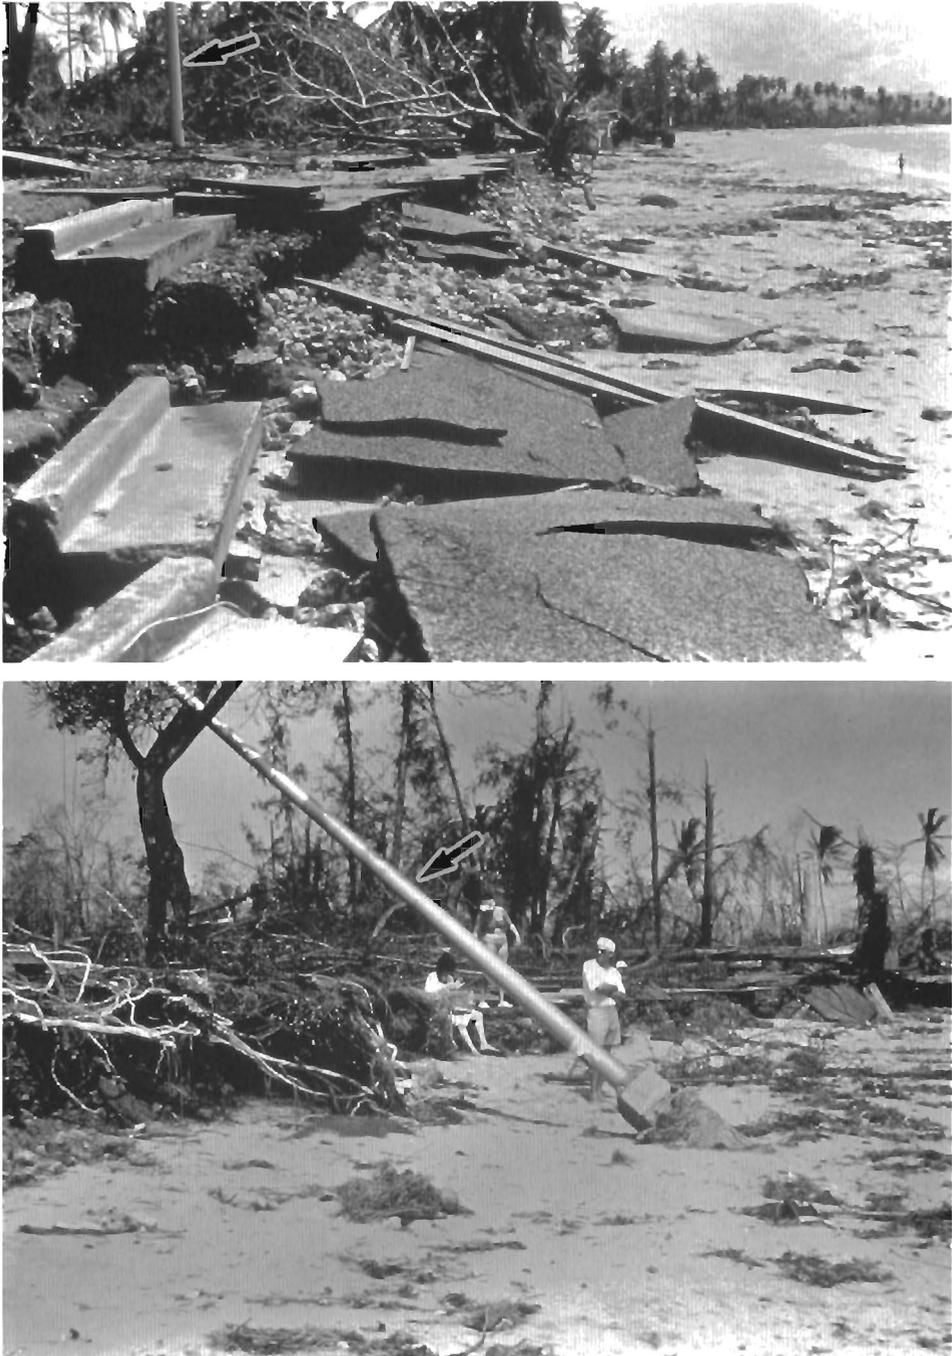
Figure 9. Balneario Isla Verde (see Figure 2 for location). (Upper) January 1988 photograph of Balneario parking lot. Scarp has been maintained by frequent storms. Arrow points to light pole that was toppled by Hurricane Hugo. (Lower) September 1989 photograph showing Hugo erosional scarp and toppled light pole.

The rapidly eroding shoreline is evidenced by a stranded boat ramp some 50 m from shore. When storm events are relatively frequent, a 1 m scarp is maintained along the northern section of beach where a paved parking lot is eroding (BUSH, 1991).

Hugo further undercut the parking lot causing 10 m of retreat, leaving behind a fresh scarp (Figure 9). Farther south along the open beach most used for recreation, Hugo flattened the natural berm, undercutting several lifeguard stands and shower facilities located within 15 m of the shoreline. The storm waves lowered the beach face several feet, exposing fresh beachrock. In the days following Hugo, the beach material was redistributed into large cusps with a 20 m spacing. Two years after Hugo, the scarp and the beach had returned to

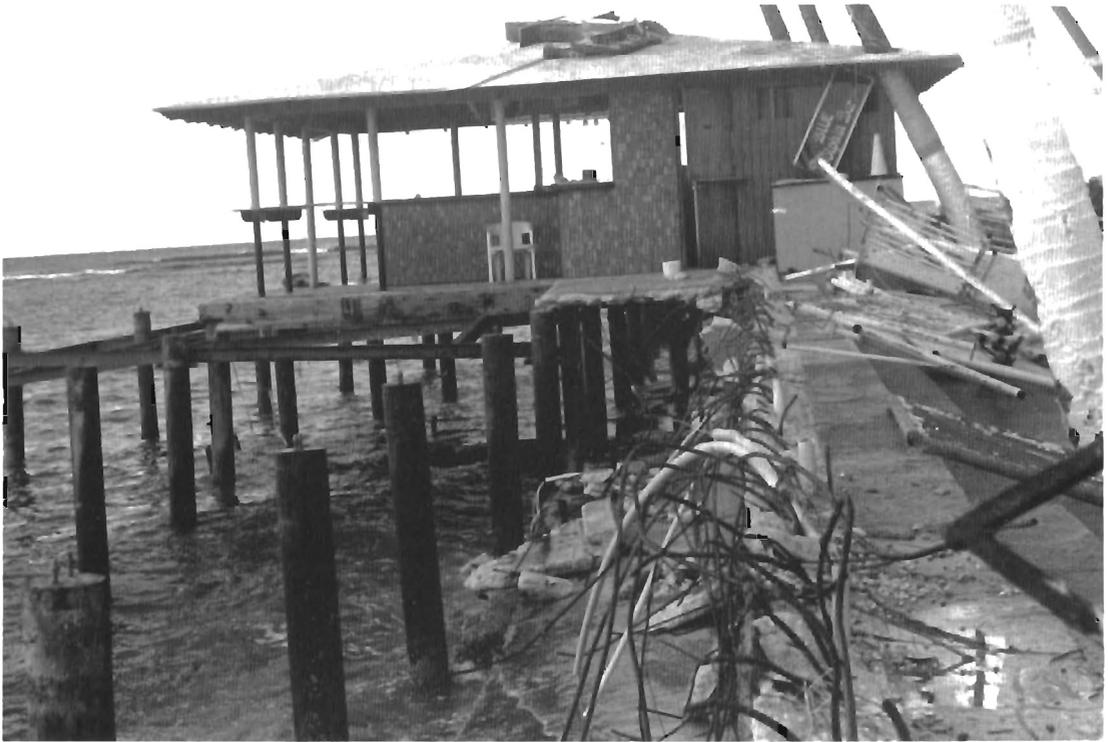
Figure 10. Empress Hotel boardwalk located at Punta El Medio. An extensive boardwalk, bar and pool built out over the ocean in the mid-1980's was destroyed by Hugo and has since been rebuilt.

Both the Empress Hotel, built on Punta El Medio, and the infrastructure in front of the Playamar Condominium were heavily impacted by Hugo (Figure 10). Although the beach on the western flank of the point changed little (Playamar profile, Figure 11A), the sidewalk was undermined and the adjacent streets flooded.

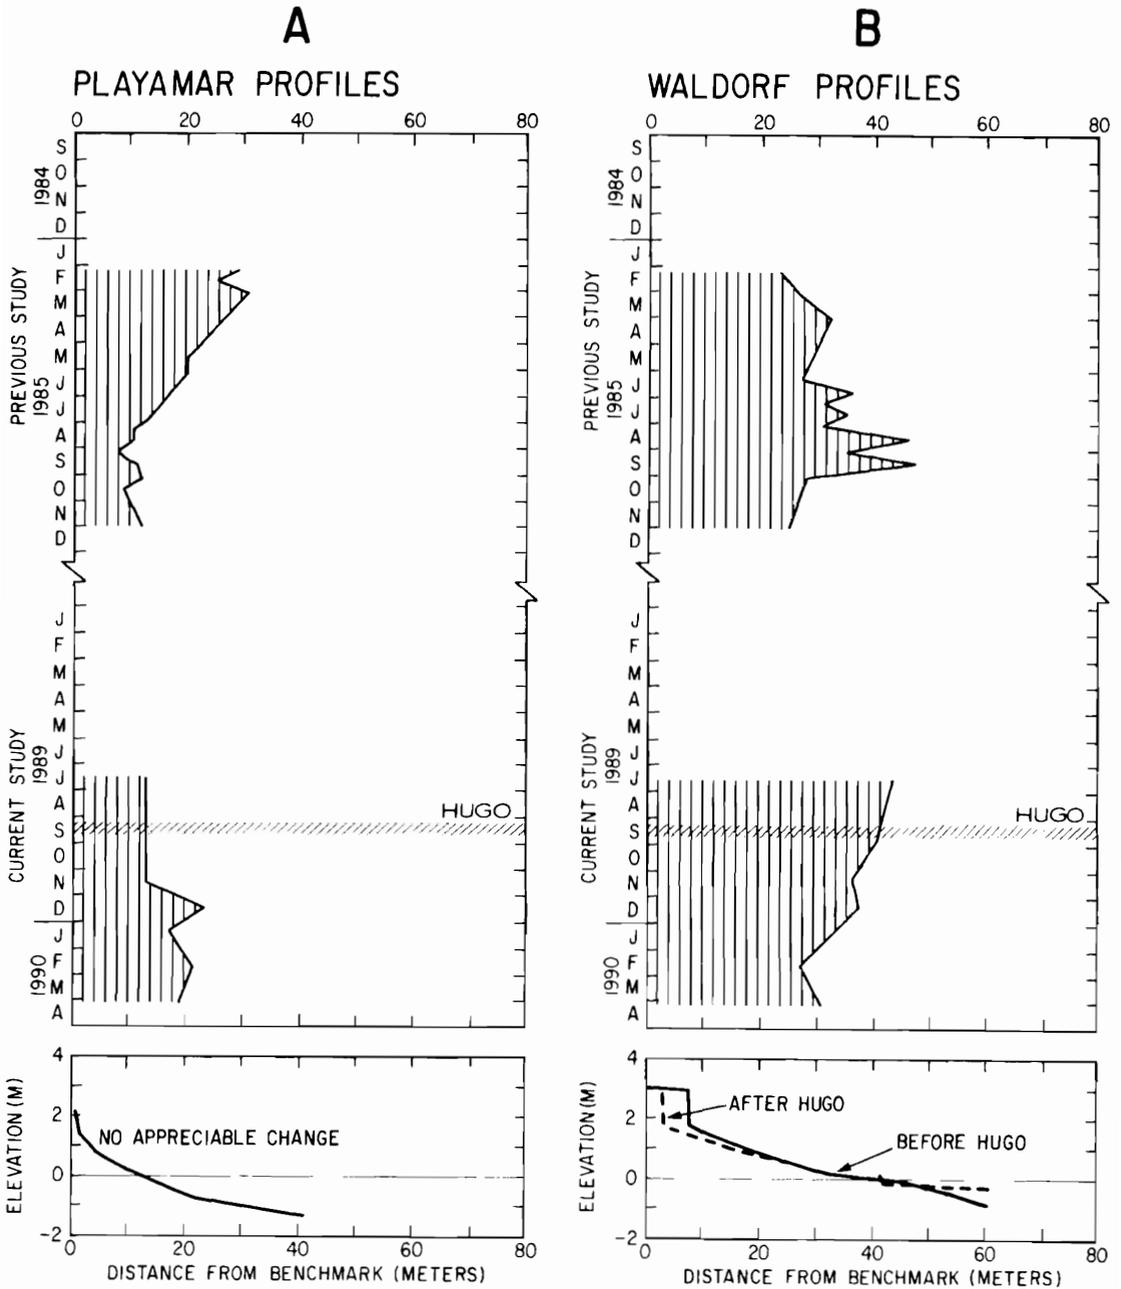
Figure 11. Distance from benchmark versus time as observed from October 1984 to November 1985 and again from July 1989 to April 1990. The profiles beneath the graphs show the change in the beach morphology caused by Hugo. (A) Playamar, (B) Waldorf Towers, (C) Barbosa Park, (D) Ocean Court, (E) Dupont East, and (F) Dupont West (see Figure 2 for locations).

East of Punta Las Marias, the shoreline has retreated more than 50 meters since the 1930's. Hugo damaged the seawalls and gabions but did not cause extensive flooding or alter beach width or the profile significantly. Farther east, Hugo cut heavily into the berm behind Waldorf Towers (Figure 11B) destroying the sidewalk (Figure 12).

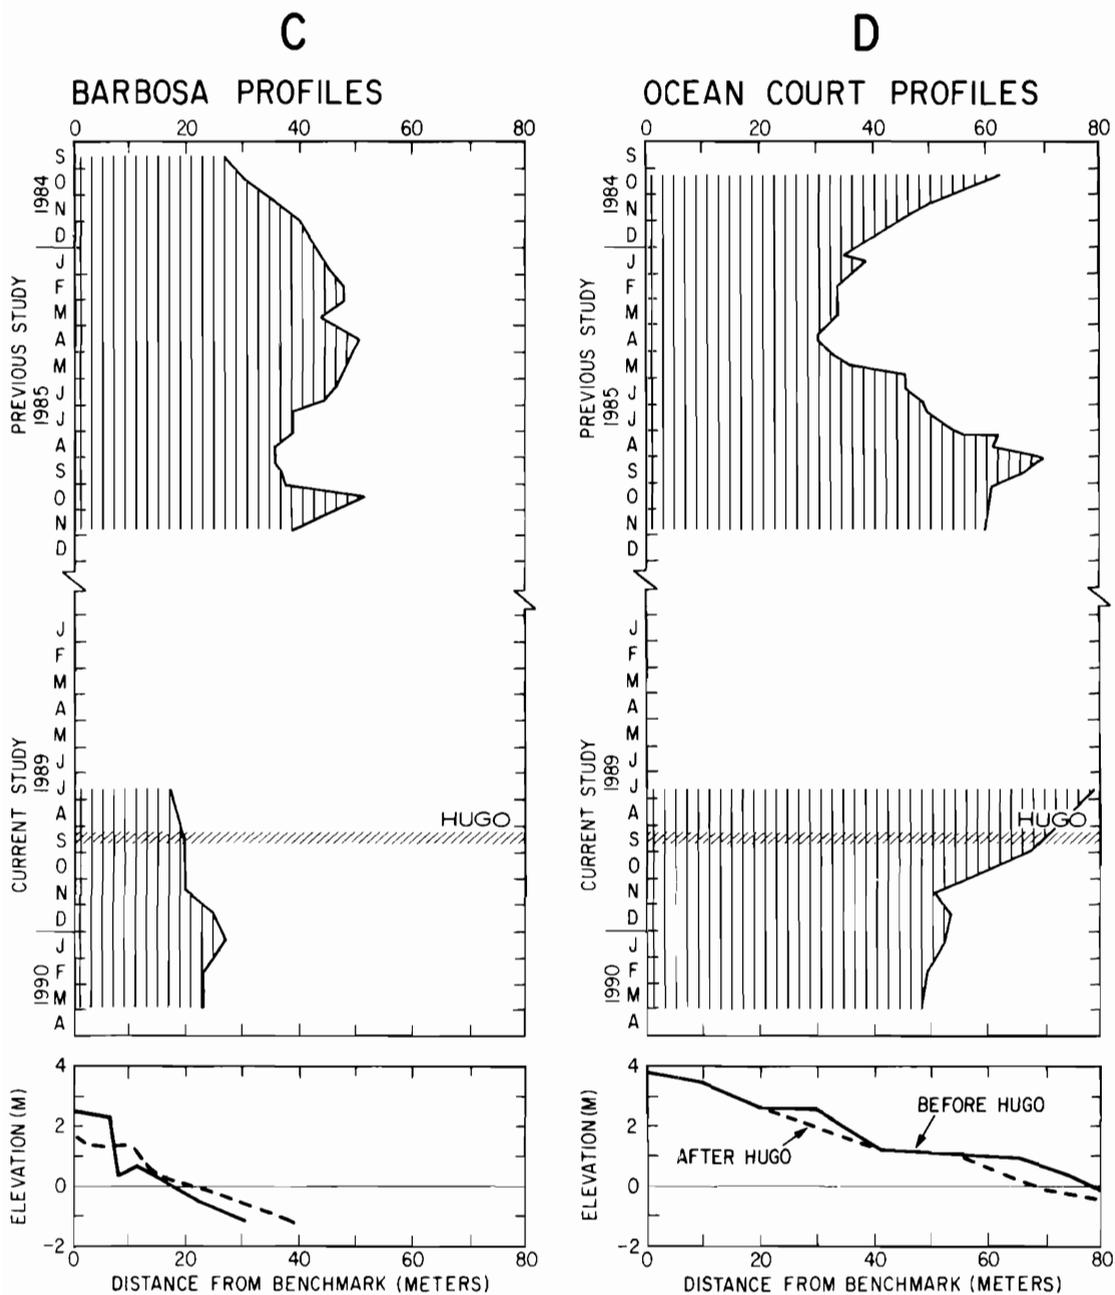
Figure 11CD.

The Ocean Court beach has typical seasonal cycles, wider in the summer and narrower in the winter (Figure 11D top). Hugo flattened the beach (Figure 11D bottom). The backshore elevation is approximately 4 m and flooding did not occur.

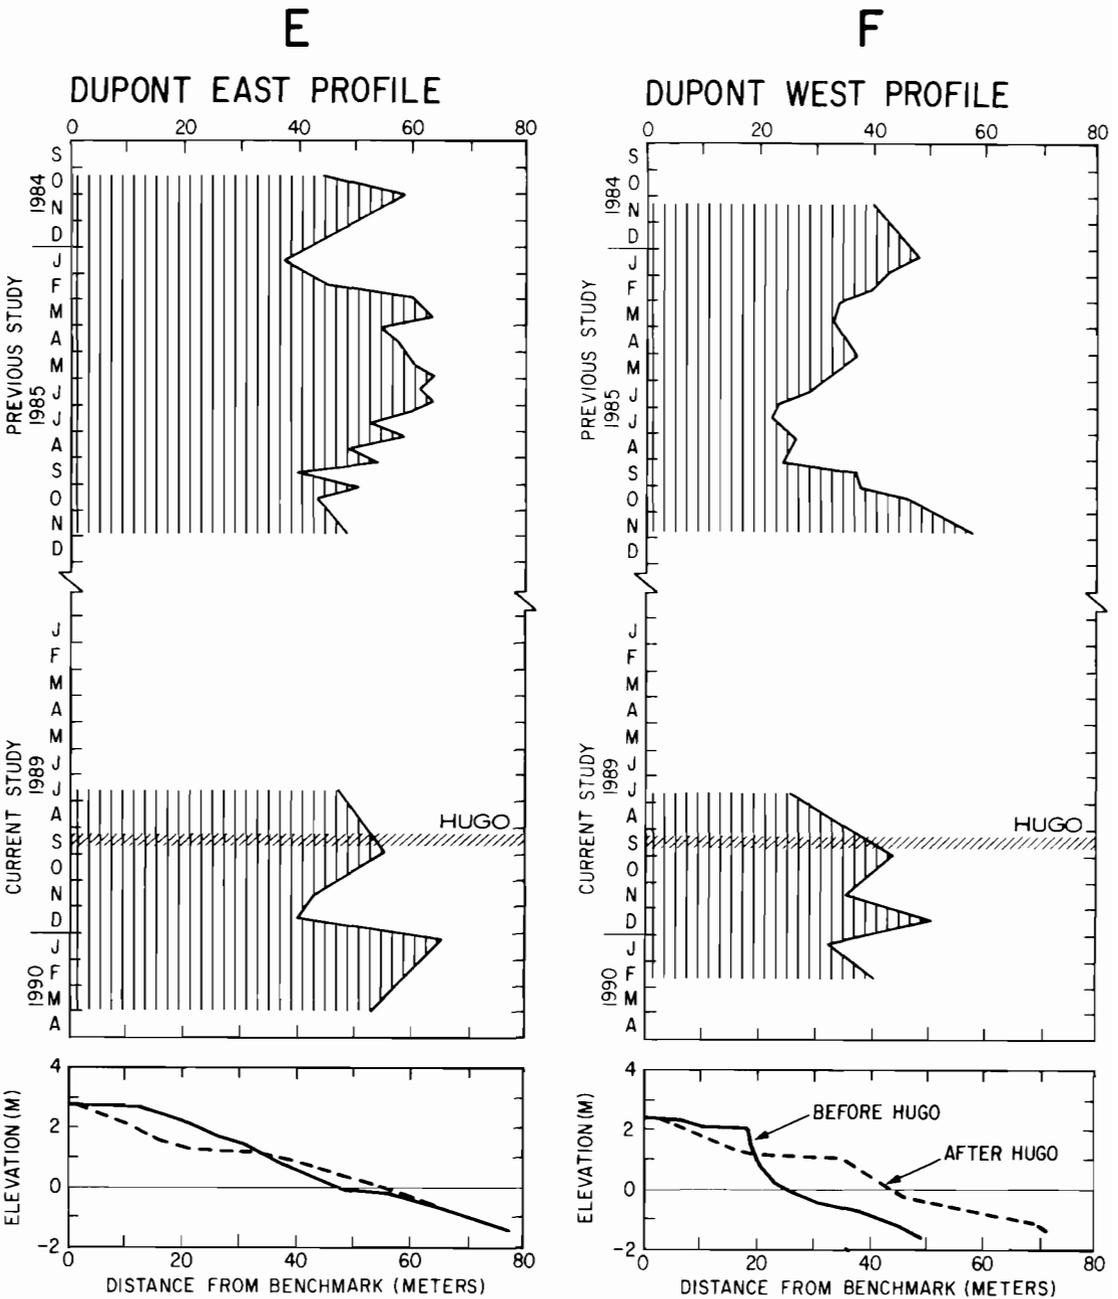
Figure 11EF.

A groin west of Punta Piedrita (behind the Dupont Plaza Hotel) traps sand travelling to the west during the summer when winds and associated wave trains are from an easterly direction. An opposite pattern is commonly observed during the winter season with the arrival of storm waves from western North Atlantic extratropical depressions. Wave erosion diminishes the beach to the east of the groin during the winter as the longshore transport to the west slows and even reverses (Figure 11E and 11F, top). Hugo-generated waves arrived

from a more northerly direction and thus reversed the sand transport direction to the east. During Hugo, the beach on the west side of the groin increased much more than that on the east side (Figure 11E and 11F, bottom).

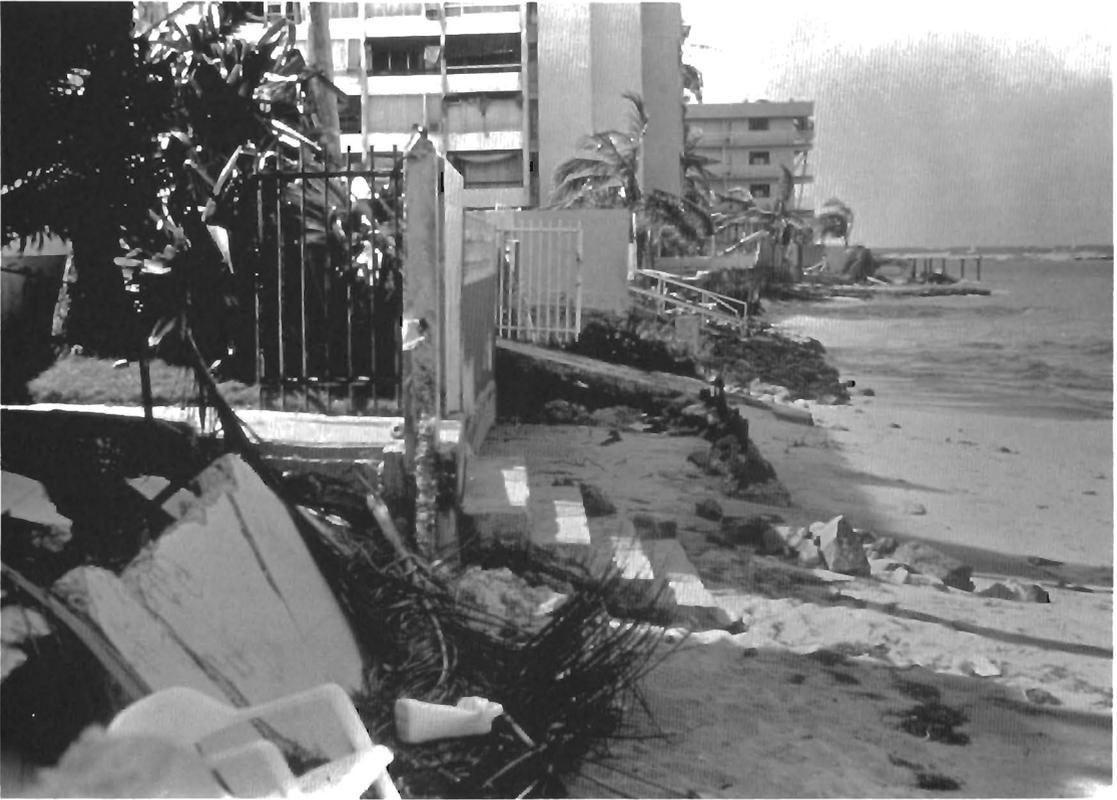
Figure 12. Photograph of Waldorf Tower Condominium ocean front showing effects of Hurricane Hugo.

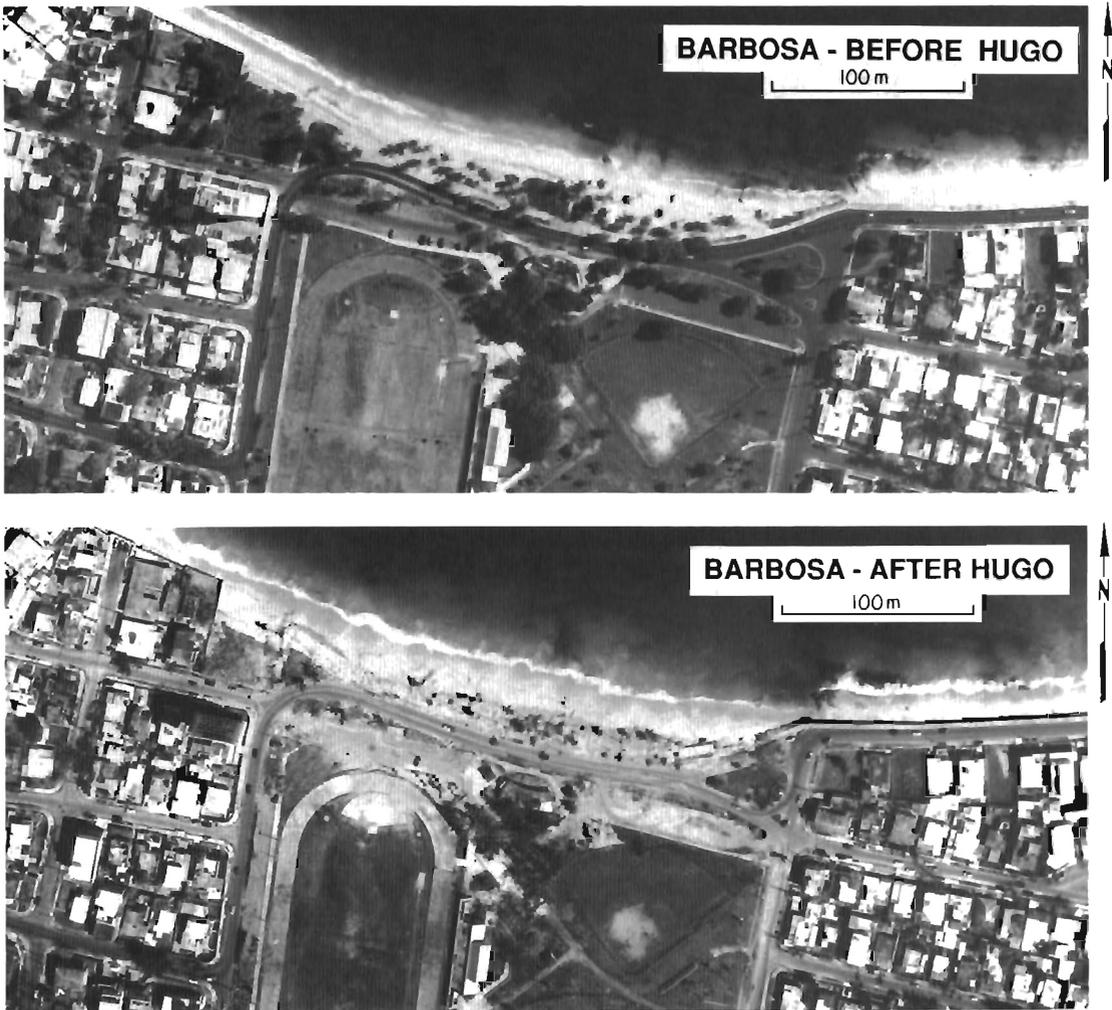
Figure 13. Aerial view of Barbosa Park (see Figure 2 for location). (Upper) Before Hugo (August 1989). Significant quantities of sand are regularly deposited on the shore parallel street by minor overwashes and eolian transport. (Lower) After Hugo (October 1989). Overwash extended across the street into the track area.

Battered seawalls extend from Punta Las Marias to Barbosa Park preventing sand from overwashing but also from forming natural dunes. At Barbosa Park significant quantities of sand are regularly deposited on the shore-parallel street north of the park by minor overwash events and eolian transport. Hurricane Hugo caused a major overwash and significantly altered the profile of the beach (Figures 11C and 13). To maintain the street clear of sand, the municipality regularly collects and transports the sand offsite. Removal of that sand has prevented the natural rebuilding of sand dunes that existed there before the road was built. Hugo destroyed the sidewalk and undermined the streets (Figure 14).

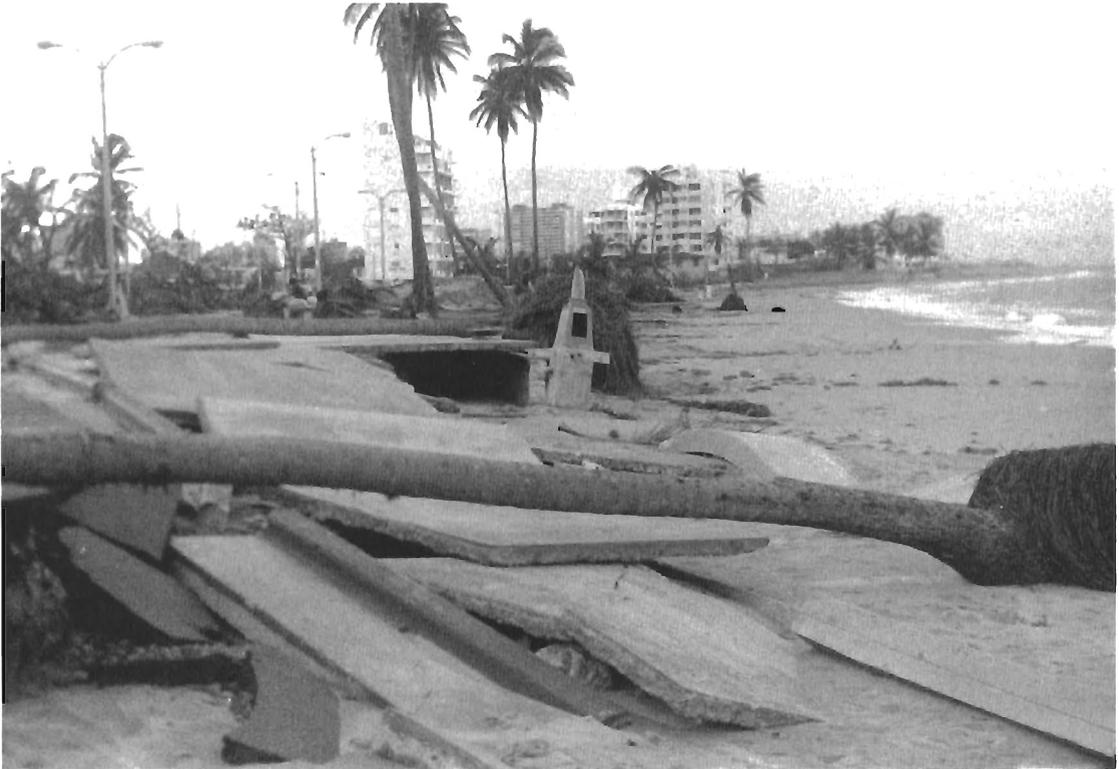
Figure 14. Barbosa Park after Hugo (September 1989). Hurricane Hugo destroyed the sidewalk and undermined the street.

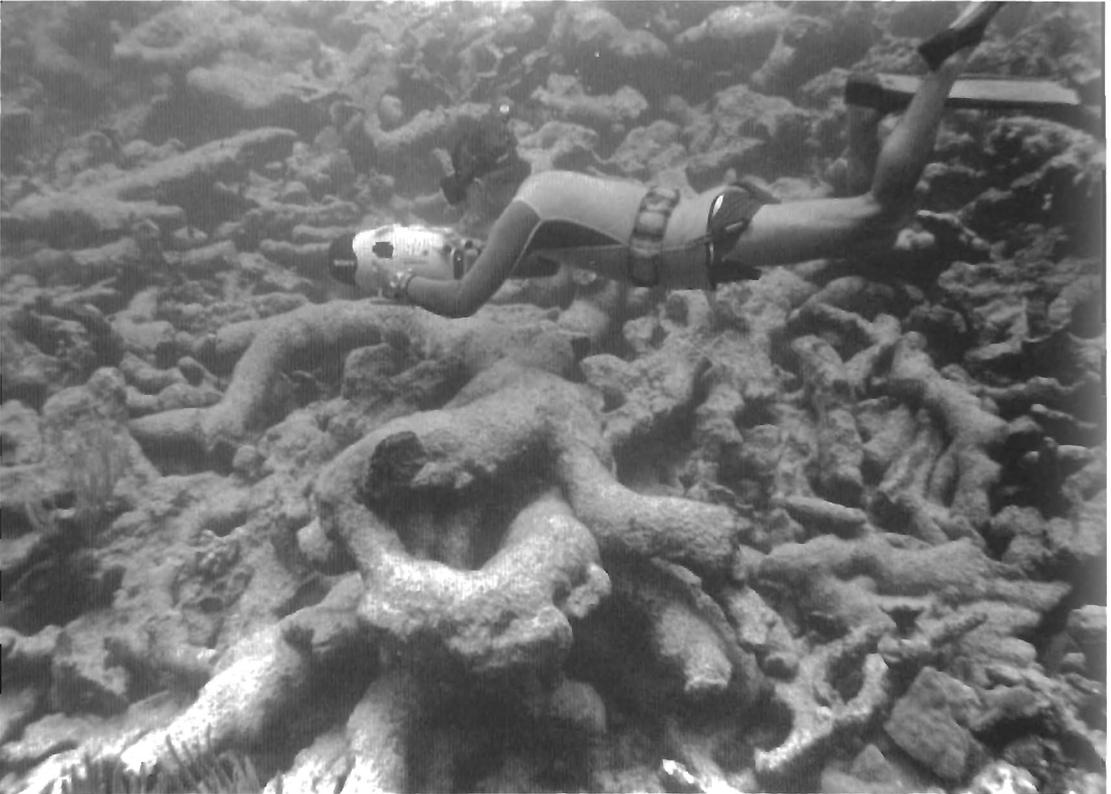
Figure 15. Underwater photograph of coral rubble in eastern Culebra (July 1991). E. Shinn photograph.

ation, 1991). The finger coral, *Porites porites*, and staghorn coral, *Acropora cervicornis*, were also greatly affected. Large quantities of these delicate branching corals had been reduced to gravel-size rubble forming steep (20° to 30°) debris slopes (Figure 15) that buried boulder corals such as *Montastraea annularis*. In spite of the devastation, the reefs on the eastern side of Culebra are showing signs of healthy regrowth (SHINN, personal communication, 1991). Monitoring of coral community response will continue as part of the USGS-DNR project.

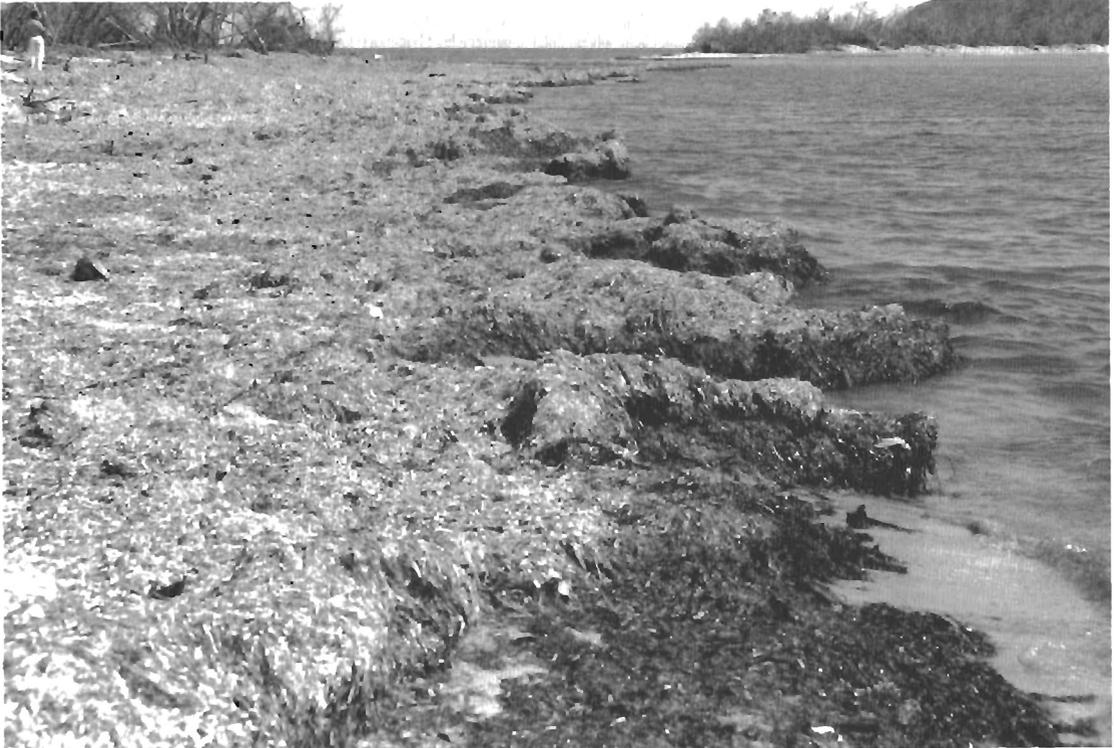
Figure 16. Mat of seagrass debris deposited by Hugo onto the beach at Esperanza, Vieques.

grass and deposited the debris on beaches on the south coast of Vieques Island and along the south and southeast coast of the main island. The mat of seagrass debris on the beach at Esperanza, formed a large spit (approximately 2,000 m²) over a meter thick (Figure 16). More than a square kilometer of seagrass beds were uprooted around the Escollo de Arenas, and another 1 to 2 km² were covered with sand. Significant deposits were found as far west as Jobos Bay where a mixture of calcareous sand and seagrass debris formed a 0.5 m thick overwash deposit in the adjacent mangroves. Likewise, the main ocean street in Playa de Naguabo was covered by 0.5 m of seagrass debris in places. Monitoring of seagrass bed recovery and dynamics will continue as part of the USGS-DNR project.
