## The Role of Flow in the Everglades Landscape<sup>1</sup>

H. Fling, N. Aumen, T. Armentano, F. Mazzotti<sup>2</sup>

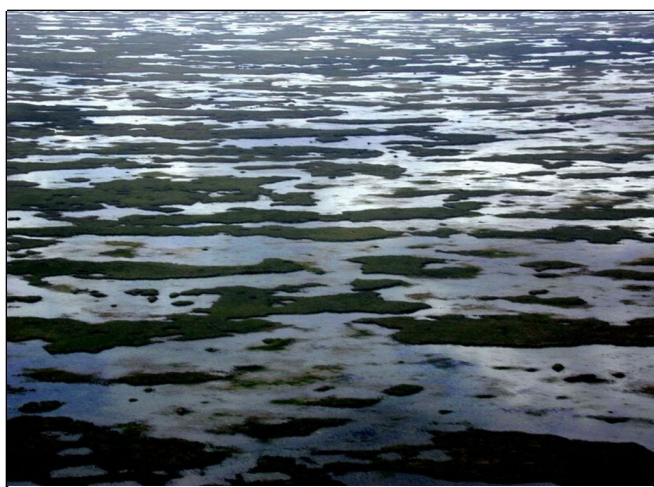
**Figure 4.** Well-preserved ridge and slough habitat from Water Conservation Area 3A. North is to the left, dark strips are sawgrass ridges, light areas are open water sloughs. Credits: Chris McVoy, aerial photo June 2001.

Loss of water flow is largely attributed to water management and development and has severely altered the ridge and slough landscape. Elongated ridges aligning with the direction of water flow are evident in Figure 4, which is consistent with pre-drainage patterns, while Figure 5 & 7 depict a degraded pattern with amorphous vegetation clusters having no directional alignment. Although some construction attempted to retain the integrity of the flow pattern using canals along the road connecting
