Frequency of Residential Irrigation Maintenance Problems¹

Thomas R. Olmsted and Michael D. Dukes²

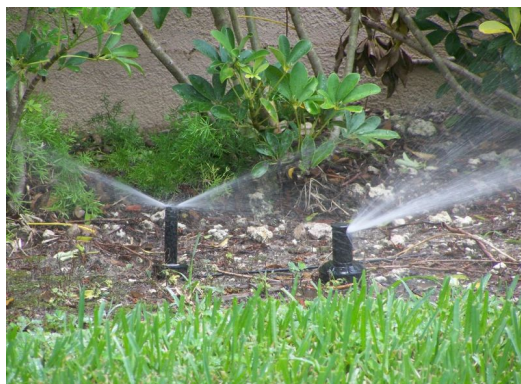
In 70% of the residential systems evaluated, the turf and landscape (ornamental beds) areas were irrigated by the same zone. This means that ornamentals and turfgrass are irrigated simultaneously because an irrigation zone covers both types of plant material (Figure 1). In most cases, ornamentals need less frequent irrigation than turfgrass. If the zone is programmed with a run-time for the water requirement of the turfgrass, the result could be over-irrigation of the ornamentals.

Figure 1. Ornaments and turfgrass being irrigated from the same irrigation zone. Note: the spray head in the background is irrigating the ornaments and the rotary sprinkler is irrigating the turfgrass in the foreground (photo by Michael Gutierrez).

How this is "fixed" depends on the severity of overlap. A few nozzles hitting the ornaments will probably not justify changing the system. However, if there are rotor sprinklers or spray heads designed for turf irrigation irrigating ornamentals beds instead, they probably should be replaced with a lower flow-rate sprinkler or removed altogether.

On newly installed irrigation systems, this overlapping of two different plant materials should be avoided. The irrigation contractor should have the landscape plans and install the irrigation system zones according to plant type. Correcting this problem has a potential to save water, depending on how many spray heads or rotor sprinklers are removed (Table 3).

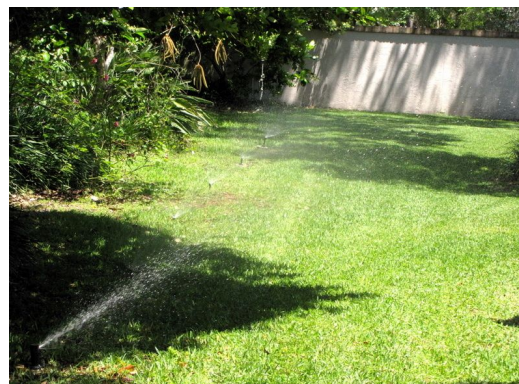
Mixing sprinkler types with different flow rates or application rates in the same zone was found to be the next most frequently occurring problem (Figure 2). For pictures of the different sprinkler types see *Operation of Residential Irrigation Controllers* at <http://edis.ifas.ufl.edu/ae220>. The result of this problem could be either over- or under-irrigation of part of the zone. If the rotor or spray head has a higher application rate than designed, the plant may not effectively use the excess water. If the application rate of an individual rotor sprinkler or spray head is less than designed, the homeowner may see that area is drier than the rest of the zone and increase the run-time to compensate, over-irrigating the other areas of the zone.

Figure 2. Mixed sprinkler types. Note: rotary sprinkler in foreground and spray heads in background (photo by Bernard Cardenas).

Unmatched application rate rotor sprinklers or spray heads can easily be fixed by changing out the incorrect nozzle and installing the correct one. The size of the mismatch will determine the quantity of water saved. Changing out the nozzles should involve only a moderate investment of time and money (Table 3).

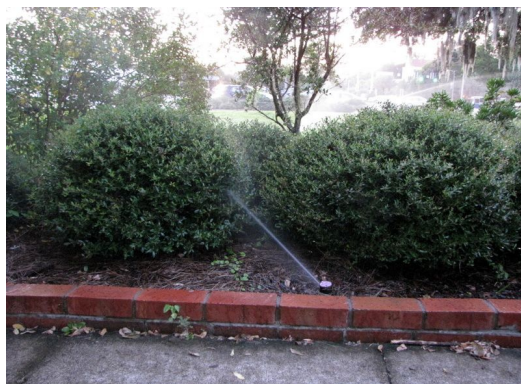
The next most often occurring problem is the water stream from the sprinkler is deflected or blocked by vegetation (Figure 3). When the water hits vegetation close to the sprinkler, it is concentrated in certain areas and prevents spray uniformity. In older homes, either the vegetation could have grown substantially since the irrigation system installation or the system was installed without the proper risers to clear the vegetation. If the stream of water is being blocked, then the plant material on the other side is not receiving the water the system was designed to deliver. This could stress the plant material or possibly result in an ill-advised decision to increase run-times to try to compensate for the lack of water in those areas.

Figure 3. Blocked water spray (photo by Bernard Cardenas).

If vegetation is blocking a stream of water from a nozzle, the options to fix it include cutting or trimming the vegetation, installing a new sprinkler with a higher riser, moving or removing the offending sprinkler or spray head, or replacing vegetation in the area not receiving water with drought-tolerant plants. Any water savings after fixing the problem may be minimal and depend on the area being blocked and the type of vegetation not receiving the full coverage. If the water blockage is

causing turf stress, then one of the repair options should be considered (Table 3).
