COASTAL PHOTOGRAPH BY SHOJI FUJII

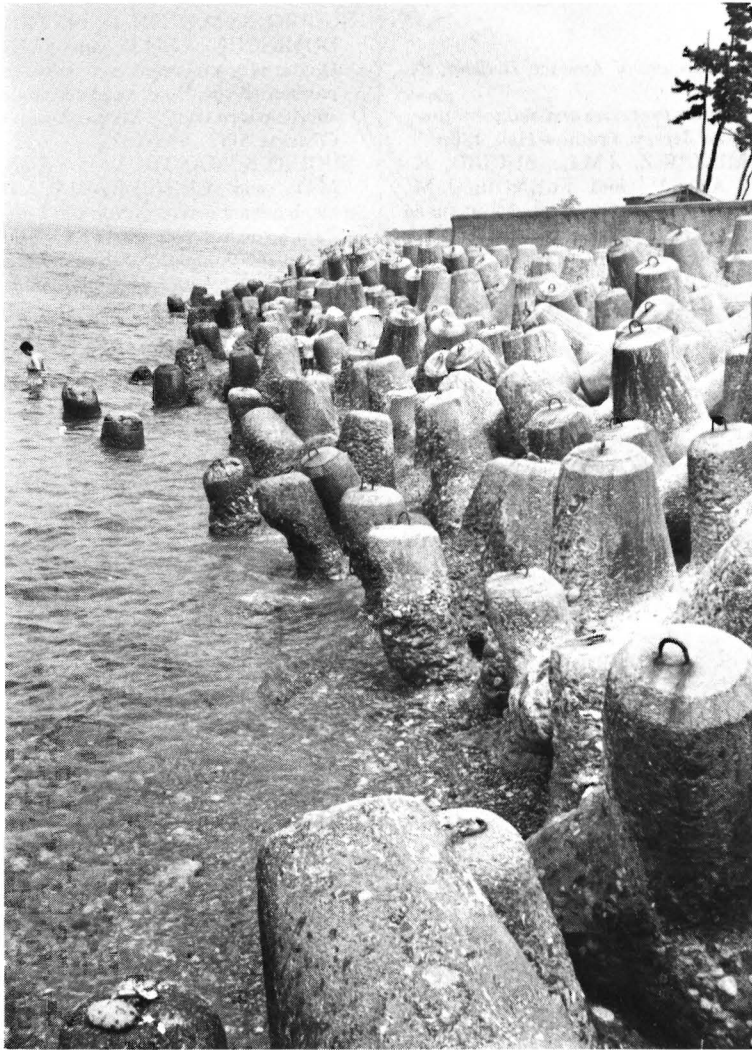
PHOTO 16. Sea notches on tetrapods depicted here have been severely eroded, often showing notch features. The notches are, however, not associated with coastal biological erosion. In just a few years cobble-sized gravels, moved by oscillating wave action, have abraded the tetrapods forming notches. The tetrapods are part of a coastal protection structure at Tanaka near the Nyuzen submarine forest, Kurobe alluvial fan, Toyama Prefecture, Japan. The tidal range here is about 20 cm. [Shoji Fujii: Department of Geology, Toyama University, Toyama City 930, Japan. Photography — Summer 1973].
