**COASTAL PHOTOGRAPH BY CHARLES W. FINKL, JNR.**

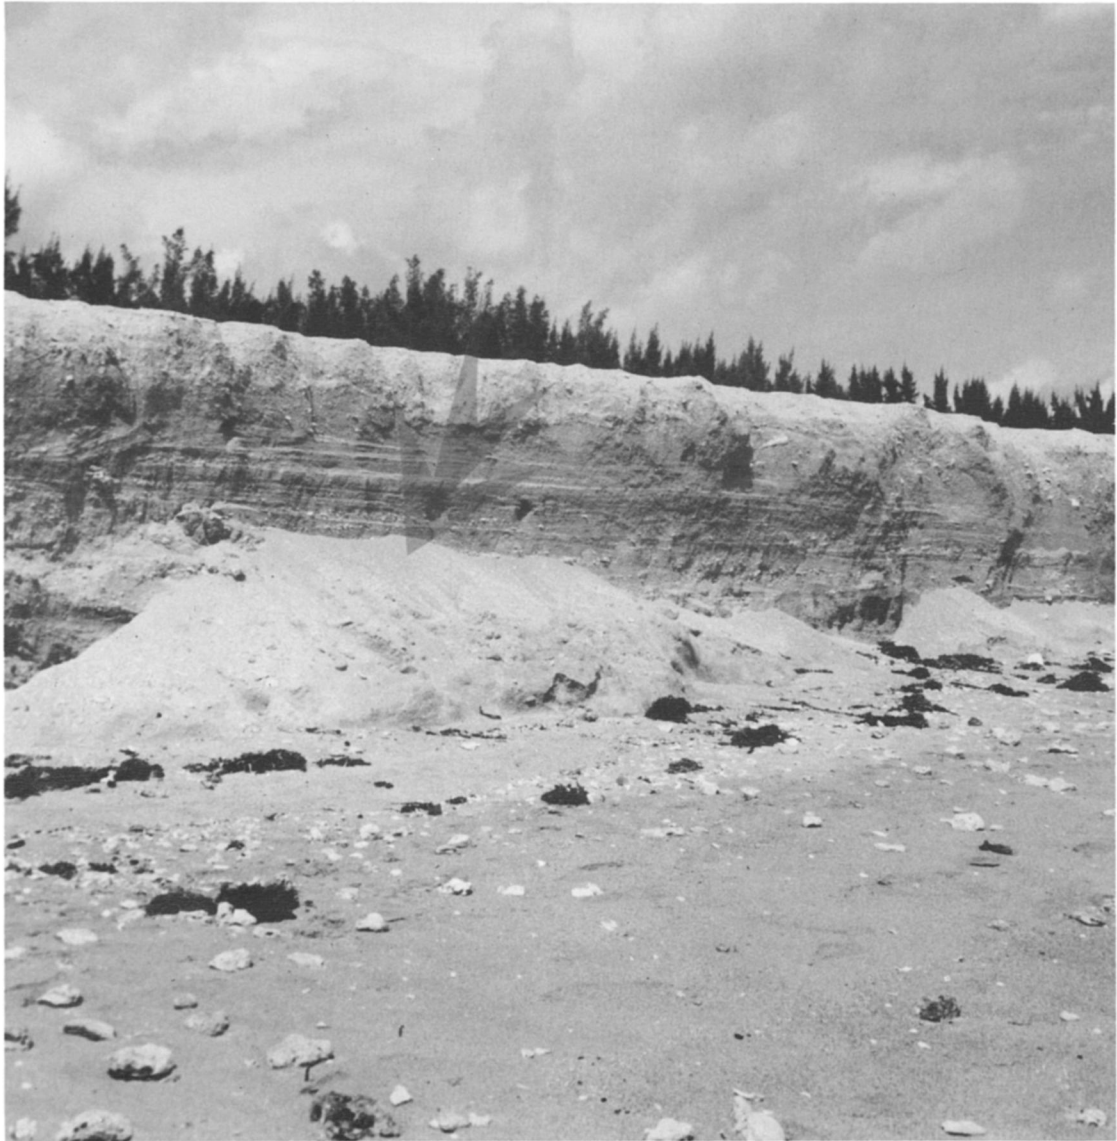
**PHOTO 36.** Degradation of artificial beach fill by scarp retreat, John U. Lloyd State Recreation Area, Dania, Florida. Wave action at the base of the scarp oversteepens the scarp face and leads to slumping. Alluvial cones (arrow) frequently form at the scarp base in response to wind action and human activity along the crest. Note coarse fragments from the fill are left as a lag deposit in the intertidal zone. (Photography, 1979. Charles W. Finkl, Jr., Coastal Education and Research Foundation, Charlottesville, Virginia)
