The Severe Erosion of Cape Shoalwater, Washington¹

Thomas Terich and Terrance Levenseller

TERICH, T. and LEVENSELLER, T., 1986. The severe erosion of Cape Shoalwater, Washington. *Journal of Coastal Research*, 2(4), 465-477. Fort Lauderdale, ISSN 0749-0208.

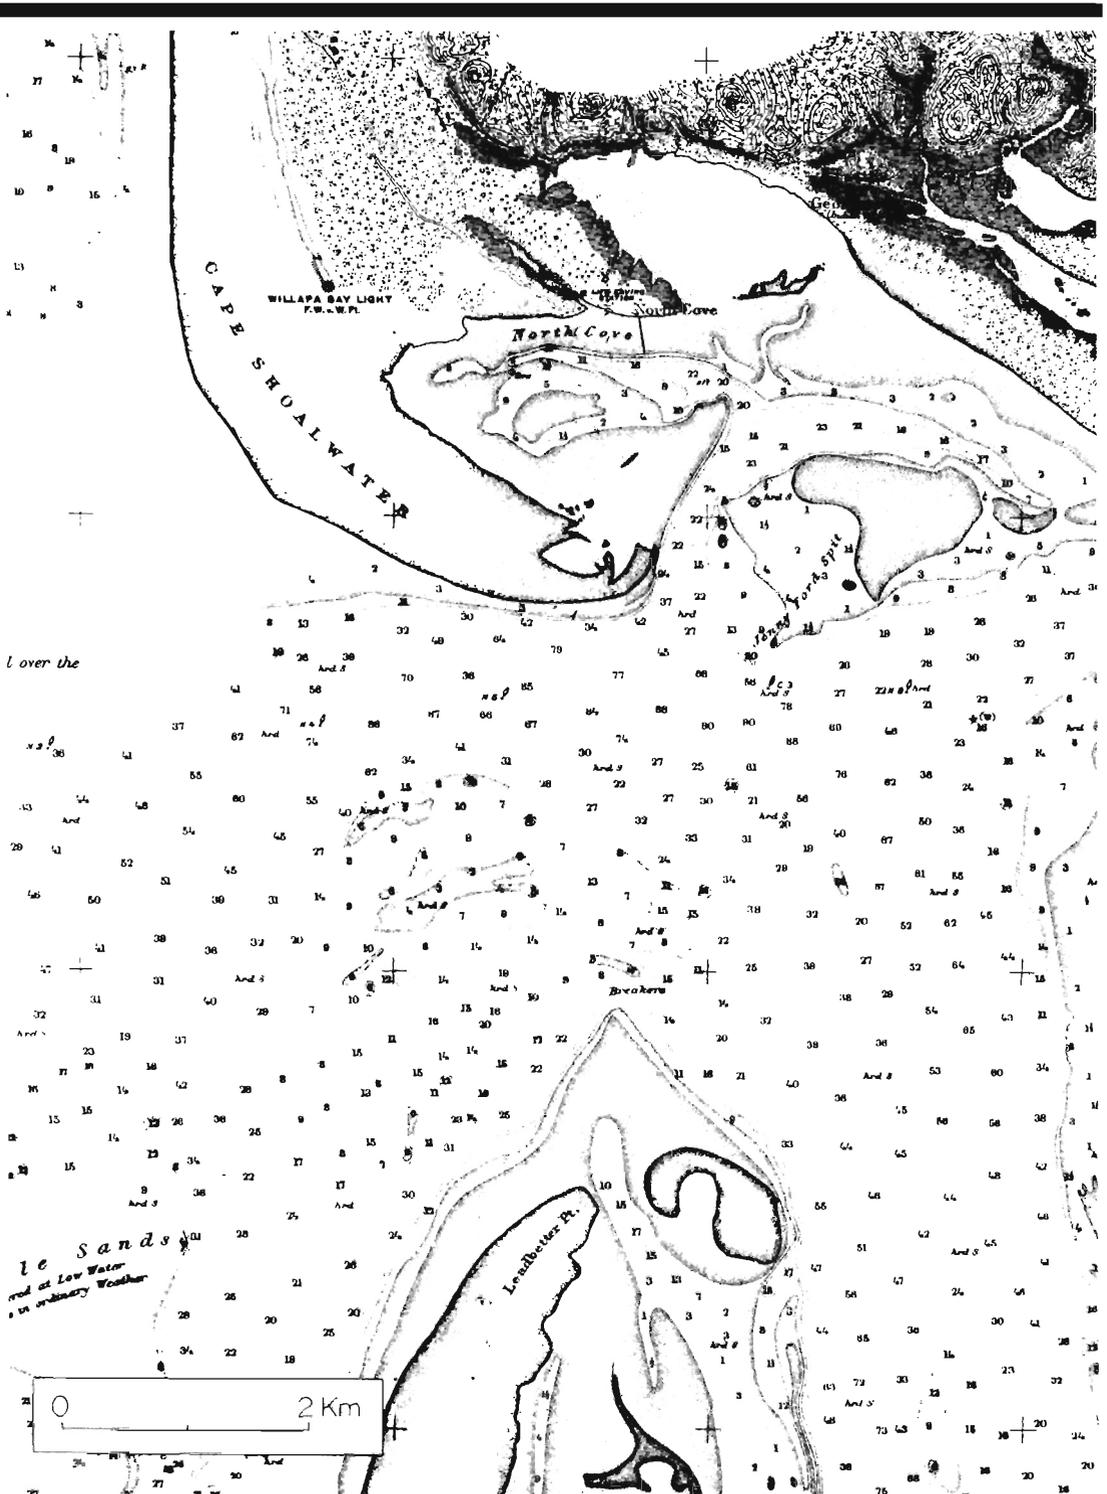
Figure 2. Coast and Geodetic Survey chart from 1911 with survey data to 1991 showing the southerly extent of Cape Shoalwater.

Cape Shoalwater has had a very long continuous erosion history. U.S. Coast and Geodetic Survey charts dating back to the turn of the century provide evidence of the shoreline changes. One of the earliest known charts for the area, published in 1911, shows Cape Shoalwater with topographic, triangulation, and hydrography surveys dating from 1871 to 1891 (Figure 2). The Cape is shown as a pronounced south trending spit projecting southeasterly into Willapa Channel. The configuration of the shoreline appears relatively smooth, giving no indication of erosional retreat. At the time of the survey, the navigable channel was approximately 1.5 kilometers wide with maximum depths to 26 meters (85 ft.).

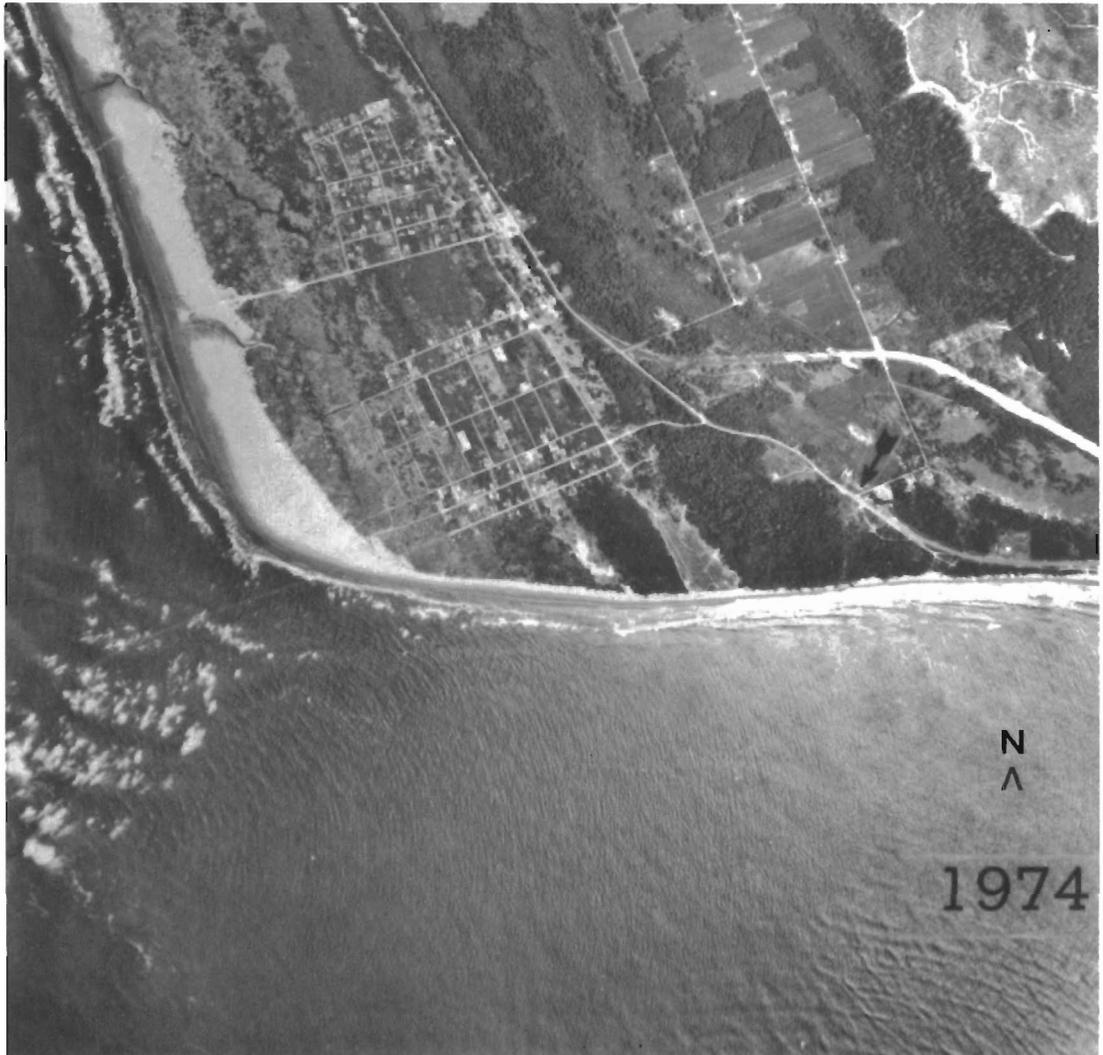
Figure 6. Aerial photograph of Cape Shoalwater taken in 1974. The black arrow indicates the location of the old coast highway threatened by the erosion. The new alignment is under construction to the north.

Of great concern in the late 1960s and early 1970s was the inevitable breaching of the State Highway 105 (Figure 6). In 1971 the State of Washington prepared a new alignment 1 km north along the base of the uplands. By the mid 1970s the old highway

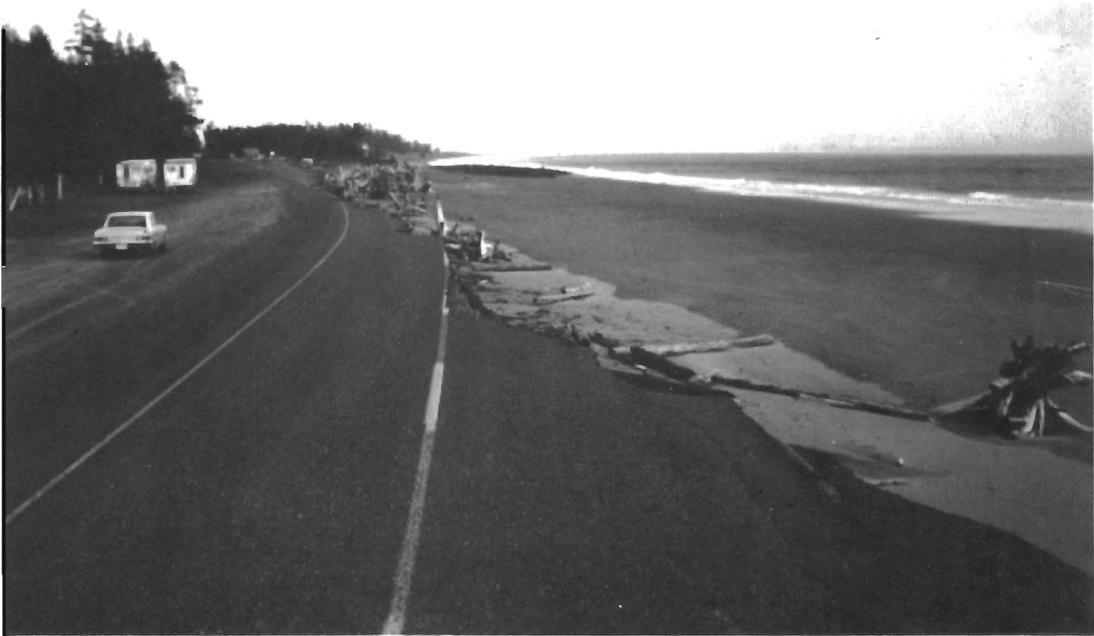
Figure 7. A 1976 view to the east of the old coastal highway eroding away.

was being undermined and was soon completely severed (Figure 7). At this same time controversy also emerged about the fate of an old pioneer cemetery adjacent to the eroding highway. Some suggested leaving it to erode away, as moving it would be too costly. Other pleaded for relocation of the cemetery. Several prominent public officials were brought into the issue, including the Governor of the State (Seattle Times, April 18, 1976). In spite of the cost, the cemetery was moved and sited adjacent to the new alignment of the state highway.
