# Old and New Observations on Coastal Changes of Jakarta Bay: An Example of Trends in Urban Stress on Coastal Environments

Herman Th. Verstappen

VERSTAPPEN, H. Th., 1988. Old and new observations on coastal changes of Jakarta Bay: an example of trends in urban stress on coastal environments. *Journal of Coastal Research*, 4(4), 573-587. Charlottesville (Virginia), ISSN 0749-0208.

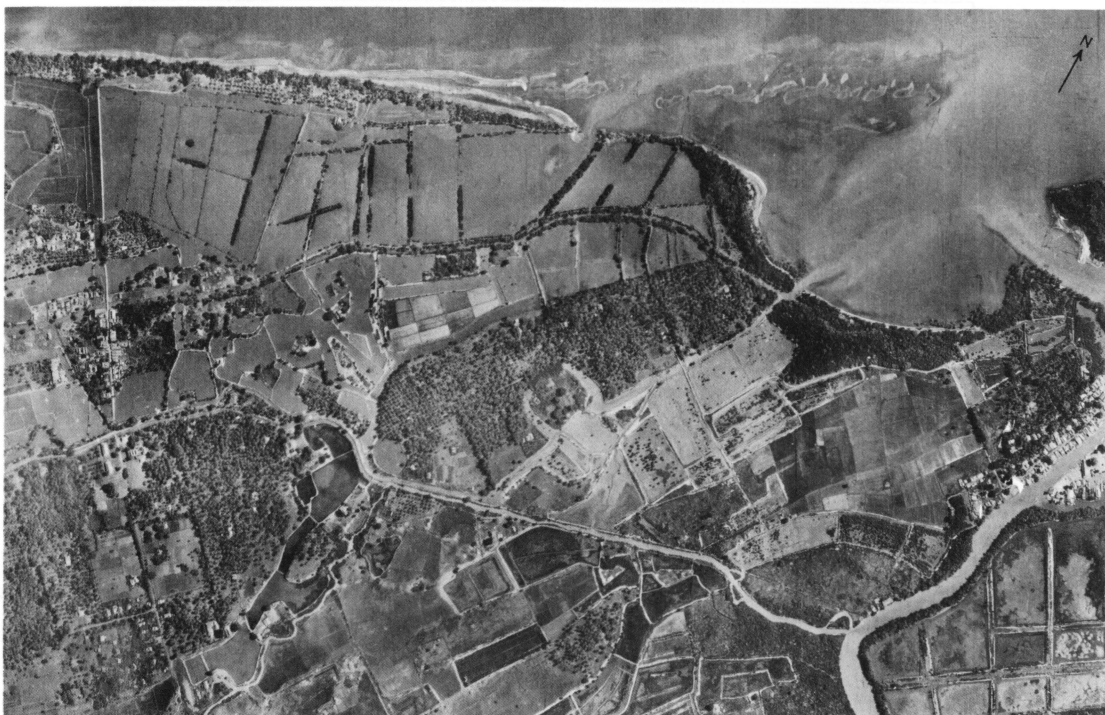
Figure 5. Vertical aerial photograph, scale 1:12,500, of the Cilincing area, east of Tg. Priok picturing the situation of 1948. Compare with Figure 7.

The most dramatic environmental deterioration of the coastal zone has occurred a few kilometres to the east of the harbour of Tg. Priok, near Cilincing. The main cause of the coastal abrasion in this case is beyond doubt the excavation of sand for construction from both the beach and beach ridges. The strong northerly winds have, of course, aggravated the impact of these activities. PARDJAMAN (1977) claims an abrasion of 600 m during the period 1951–1975, whereas the annual abrasion used to be less than 1 m. By 1982, the abrasion totalled 750 m. The aerial photographs of Figures 5 and

6 illustrate the situation in 1948 and 1982, respectively. A surface area of 2.25 km<sup>2</sup> has been lost along this part of the coast. In 1948, the environment was still semi-natural and the population was sparse. In 1982, the area formed part of the greater Jakarta urban area and thousands of people lived in increasingly congested quarters. The continuous abrasion aggravates the situation. The area is composed of a series of parallel beach ridges with intervening swales; every time a beach ridge disappears, the swale behind is inundated. The coastal protection works consist of only bamboo poles. Since wave energy is not dissipated, sand behind the poles is removed, making this construction utterly inadequate. Many people have already been resettled in other near-coastal areas farther to the west. Another result of the abrasion is that saline water intrudes much farther inland than previously. A total of 3 km<sup>2</sup> of paddy fields had to be transformed into brackish-water fish ponds. The map in Figure 7 illustrates the situation. There are no (automatic)

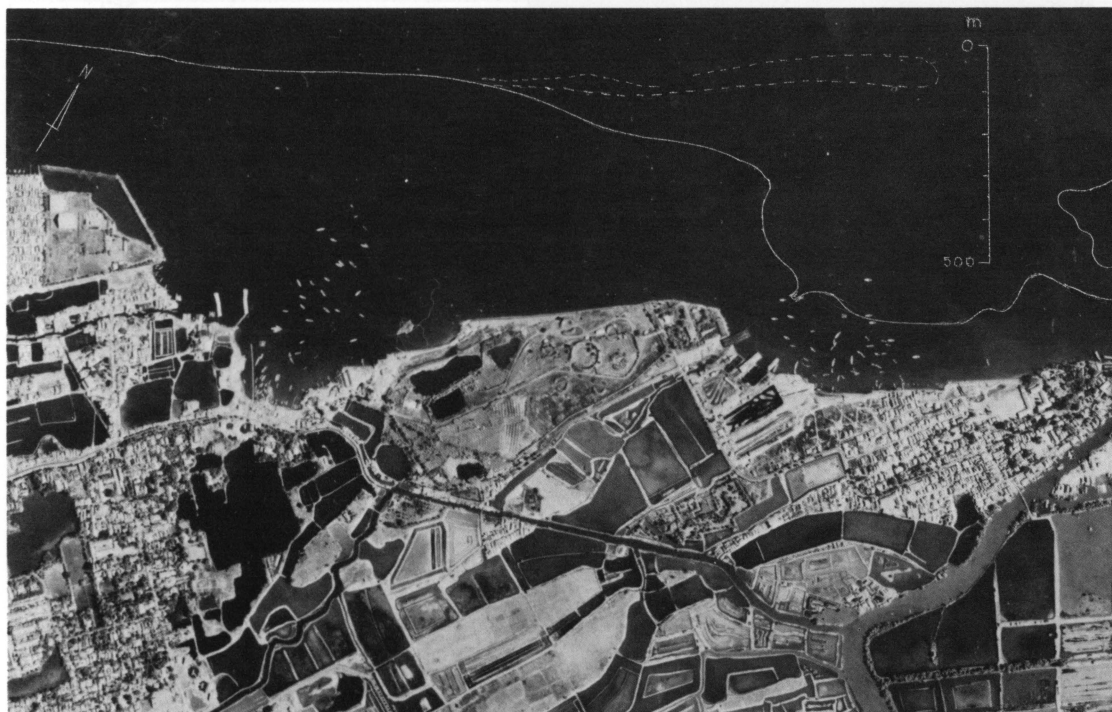
Figure 6. The same area as pictured in Figure 7 as it was in 1982, scale 1:12,500 (enlarged from a 1:30,000 aerial photograph). The 1948 coastline is added for comparison. Note the strong abrasion (up to 750 m) and the urbanization.

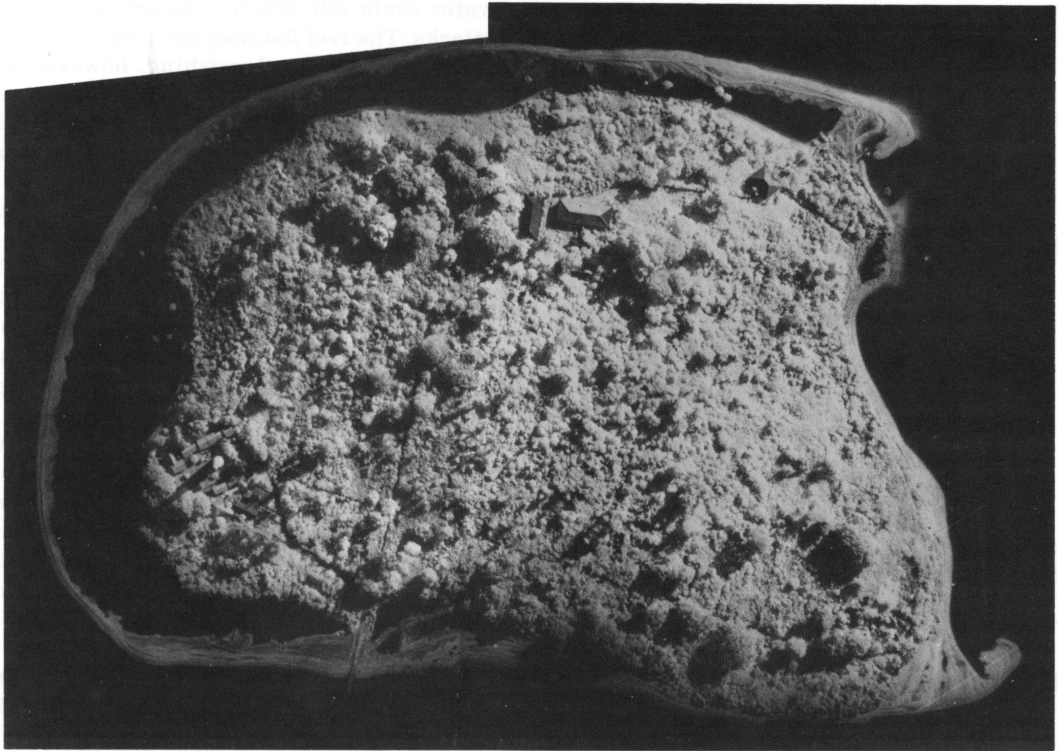
Figure 8. Aerial photograph (1980) of the coral island of Damar besar, scale 1:5,000 (reduced from original aerial photograph).

the bay; and, (3) reefs in the south-central parts of the bay closest to Jakarta. The island Damar besar, by far the largest cay in the bay, is representative of the first group. It is pictured on the aerial photograph of 1980 (Figure 8), which served as the basis for the 1:10,000 map shown in Figure 9.
