COASTAL PHOTOGRAPH BY R.W.G. CARTER

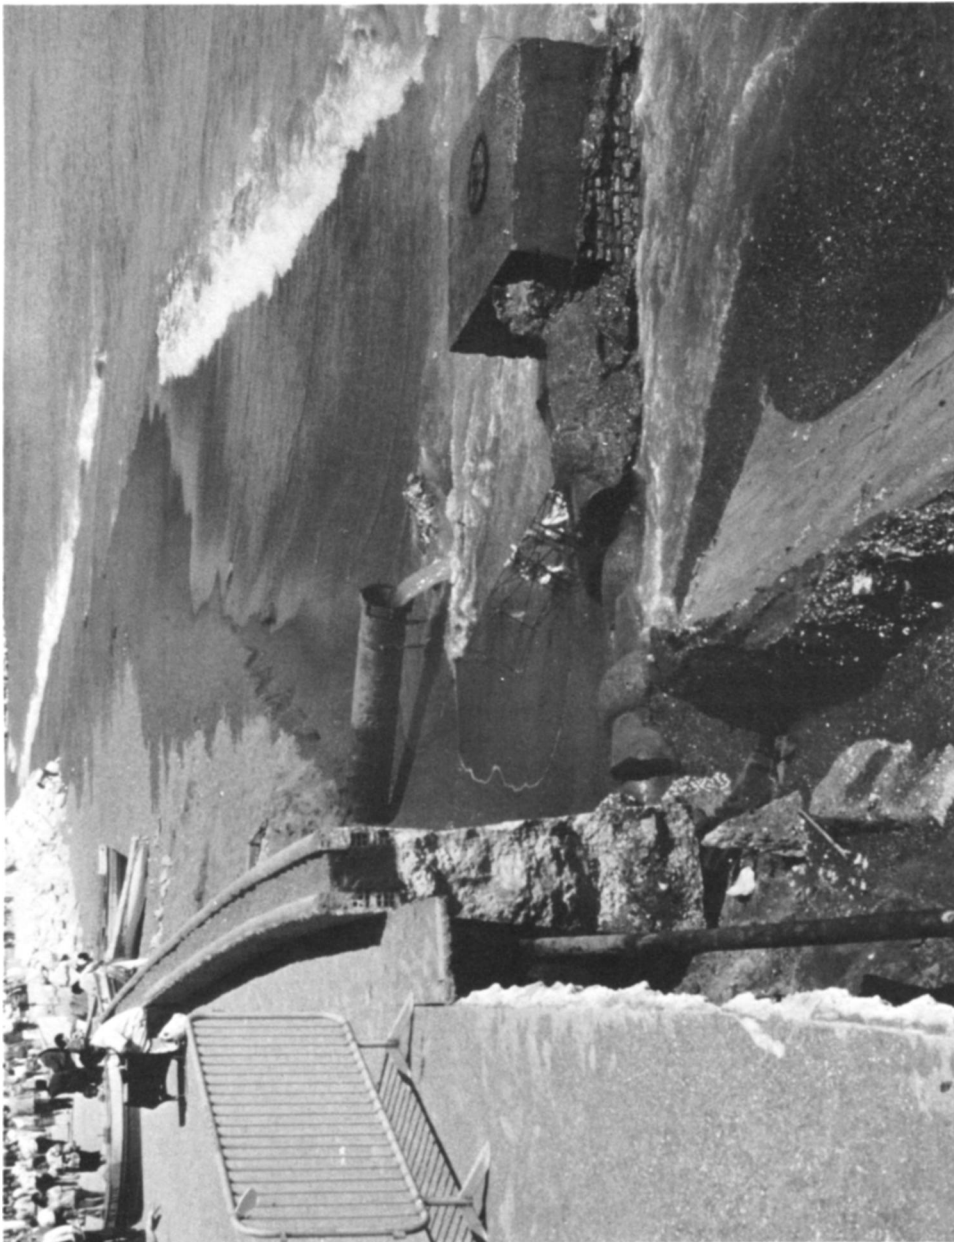
PHOTO 129. Beach erosion, caused by the interception of easterly moving longshore transport following the construction of a marina, has undermined the seawall at Torremolinos on the Costa del Sol in Southern Spain. This beach was over 50 m wide in 1970, but is now reduced to a few small, residual sand patches. The wall has fallen forward exposing the foundations, and fracturing the sewer pipe (centre of photograph) which is now discharging onto the beach. (Photo: R.W.G. Carter, Department of Environmental Sciences, University of Ulster, Coleraine BT51 1SA, Northern Ireland).
