COASTAL PHOTOGRAPH BY ANGUS JACKSON

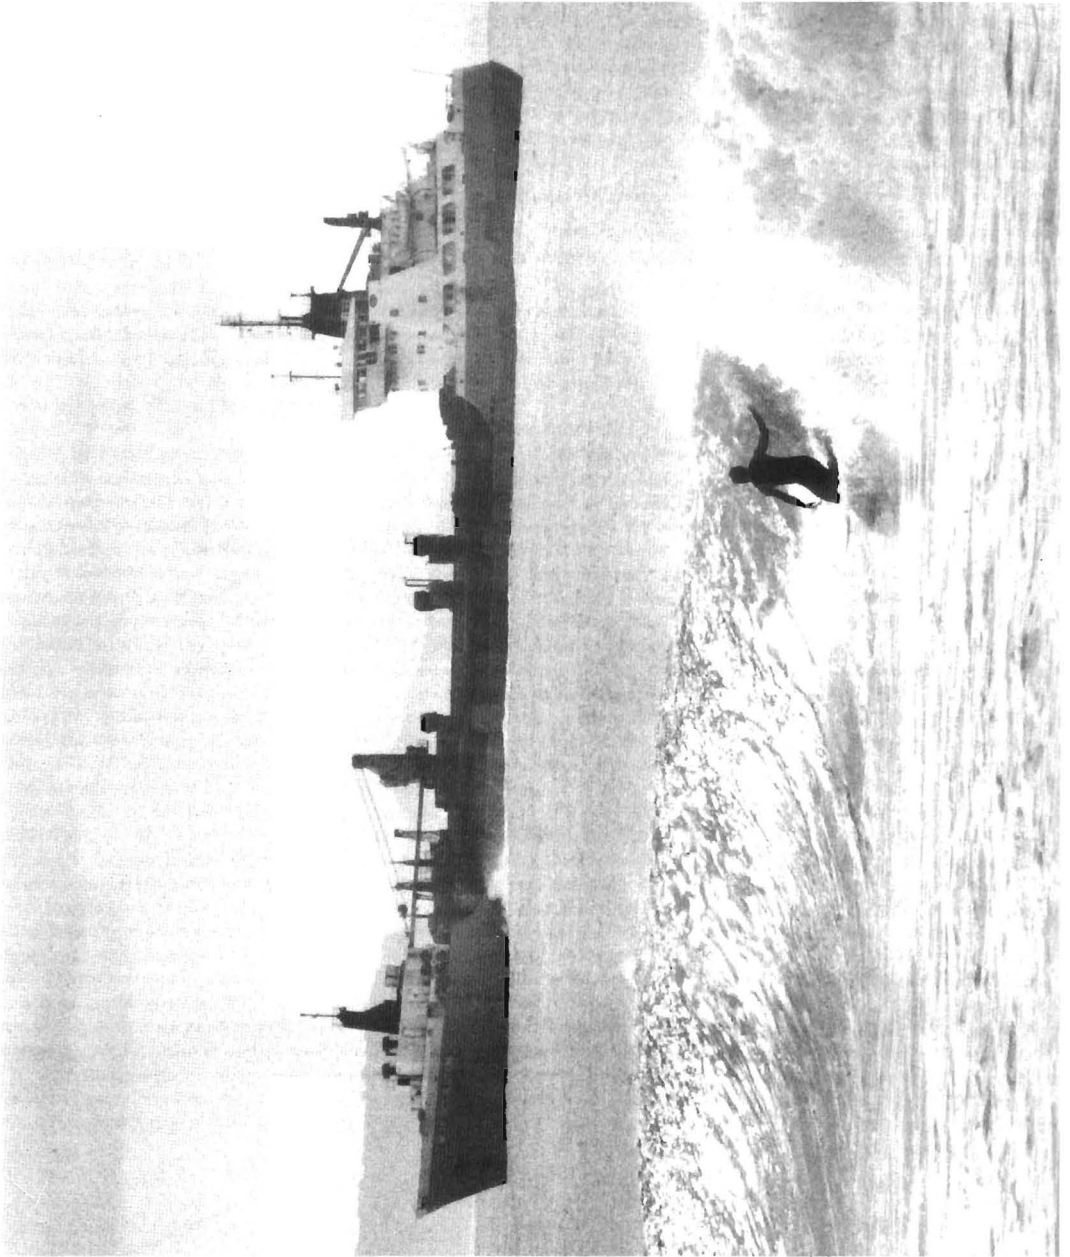
PHOTO 106. Trailing suction hopper dredge W.H. Resolution bottom dumping 1.5×10^6 m³ of sand dredged from offshore (23 m depth) in 6 to 10 m of water off the Kirra and Bilinga Beaches, Gold Coast, Australia, where some 2 Km of beach has been lost and the foreshore is presently protected by a boulder wall. The cost of the works was A\$2.5 $\times 10^6$. (Photo: Angus Jackson, Supervising Engineer—Special Projects, Gold Coast City Council, Gold Coast, Queensland, Australia.)
