COASTAL PHOTOGRAPH BY DAVID M. BUSH,
E. ROBERT THIELER & ORRIN H. PILKEY

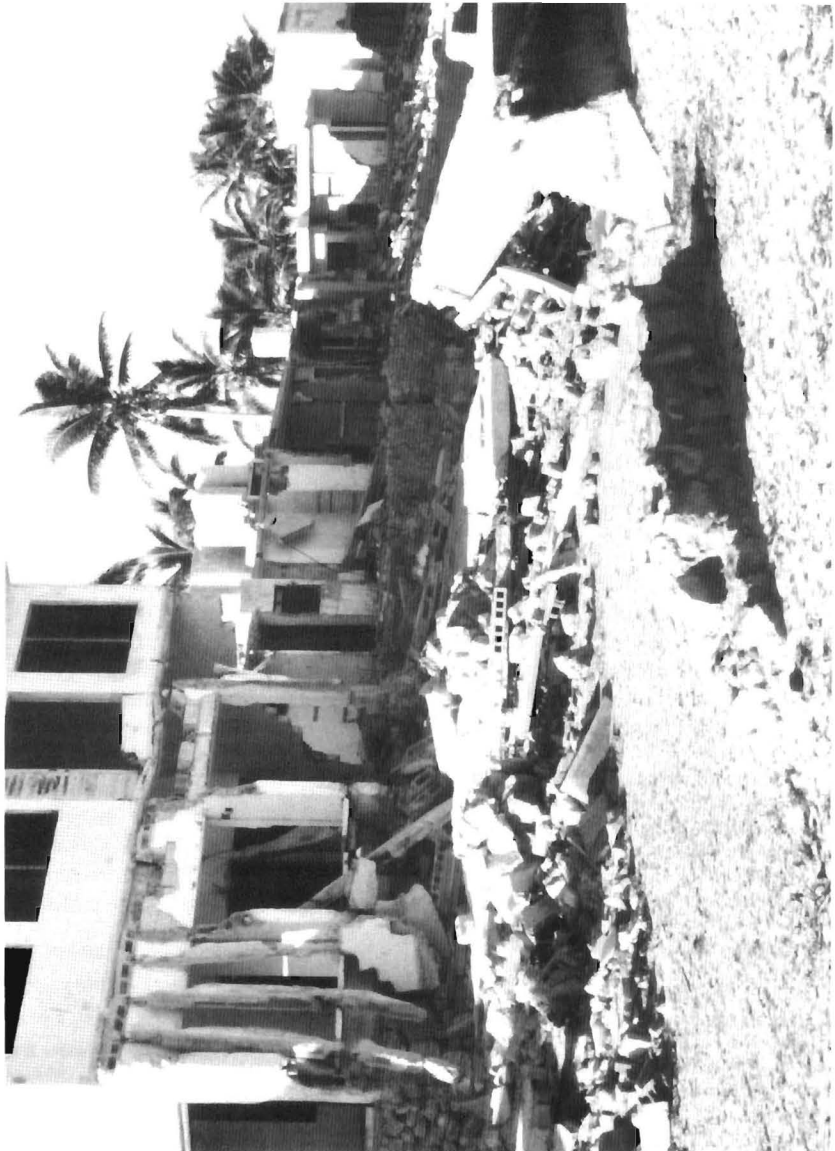
PHOTO 110. During Hurricane Gilbert in September, 1988, low seawalls at this location on the north coast of the Yucatan peninsula, Mexico were overstepped and the first row of buildings became the seawall. Seawalls can be seen in the foreground. The first row of buildings absorbed the brunt of the storm wave energy and protected the development behind them. Note that most of the debris from these concrete buildings remains in place. On U.S. barrier islands, where most small buildings are constructed of wood, flying and floating debris is a major cause of building damage. (Photo: David M. Bush, E. Robert Thieler, and Orrin H. Pilkey, Program for the Study of Developed Shorelines, Department of Geology, Duke University, Durham, NC 27708).
