## **COASTAL PHOTOGRAPH BY PER BRUUN**

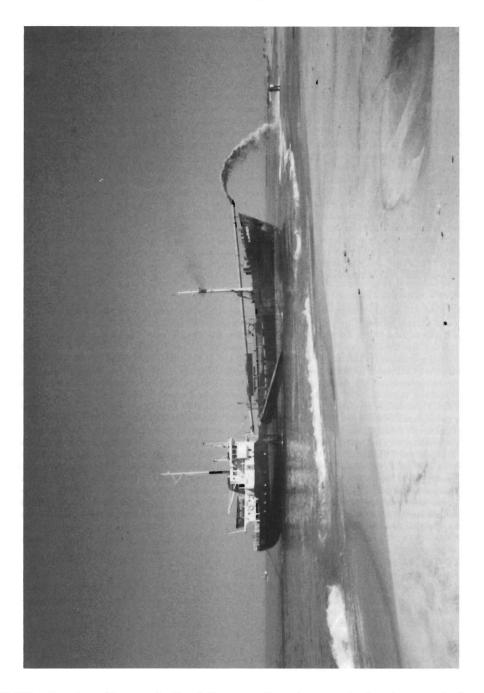
**PHOTO 170.** Beach spoiling on the North Sea coast. Pumping over the bow is a practical method of sand emplacement for beach renourishment projects in many parts of northern Europe. (Photo: Per Bruun, 34 Baynard Cove Road, Hilton Head, South Carolina. May 1988).
