TECHNICAL COMMUNICATION

Tsunami Disaster Caused by 1993 Earthquake in Northern Part of Japan Sea

Yoshitaka Hayashi

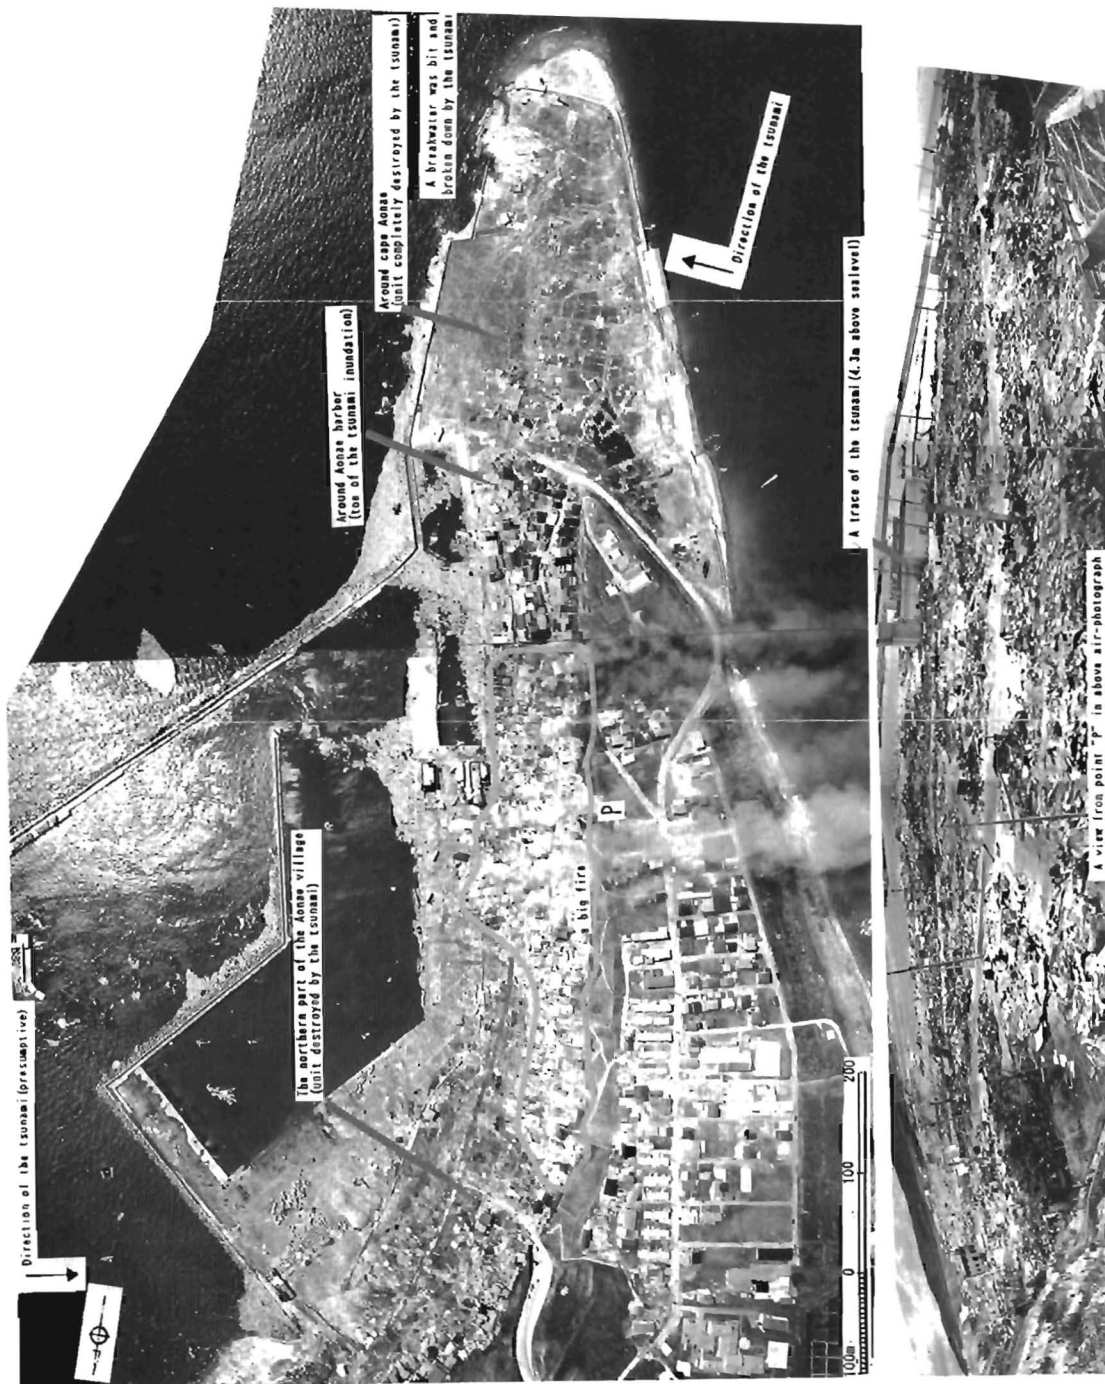
Photo 1. Aonae area.

The Aonae area was seriously damaged by the tsunami and a fire caused by the earthquake. The damaged area was divided into 4 units according to state of damage, as listed below.

Aonae Area (Southern Coast, Photo 1)

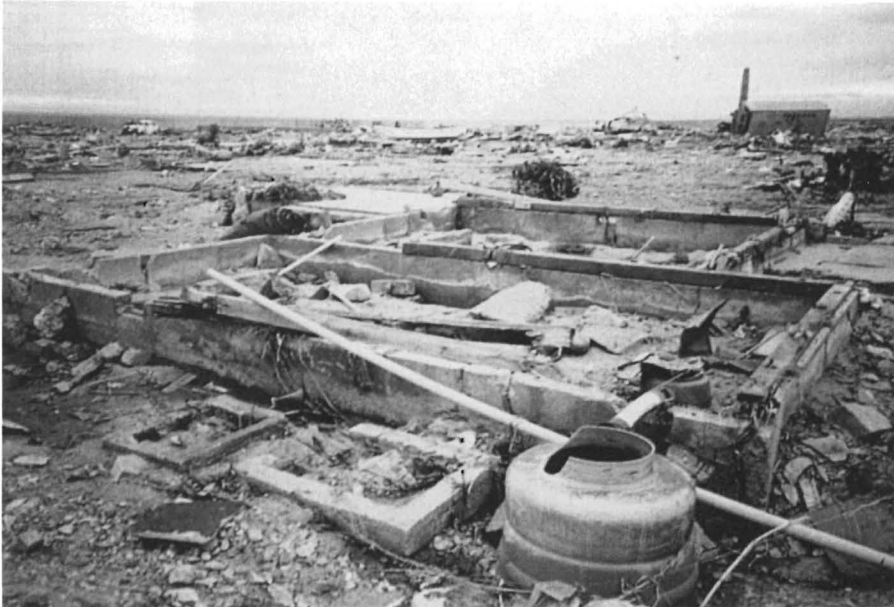
Houses were completely destroyed and washed away by the tsunami (they were almost all mortared frame houses). Only basements made with concrete were left intact (Photo 2).

Photo 2. Around cape Aonae. (Unit completely destroyed by the tsunami.)

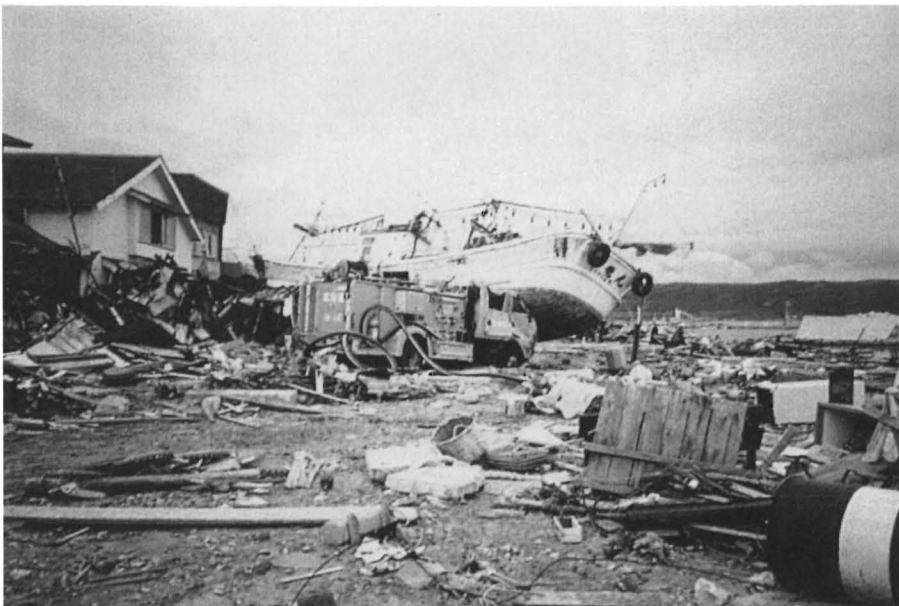
Houses were not destroyed completely, but first floors were damaged. The tsunami washed everything away and moved debris onto this unit (*i.e.*, toe of inundation, Photo 3).

Photo 3. Around Aonae harbor. (Toe of the tsunami inundation.)

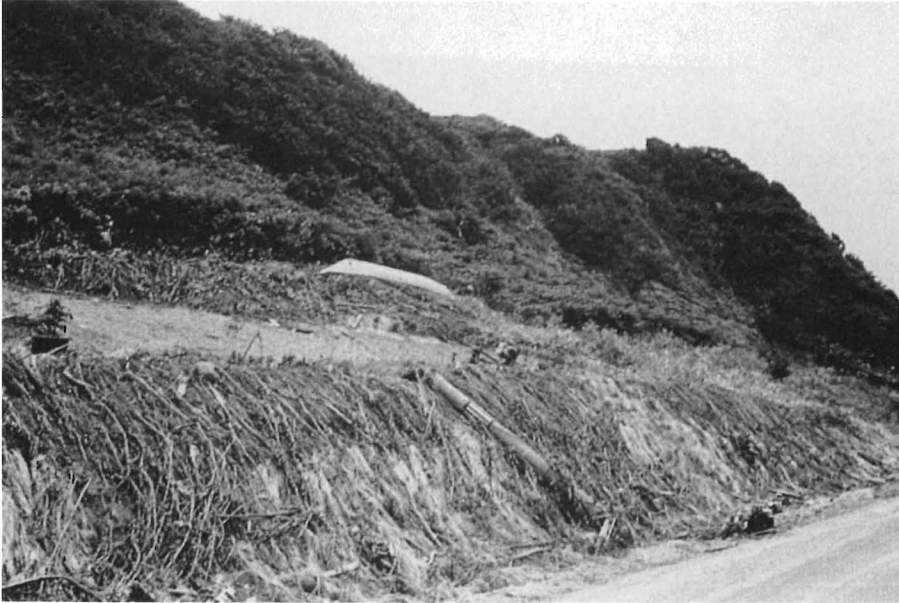
The Monai coast faces the Japan Sea, where the tsunami was produced. The tsunami ran up to 10 to 30 m above sea level. Electric-light poles were broken down, and a boat was carried inland

by the tsunami (Photo 4). The tsunami also flooded a small valley which faces the coast. Here the maximum "run up height" (30 m) was measured by investigators from Tokyo University (Photo 5).

Photo 4. Monai area. A boat was carried beyond a road by the tsunami.

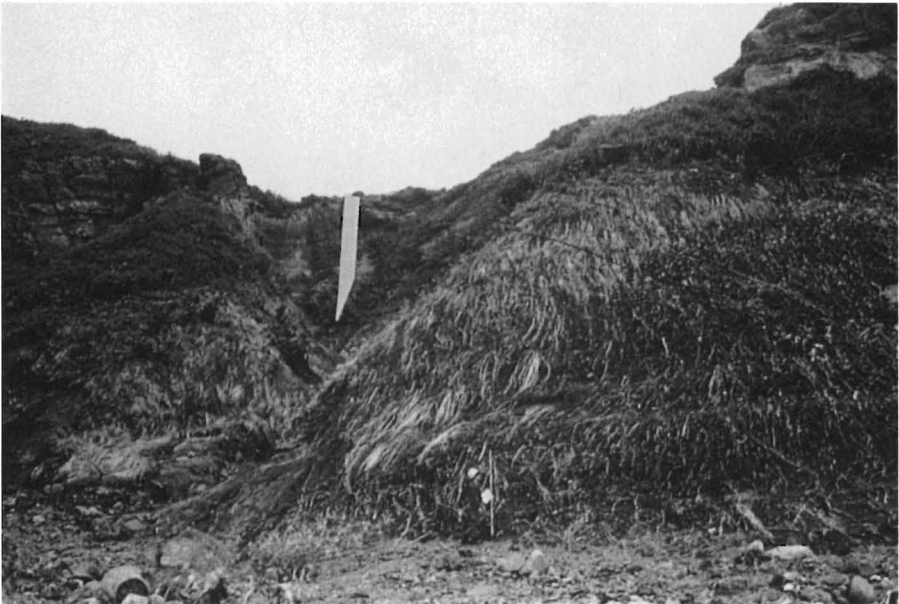
Photo 5. Monai area. A small valley where the maximum run up height was measured.

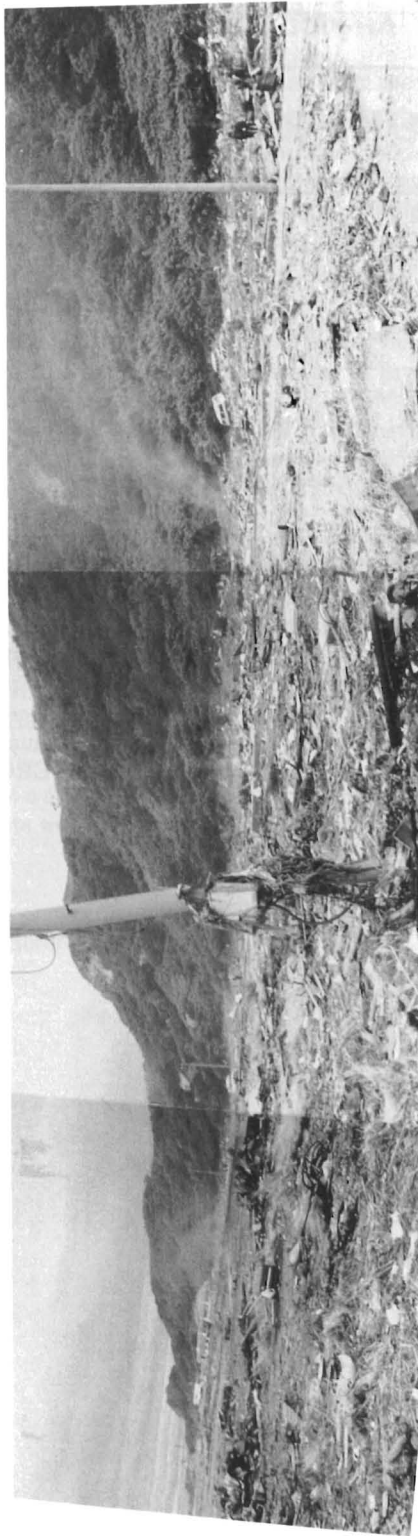
The Inaho coast also faces the sea. The tsunami ran up Inaho village to 15 m above sea level, and destroyed it completely (Photo 6).

Photo 6. Inaho area. This village was also destroyed completely. At a foot of a mountain, traces of the tsunami can be seen clearly.
