COASTAL PHOTOGRAPH BY R.P. PASKOFF

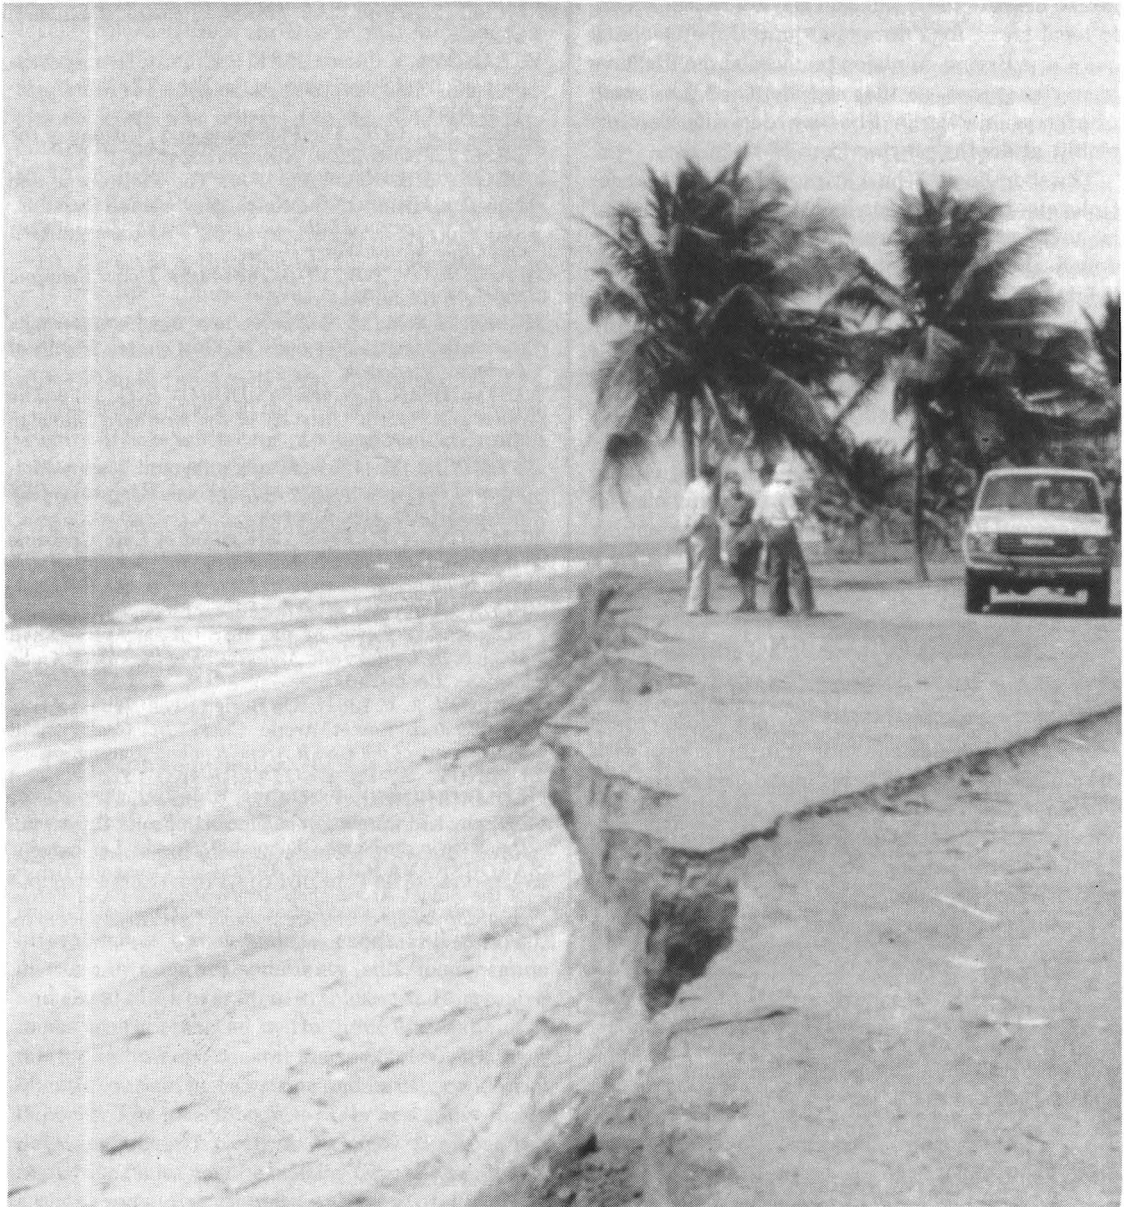
PHOTO 33. Beach erosion is severe on the sandy coast of Togo (West Africa). It started just after the completion of the Akosombo dam, erected in 1961 on the Volta river (Ghana), which dramatically reduced the eastward-oriented littoral drift. The construction of the new harbor of Lome in 1965 with a jetty 120 m long substantially increased the sand deficit. The photograph was taken in March 1986 about 30 km east of Lome where the recession of the shoreline has amounted to 130 m in the last 15 years. In July 1984 a single storm caused a retreat of 15 m. The primitive coastal road has already been completely eroded away. (Roland P. Paskoff, University of Lyon II, 10 Square Saint-Florentin, 78150 Le Chesnay, France).
