New Developments on Coastal Protection along the Belgian Coast

Roger H. Charlier and Christian P. De Meyer

HAECON, Inc.

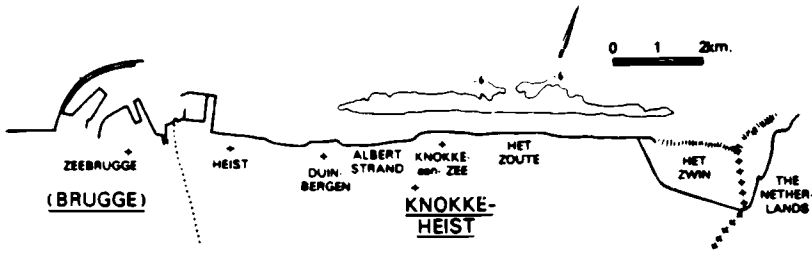
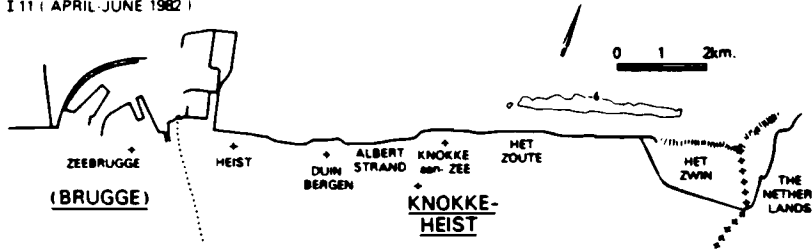
Figure 2. Evolution of "Appelzak" gully.

The Appelzak trough has gradually extended itself to within 500 m (550 yds) of the seawall extending from Het Zoute to the harbor of Zeebrugge. The "pier" or "mole" of the port hampered sand transport and by deflecting longshore currents had a starving effect upon the beaches situated to the east. Roovers, Kerckaert and others have described the beach nourishment project in detail. Coastal changes and beach evolution are being monitored (Figure 2). The Appelzak trough

or gully acted as a trap for the sediments removed from the beaches; it has been reduced in size and the westerly segment is doomed to disappear. Currently a wide beach of some 100 m (330 ft) has been built and is being described as "stable".

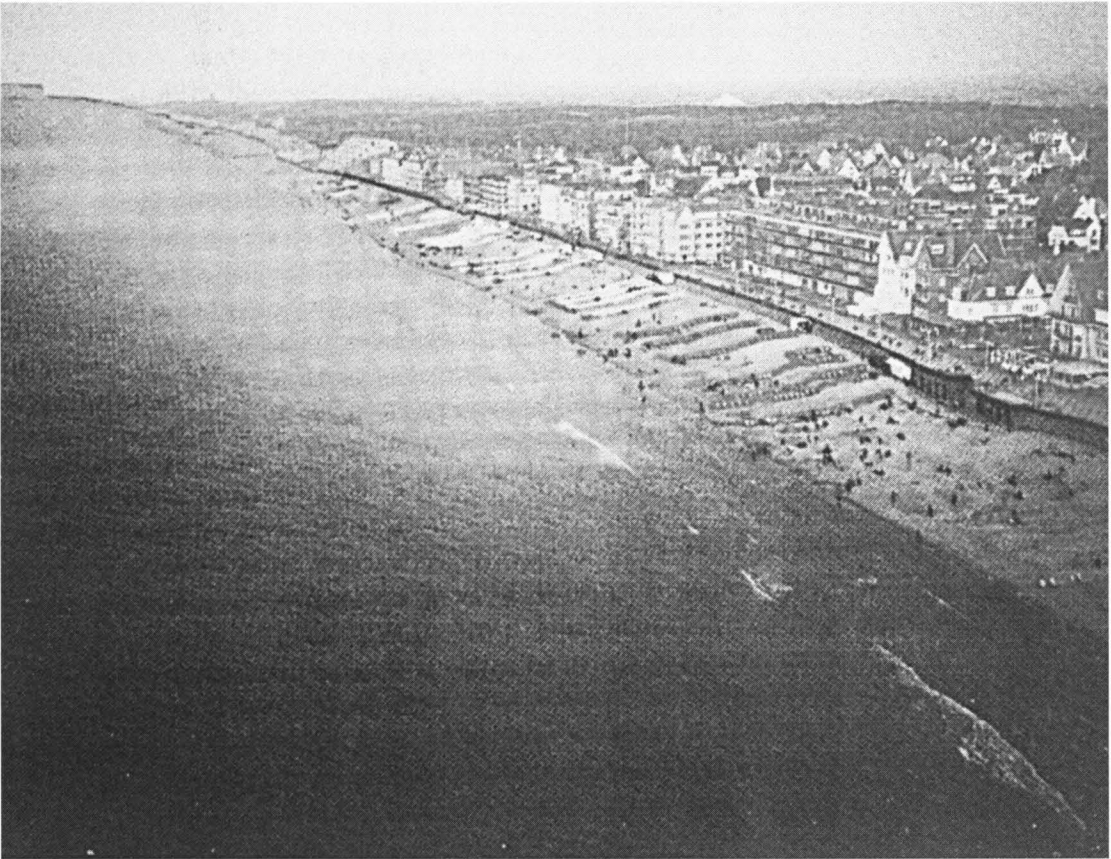
Figure 5. De Haan, Belgian coast, beach prior to artificial nourishment.

Completed works will have resulted in a beach on the average one meter (\pm 40 inches) higher than the pre-existing one. Furthermore a berm will have been constructed on the upper beach, against the new seawall; 40 m (\pm 13.5 ft) wide, the berm is 3 m (10 ft) high (Figures 5 and 6). Figures 5 and 6 show beach extension before and after works are completed.

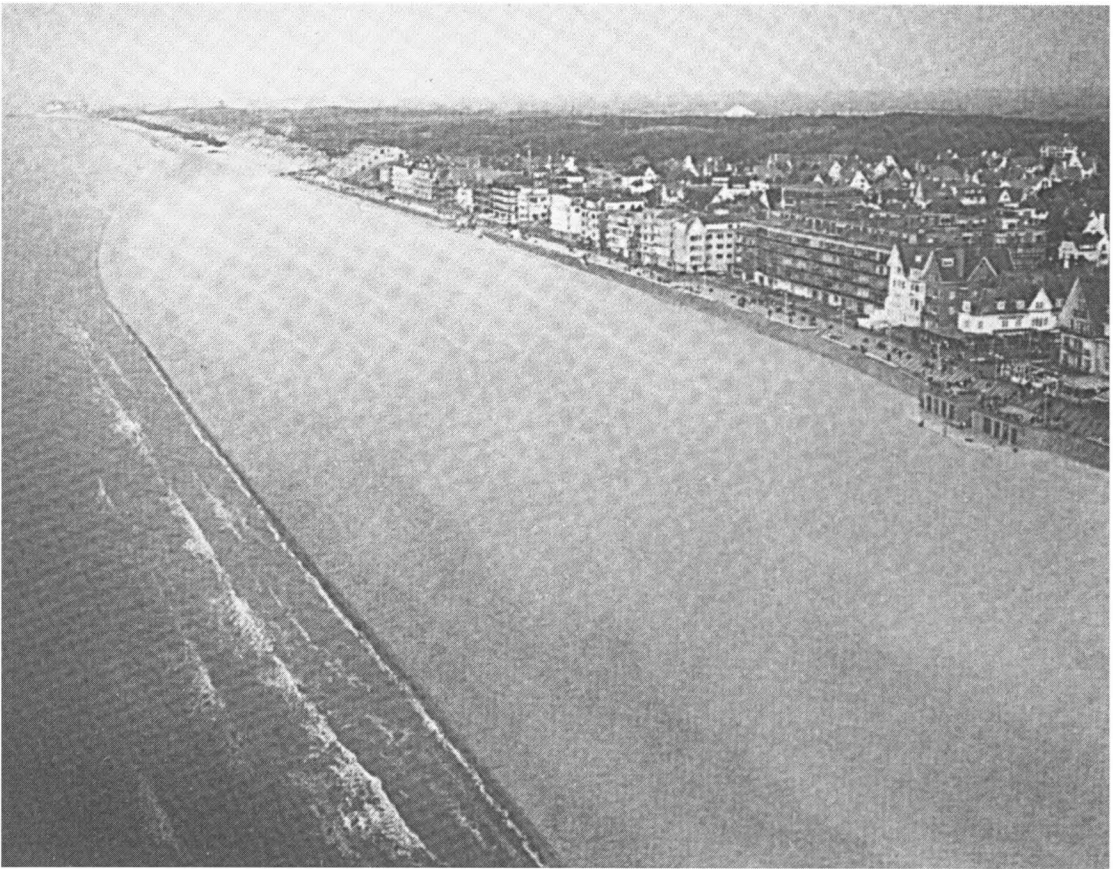
Figure 6. De Haan, Belgium, beach extension after completion of the works.
