TECHNICAL COMMUNICATION

Geological Development of the Northern Coast of Lake Peipsi

Elvi Tavast and Anto Raukas

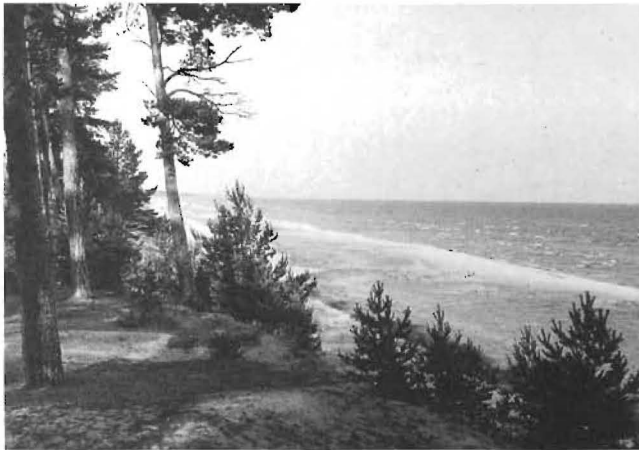
Photo 1. The picturesque sandy beaches in the northern part of Lake Peipsi opened to the south and offering favourable conditions for holiday makers. Kauksi. (Photo by A. Miidel).

shore sporadically. The foreshore is generally flat, and the bed of bulrush or reed is 40–50 m wide. One or two low beach barriers border the foreshore. The active sandy beach begins from Kauksi Brook (Photo 1) and runs as far as the Narva River. One or several bluffs have developed on the ancient dune sands. Shrubs seldom grow in front of the bluff; there is neither reed nor bulrush on the foreshore. The dunes are usually 5–6 m high. At the river mouths, the dunes are higher and in some places they form several parallel ridges. The highest dunes are situated near Alajõe and Smolnitsa. As the longshore drift is directed from west to east, the largest dunes are always distributed on the eastern banks of the rivers. In spring and autumn when the rivers are rich in water, they bring sand from the long distant glacio-fluvial and glacio-lacustrine sediments which are widely distributed to the north from Lake Peipsi. The shore is at its widest in the area near the outflow of the Narva River, and the ancient bluff is situated at a distance of about 100 m from the present shoreline. The shore is widely swampy and covered with bushes and dense brush and reed on the underwater coastal slope. The scarp morainic shore is spread on the eastern bank of the lake from the outflow of the River Narva to Brook Si-manevka in Russia. The height of the scarp is 2.5 m; in front of the scarp, there is a stony floor with boulders and a thin layer of sand or pebbles.

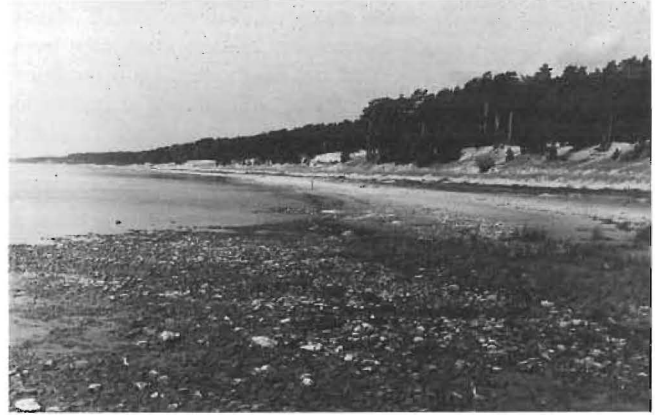
Photo 2. The water-level fluctuations in L. Peipsi are considerable. Low water near Kauksi. On the underwater slope till is exposed below sand. (Photo by A. Miidel).

Water-level fluctuations are considerable (Photo 2). During the last 90 years an amplitude of 3.04 m has been registered.

the lake are mostly represented by till (in the NW part) and sands. Sands are distributed on the backshore and till, covered with some tens of centimetres up to several metres of sand, on the foreshore (Photo 2). Well-sorted (the coefficient of sorting is usually [1.2–1.3] fine and medium-grained sand [Md 0.15–0.47]) is spread on the stretch of the beach between Avijõe and the outflow of the Narva River (Figure 6). Fine, well sorted sand (Md 0.15–0.20; So 1.26–1.14) occurs in the coastal zone between Avijõe and Kauksi Brook and between Jaama and the outflow of the Narva River. Due to river input and erosion of the backshore, medium-grained, less sorted sand (Md 0.38–0.44; So 1.29–1.7) is encountered in an area between Kauksi Brook and Jaama (TAVAST, 1984b).

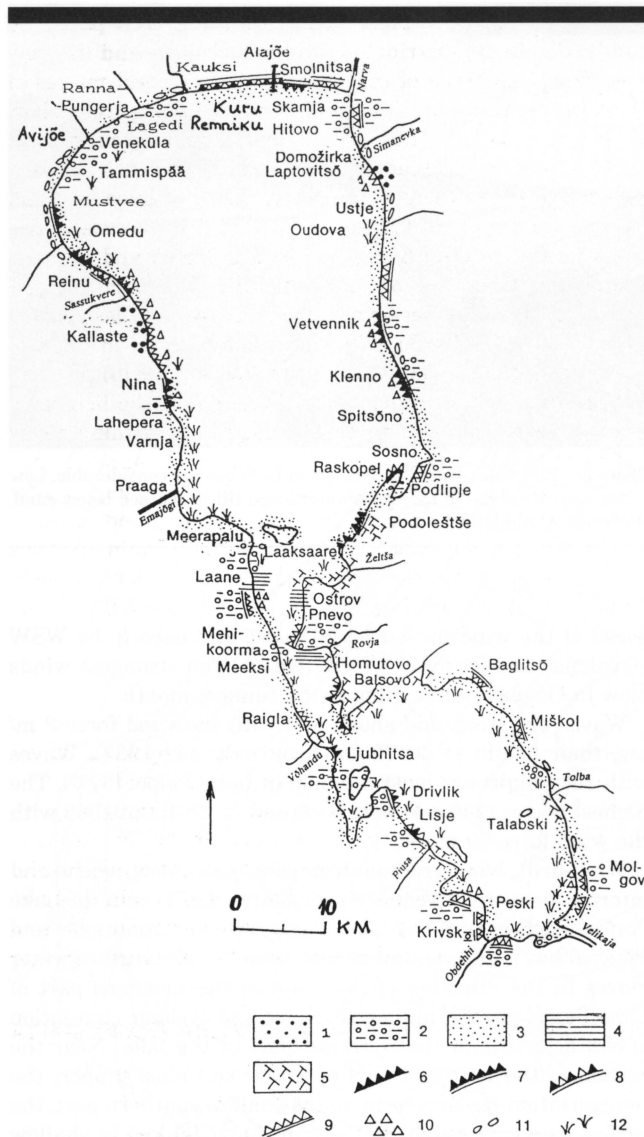
Figure 5. Shore types (after E. TAVAST, 1984a) of the Lake Peipsi. (1) Devonian sandstone; (2) till; (3) sand; (4) clay; (5) peat; (6) cliff; (7-9) bluffs in Quaternary loose sediments; (7) active; (8) passive vegetated; (9) dead; (10) erratic boulders; (11) beach ridge; (12) bulrush and reed zone.

A. RAUKAS and E. TAVAST (1989) differentiated in Lake Peipsi the following shore types (Figure 5): cliffed (in Devonian sandstones), scarped (in till, sand or peat), flat (in till, sand, peat, silt). The scarped shores can be active or swampy and overgrown with bushes. The flat shores are usually swampy and often with a wide reed and bulrush zone (Photo 3). In the northern part of the lake, sandy beaches are prevailing offering good recreational facilities (Figure 4, Photos 4 and 5).

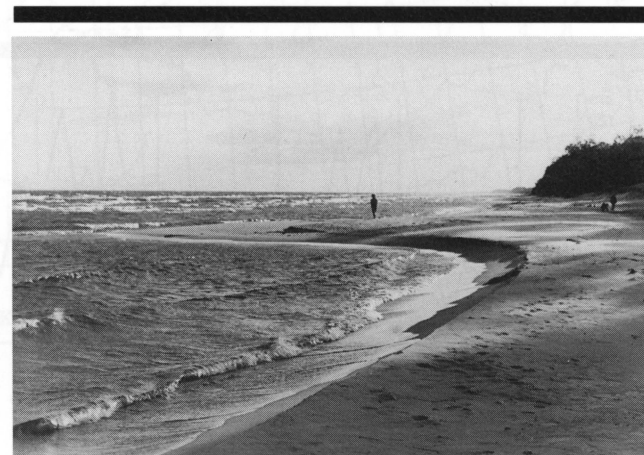
Photo 4. During southerly winds the water-level in the northern part of Lake Peipsi rises rapidly. (Photo by A. Miidel).

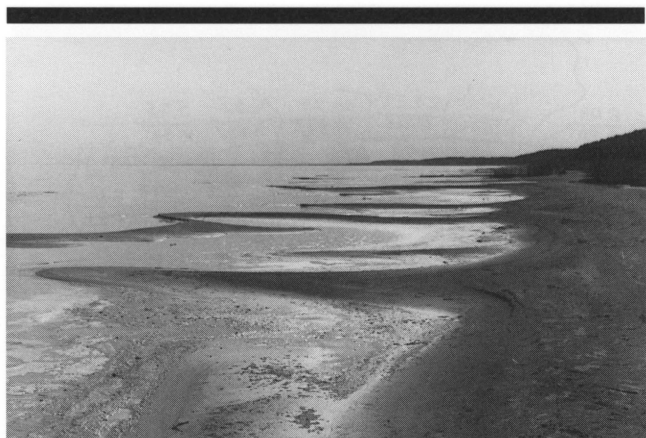
Photo 5. After the storm a new equilibrium will be formed. (Photo by A. Miidel).

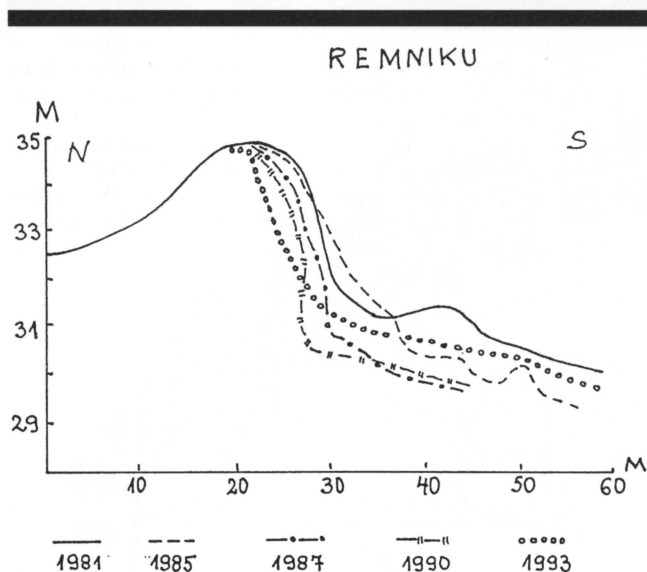
Figure 9. Beach erosion at Remniku. For the location of the profile see Figure 5.

At the end of November, 1987, wind blew several days from the south and the water-level rose on the northern coast; more than half of metre above its normal level. The beach suffered remarkable damage. Near Remniku, the coast retreated 1.9 m (Figure 9); and near Alajõe, an up to 4 m high new bluff formed into dunes. On the coast near Kuru where accumulation processes have always prevailed, the beach ridge that had formed over the past several years was destroyed and the coast retreated 3 m. After this storm, intensive erosion was registered over practically the entire length of the northern coast, excluding the north-western part of the lake. Near the village of Remniku, the storm eroded the 5-m-wide beach and destroyed large oaks and pines.
