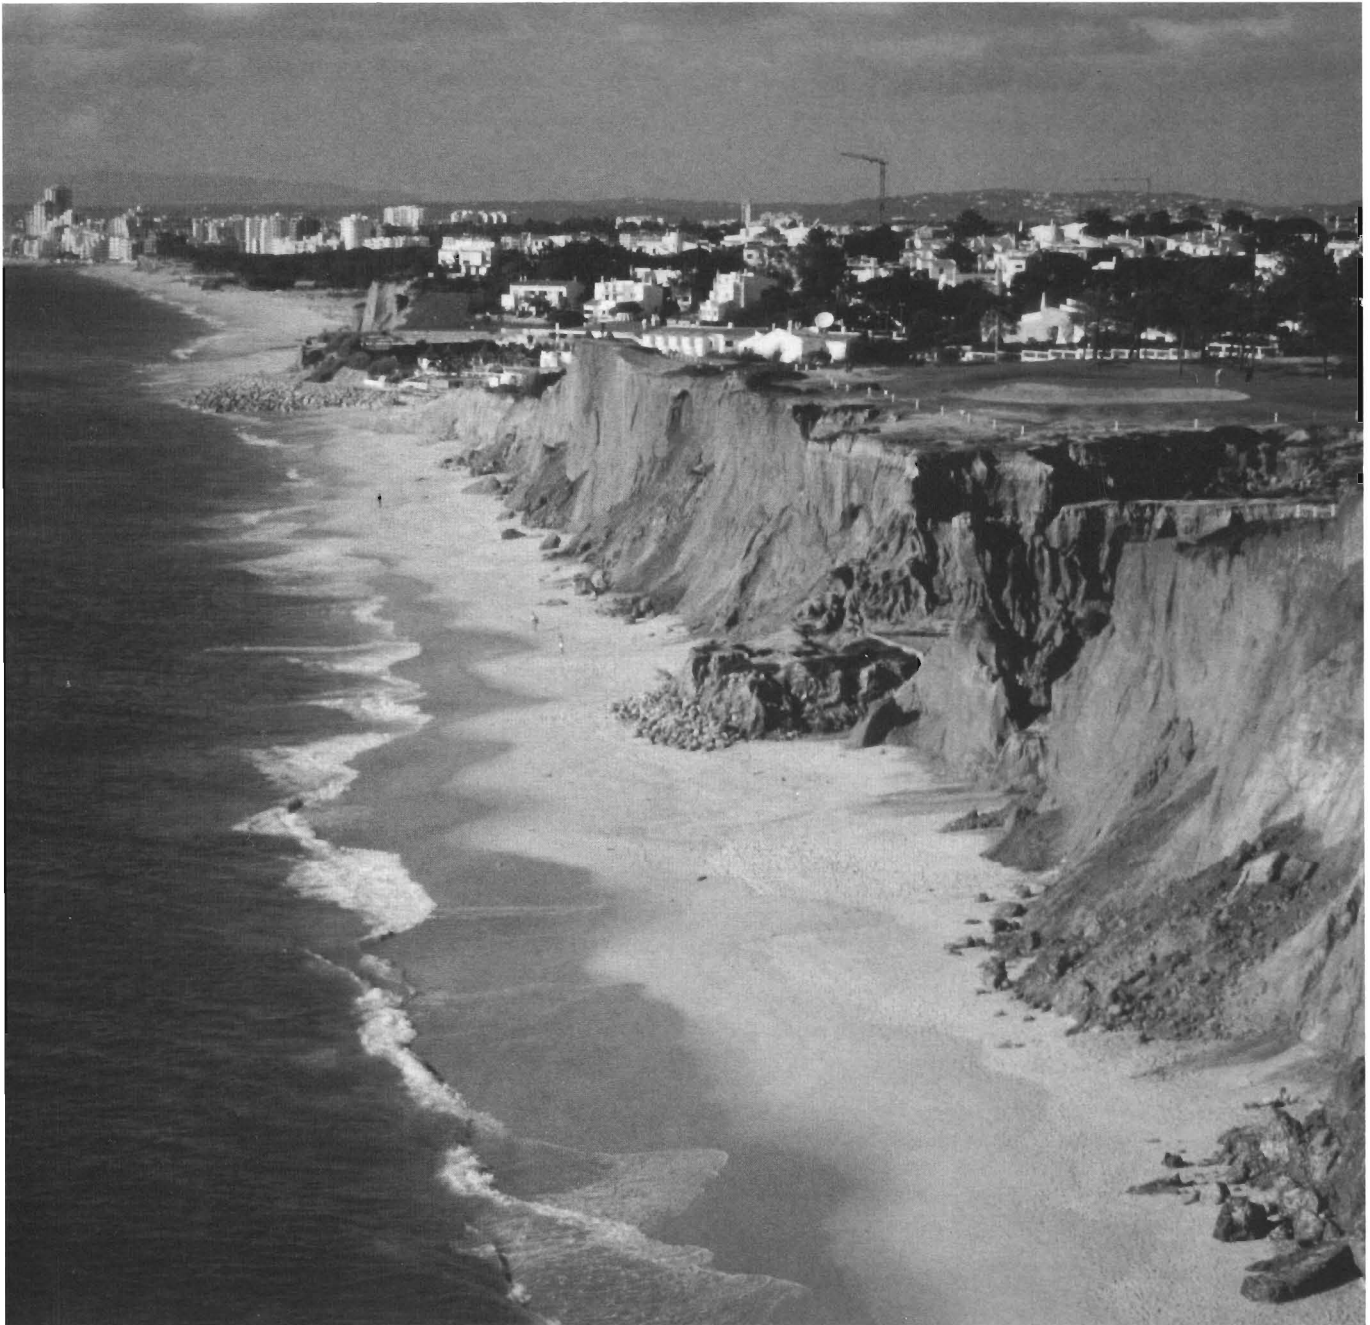
Rapid cliff erosion on the Algarve coast, southern Portugal. Vale do Garrão riprap protrudes seaward at the base of the flanking cliffs. In 1984, the cliffs were at the position of the riprap. Inland displacement of the beach is seen at the top of the photo, towards Quartiera. (Photo: João Alveirinho Diaz, Instituto Hidrografico, Lisbon, Portugal).
