The Sharon Escarpment (Mediterranean Coast, Israel): Stability, Dynamics, Risks and Environmental Management

Ithamar Perath and Gideon Almagor

Geological Survey of Israel
Ministry of National Infrastructures
30 Malchei Yisrael Street
Jerusalem 95501, Israel

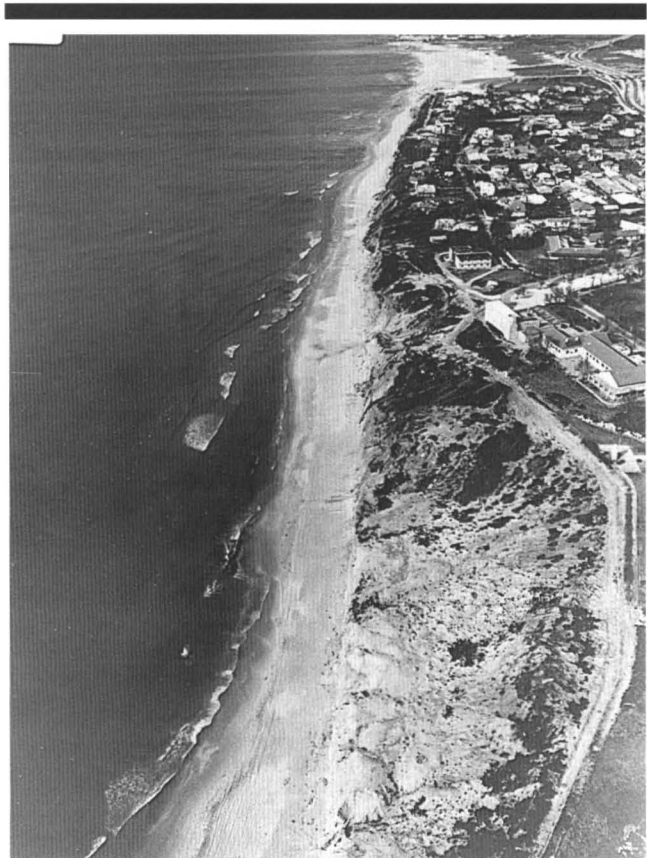
Figure 2. The Sharon Escarpment south of Alexander Creek. Note the overall rectilinearity and the slight sinuosity, expressed by the rim (Photo by Albatross).

Viewed meridionally from overhead, the cliff's rim forms an almost straight, slightly sinusoid line, projecting a wave-line front with a horizontal frequency of several hundred meters, and swinging no more than 20 m landward or seaward (Figure 2). Slump scars cause seaward-concave serration along the rim. The foot of the cliff is nonserrated and aproned by sandy talus over long stretches. Most of the rim is west of the ridge crest and truncates the west slope with a sharp nickpoint.

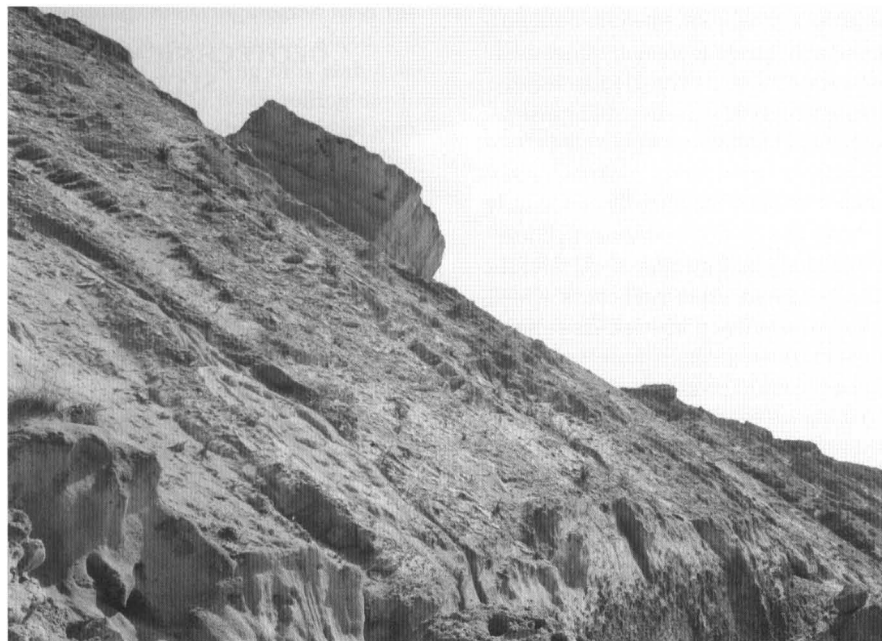
Figure 4. Calved-off block of calcarenite, riding the talus apron.

High degrees of cohesion (170-600 kPa) were measured for the upper ledge of calcarenite (Table 1), which shears under its own weight where the underlying Upper Hamra has been removed by slumping or flushing. Shearing begins with the formation of rim-parallel crevasses which appear about 2-3 years before full detachment. The breaching of a slab does not provide enough impetus to send the block rolling downslope, and constitutes no direct hazard—the bigger the slab, the greater the friction that slows its downslope sliding (Figure 4).

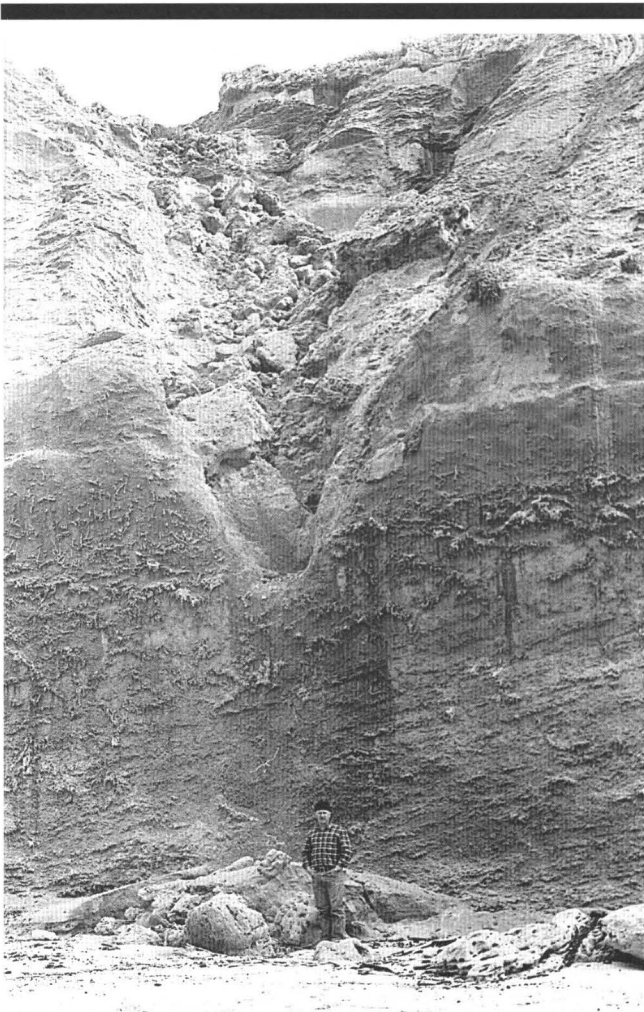
Figure 5. An erosional gully, ending as a hanging valley due to slumping and removal of its basal part.

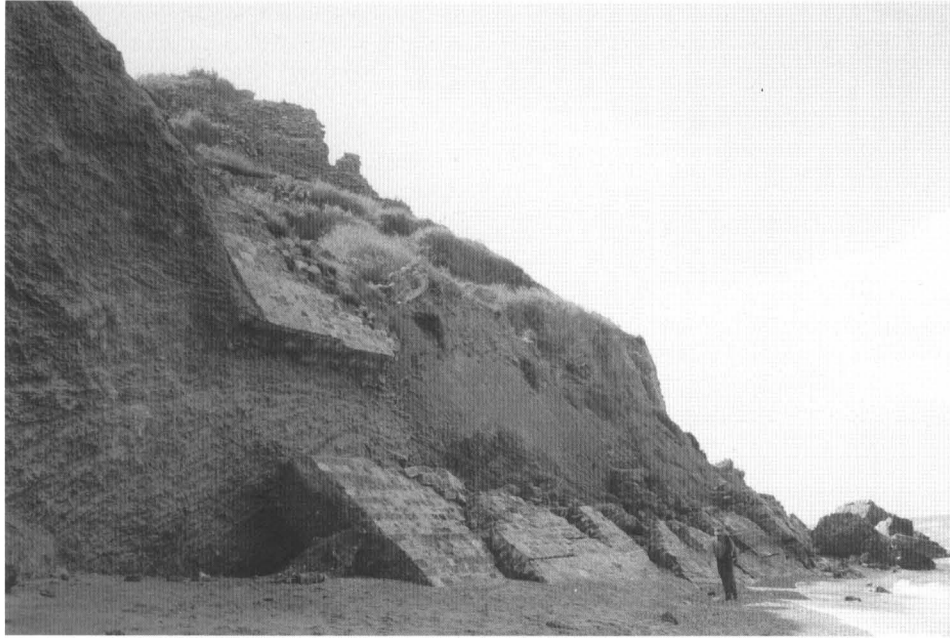
Figure 6. Slabs of cemented masonry lining the defensive moat of the 13th century castle of Arsuf. The detached slabs slumped onto the beach in late winter 1994.

Rapid landward translation of the coastal cliff is deduced from: (1) the many fresh slump scars along the cliff's face, (2) from commonly observed slumping along the slopes and the renewal of talus aprons, (3) from discernible retreat of the rim as revealed (though not measurable) by comparing aerial photographs and topocadastric records, (4) from the permanently youthful drainage pattern and its basal amputation (Figure 5), (5) from the presence of a submerged and abraded reef of eolian kurkar that reaches as far as 250-300 m seaward of the cliff's present base, and (6) from the remnants of ancient seaside buildings transected by the cliff's rim or scattered among the scree's lag gravels (Figure 6).

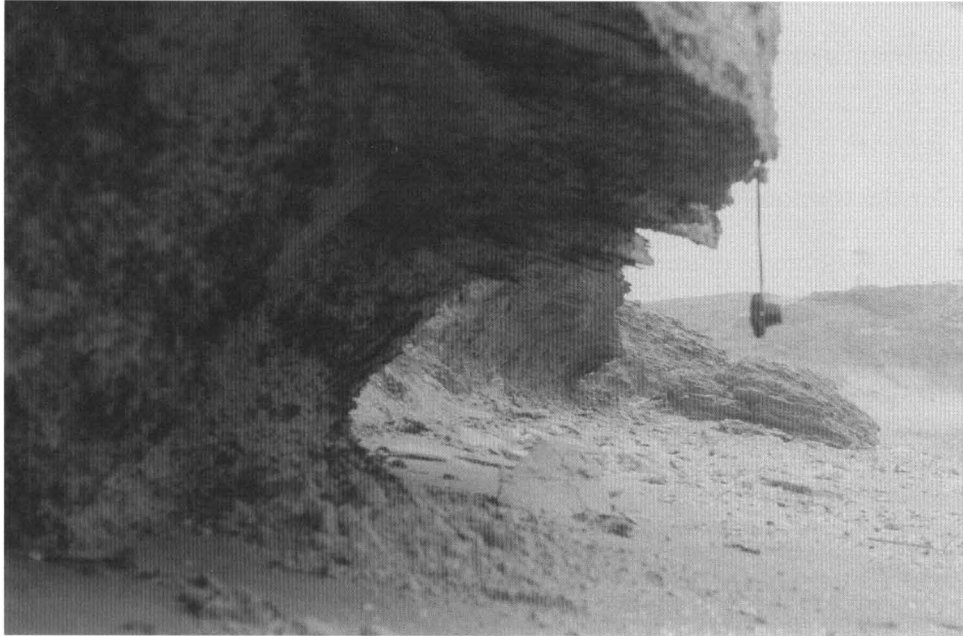
Figure 8. Wave-cut notch at the base of the cliff, slightly enlarged by roof collapse. Note Tel Malha in background, a Roman-Byzantine site truncated on its seaward side by slumping.

- (a) Creation of a wave-cut notch at the talus-free base of the cliff. This takes place during the few hours per winter that wave swash from storm swells comes into contact with the cliff. The actual mechanics of notching have not been recorded, but it has been repeatedly observed that waters reaching the cliff base have spent most of their turbulent energy, and can do little mechanical work. Cement dissolution possibly plays a role comparable to mechanical abrasion. The notch, initially 15–30 cm high and of indeterminate width, may undercut the cliff as far as 1 m, rarely more, and grow several meters upward by subsequent roof collapse, creating a conspicuous overhang (Figure 8).

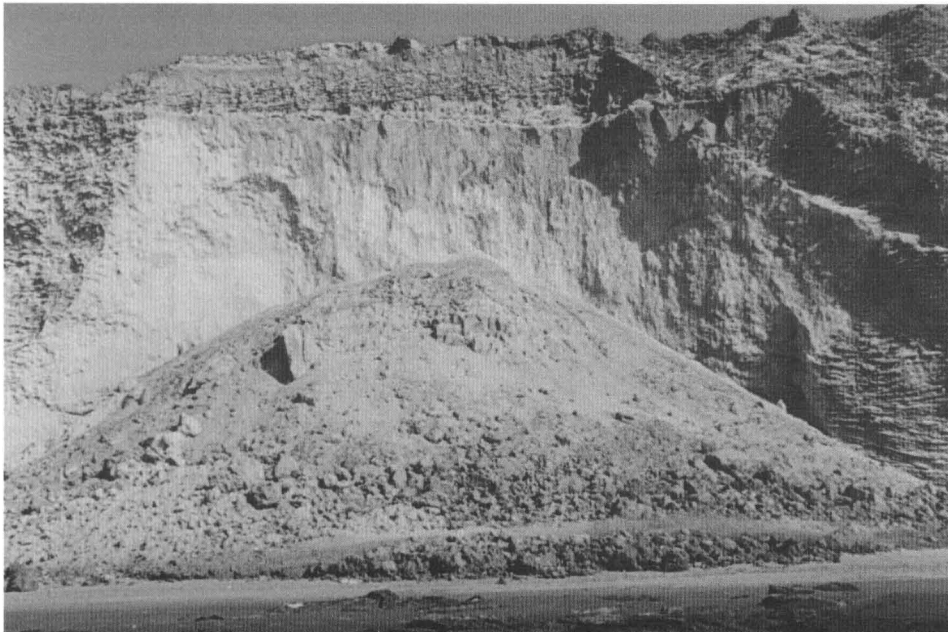
Figure 9. A large, hemiconical talus apron, formed by slumping of the entire cliff front. Note the compound scar that reaches up to the rim. The toe of the apron has been bulldozed to enable beach traffic. No change is expected in the situation (Risk C) before the waves start removing the talus (Photo Y. Nir).

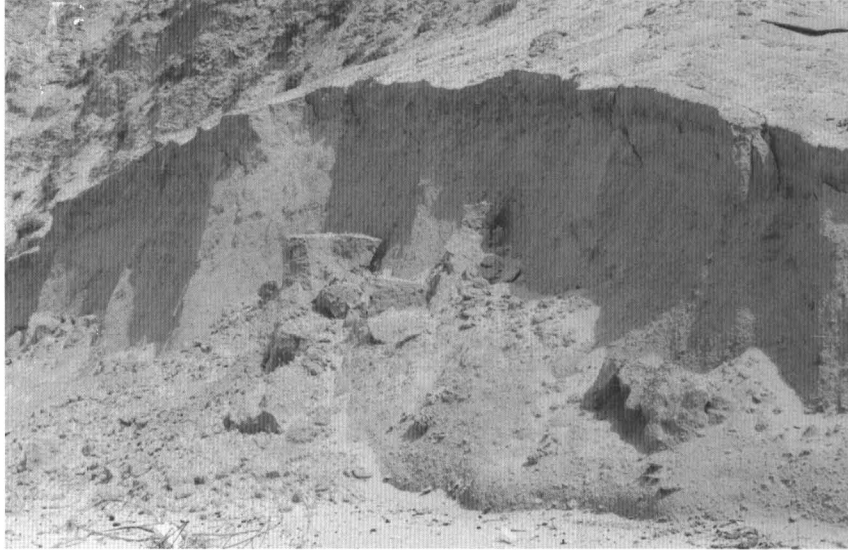
Figure 10. Wave-cut step, truncating the toe of a sandy talus apron (Risk B). The step is maintained at this high angle by capillary forces in the moist sand. Desiccation results in collapse, as has happened to the apron in the foreground.

- (c) The talus apron is removed in stages by wave swash. Collapsed waves running up the beach approach close to the cliff at high tides, and wash away the toe of the talus apron. A vertical step is formed across the base of the apron (Figure 10), initially stable because of capillary water and carbonate bonding, but soon drying out and collapsing (Figure 11). Subsequent toe removal causes repeated series of step faulting across the apron, with repeated collapse until all talus is removed, after which the base of the cliff is again exposed to wave action and notching (event a), as described above.

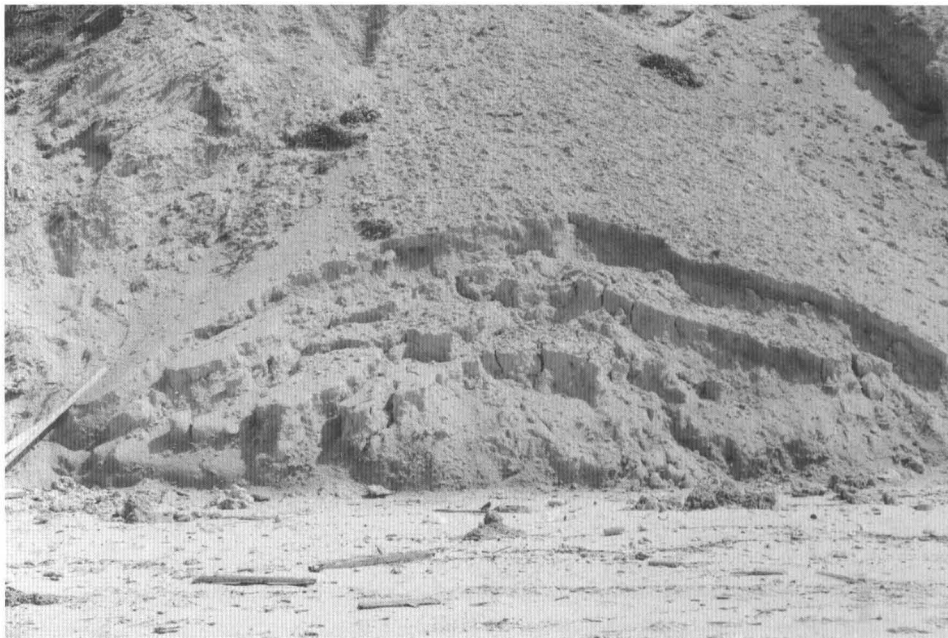
Figure 11. Serial step faults cutting across a hemiconical talus apron, the result of the collapsing of the wave-cut step formed by removal of the toe.

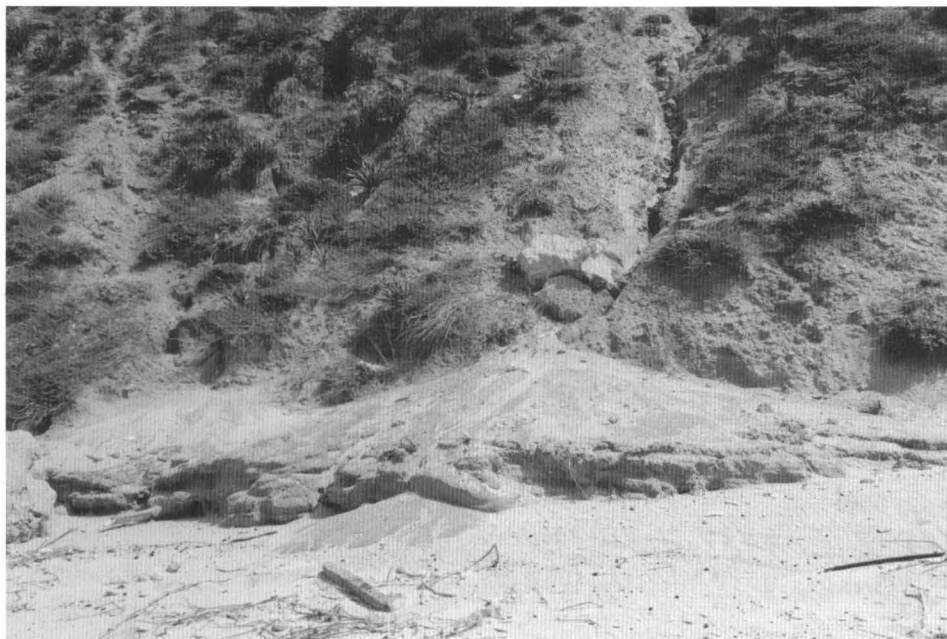
Figure 12. Low-angled alluvial fan, its toe truncated by wave swash. Note small new cone in front of wave-cut step.

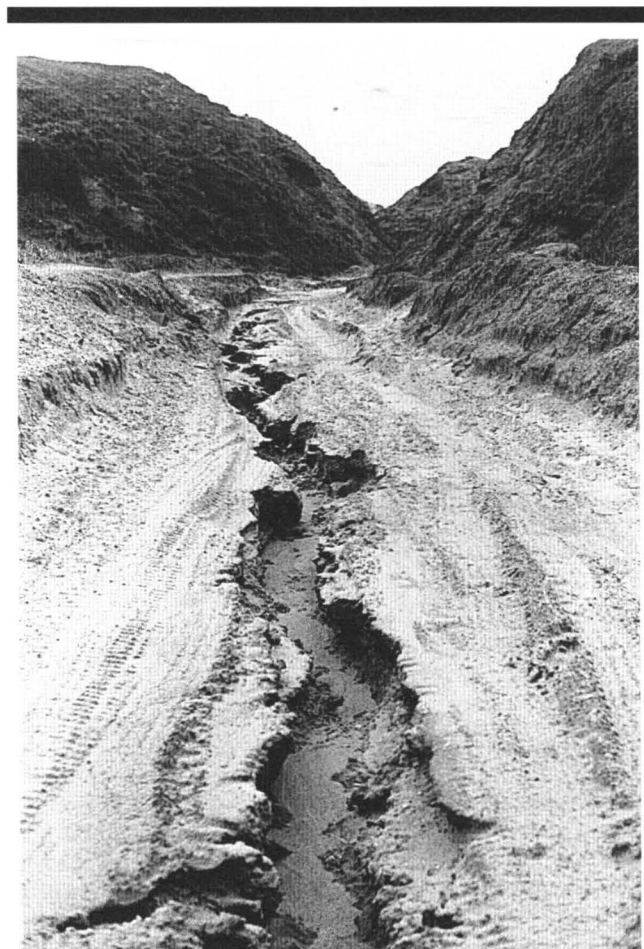
Figure 14. Artificial road gap, hewn at right angles to the cliff, repeatedly eroded, re-excavated and re-eroded.

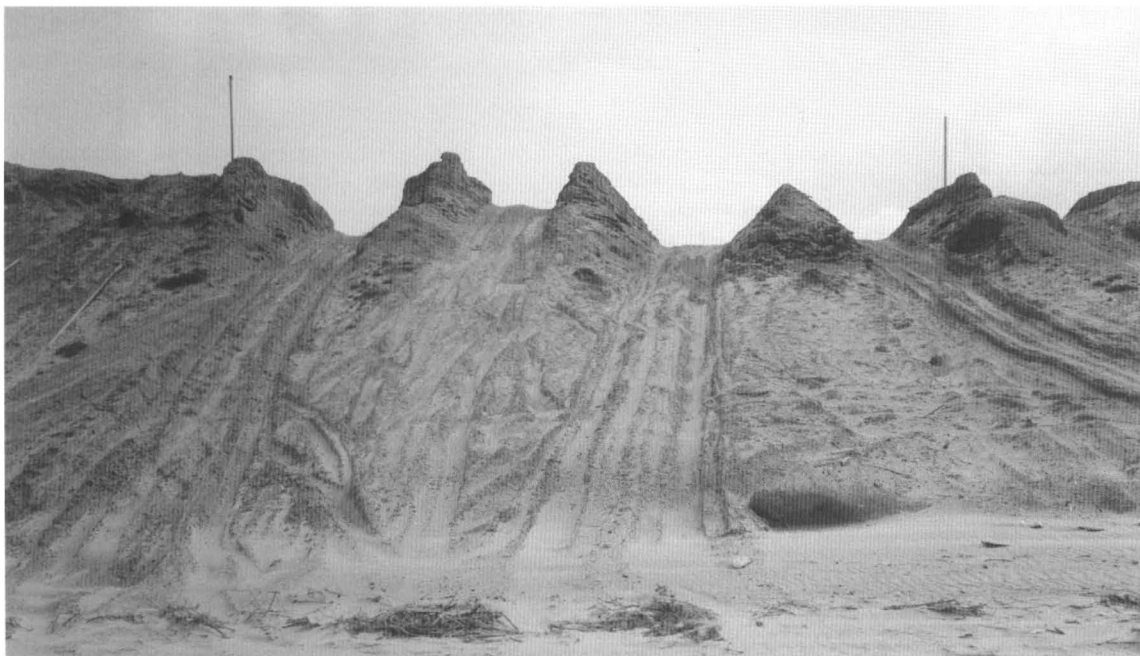
Figure 15. Deep ruts, destined to become erosion channels, made by motorized sport vehicles ploughing into a moderate-sloped section of the Sharon Escarpment.

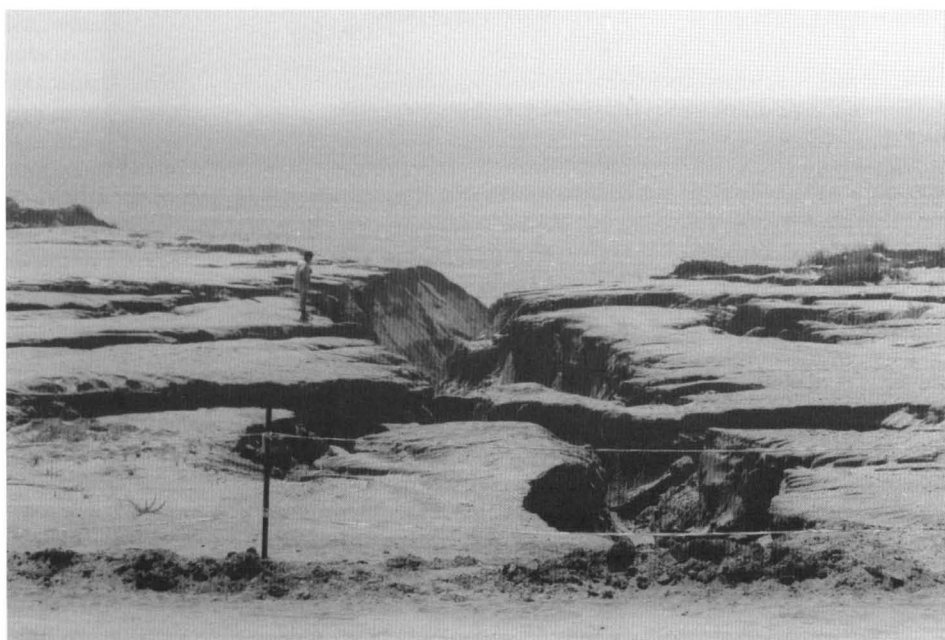
Figure 16. The Upper Hamra that has been stripped of the stratified sands and calcarenite, is attacked by sheet wash and transformed into badlands that destroy the back-cliff zone.
