The Coastal Geomorphological Development of the Skagen Spit, Jutland, Denmark. Its Fate During the Next Century. Coastal Erosion and Accretion.

Per Bruun

BRUUN, P., 2000. The coastal geomorphological development of the Skagen Spit, Jutland, Denmark. Its fate during the next century. Coastal erosion and accretion. *Journal of Coastal Research*, 16(4), 1094–1099. West Palm Beach (Florida), ISSN 0749-0208.

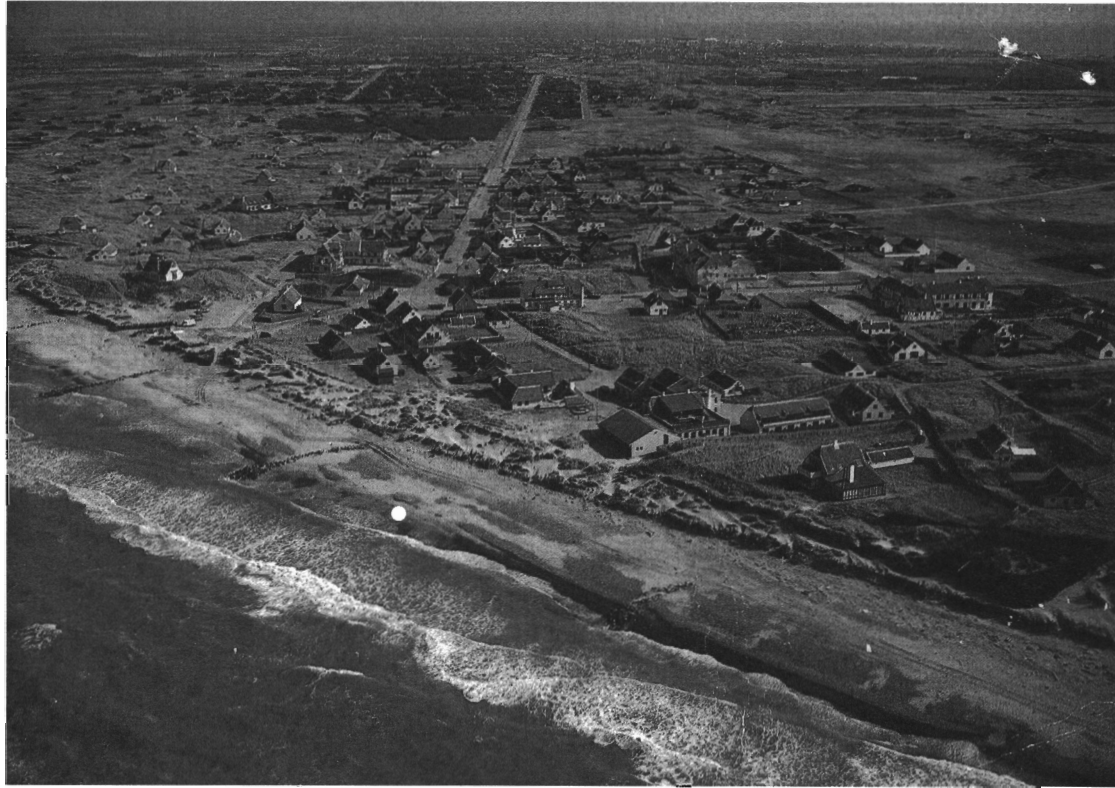
Figure 2. Groins at Gl. Skagen, 1960.

A long-range effect of the harbour at Hirtshals may be responsible for the increase of erosion at Gl. Skagen starting in the 1950's or about 25 years after the completion in the 20's of most of the harbour jetties and a navigation channel at Hirtshals (BRUUN, 1995). At Gl. Skagen, six groins were built at the beginning of the 1950's (Figure 2). They were effective, but caused severe downdrift erosion. Starting in 1977 another 16 short T-groins were built northeastward. They lowered the shoreline recession considerably but also caused further extension of leeside erosion. The total length of erosion infested shore from Gl. Skagen and northeastward is now about 2,500 meters. Some place close to the location of the North Lighthouse (Figure 1) the erosion is replaced by accretion increasing northeastward towards Grenen which during recent years has experienced offshore

(Figures 2 and 3)
