Bypassing of Dredged Littoral Muddy Sediments Using a Thin Layer Dispersal Technique

HEALY, T.; MEHTA, A.; RODRIGUEZ, H., and TIAN, F., 1999. Bypassing of Dredged Littoral Muddy Sediments Using a Thin Layer Dispersal Technique. *Journal of Coastal Research*, 15(4), 1119–1131. Royal Palm Beach (Florida), ISSN 0749-0208.

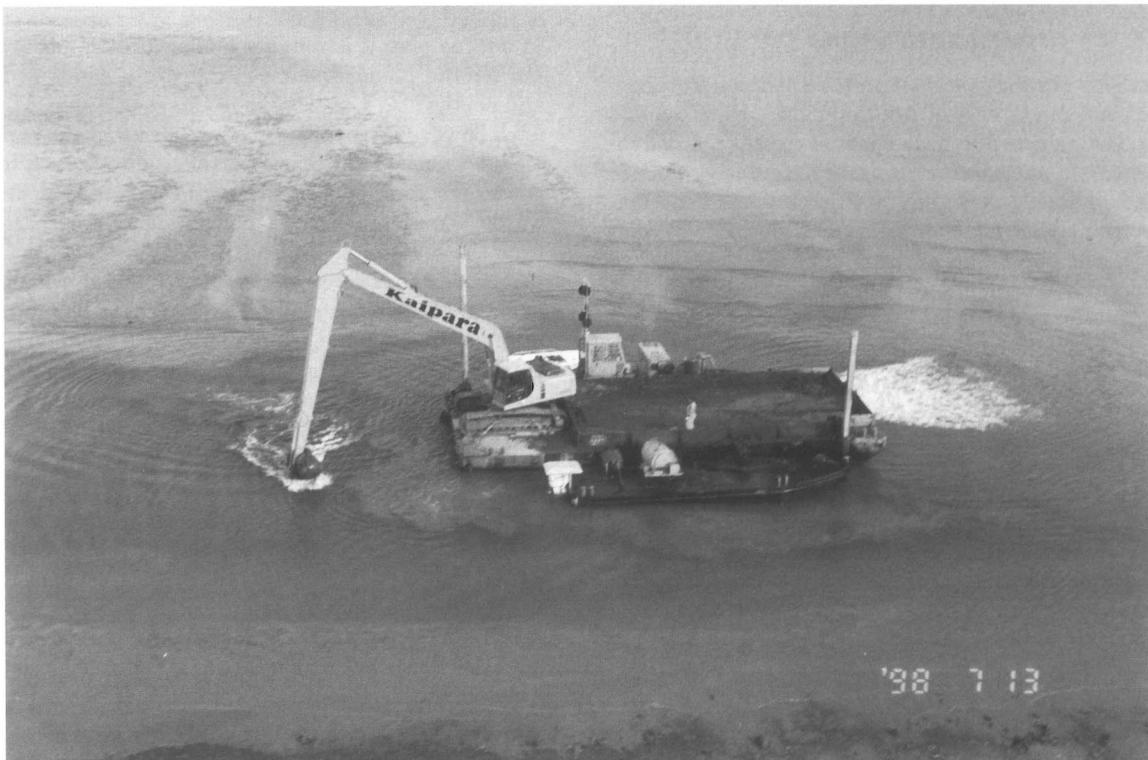
Figure 3. The dredging of muddy sediments from the marina approach channel using a digger mounted on a barge.

mulation of muddy sediment deposited in the channel was dredged using a digger mounted on a barge (Figure 3), and side-casted into a mound of muddy material about 50 m broad and 0.5 m high alongside the channel. Monitoring of the side-casted dredgings was carried out over the next year (HULL, 1996), but unfortunately some of the muddy material became transported back into the channel by the reverse littoral drift processes.

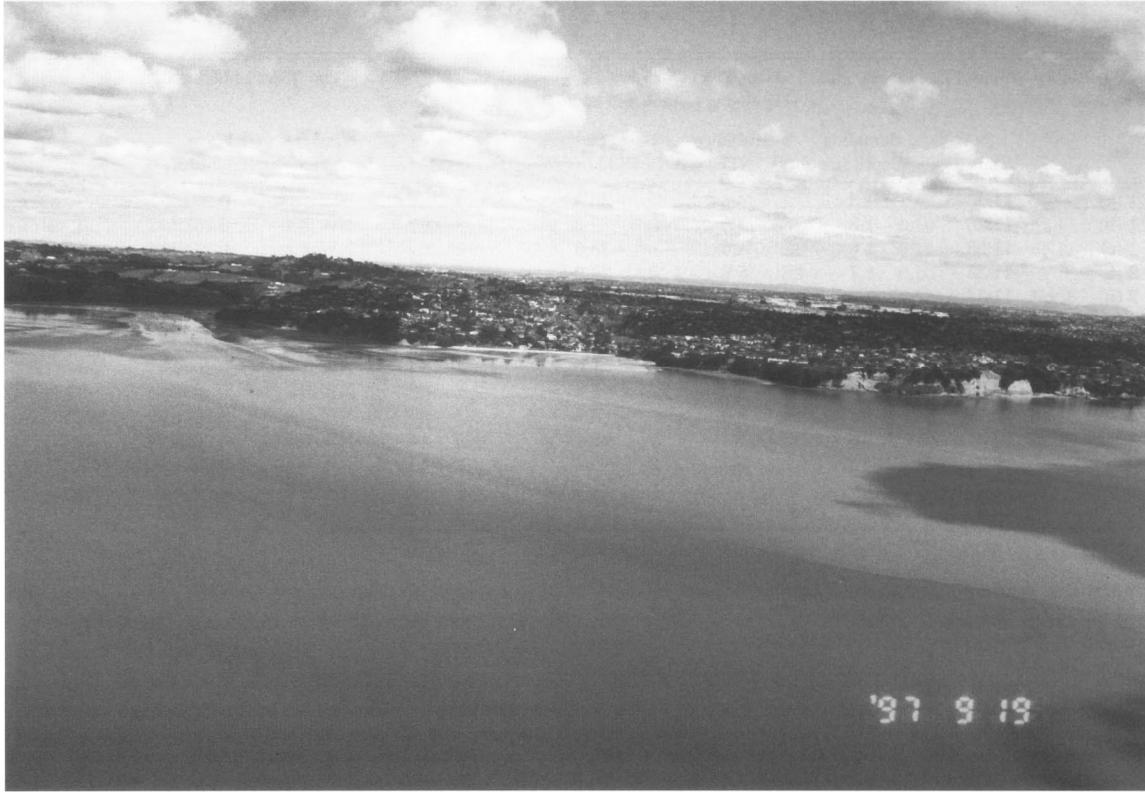
Figure 5. Turbid plume due to natural catchment discharge of high natural suspended sediment loads from the adjacent Turanga catchment.

the catchment. Suspended sediment load in the channel and control site were all close to 30 mg/l (turbidity ~ 5 NTU). But remarkable was the suspended sediment load of 140 mg/l (turbidity—61 NTU) in surface waters at site 8, representing the natural discharge from the Turanga catchment. This is an order of magnitude greater than levels measured in the direct dredging plume as represented by the site 2 values above. The Turanga catchment discharge plume is identified in the photo records for that day (Figure 5).

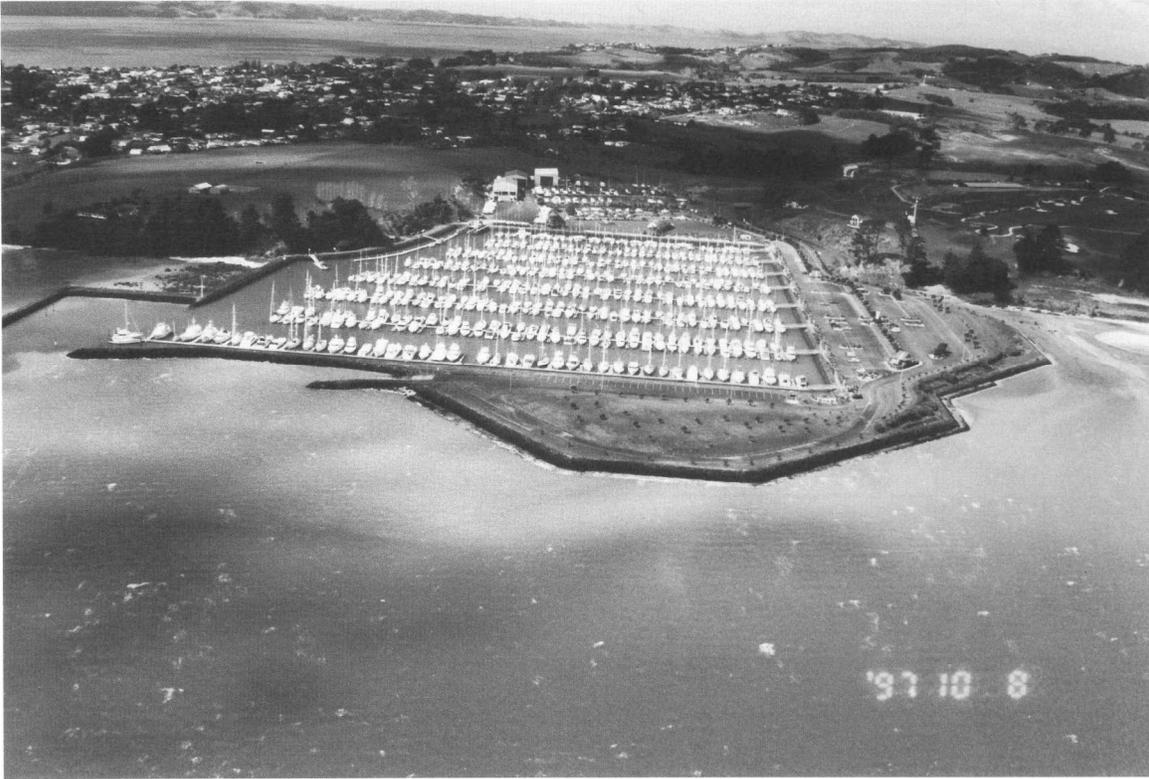
Figure 13. Turbidity and high suspended load from the estuarine turbid fringe and from the stream adjacent (to the right) of the marina flowing under the influence of southwesterly winds into the marina approach channel, where muddy deposition occurs. Such "natural" turbidity is higher than measured at the monitoring sites related to the dredging.

At times of the monitoring runs, high angle oblique air photos were taken to provide a visual record of conditions at the time of monitoring. These clearly show that the surrounding catchments and the wave agitated estuarine turbid fringe provide much greater generation of turbid water with higher suspended sediment loads which impact over much larger areas of the embayment than the dredging and disposal activity (Figure 13).
