# Coastal Erosion and Management of Majuro Atoll, Marshall Islands

Chunting Xue

XUE, C., 2001. Coastal erosion and management of Majuro Atoll, Marshall Islands. *Journal of Coastal Research*, 17(4), 909-918. West Palm Beach (Florida), ISSN 0749-0208.

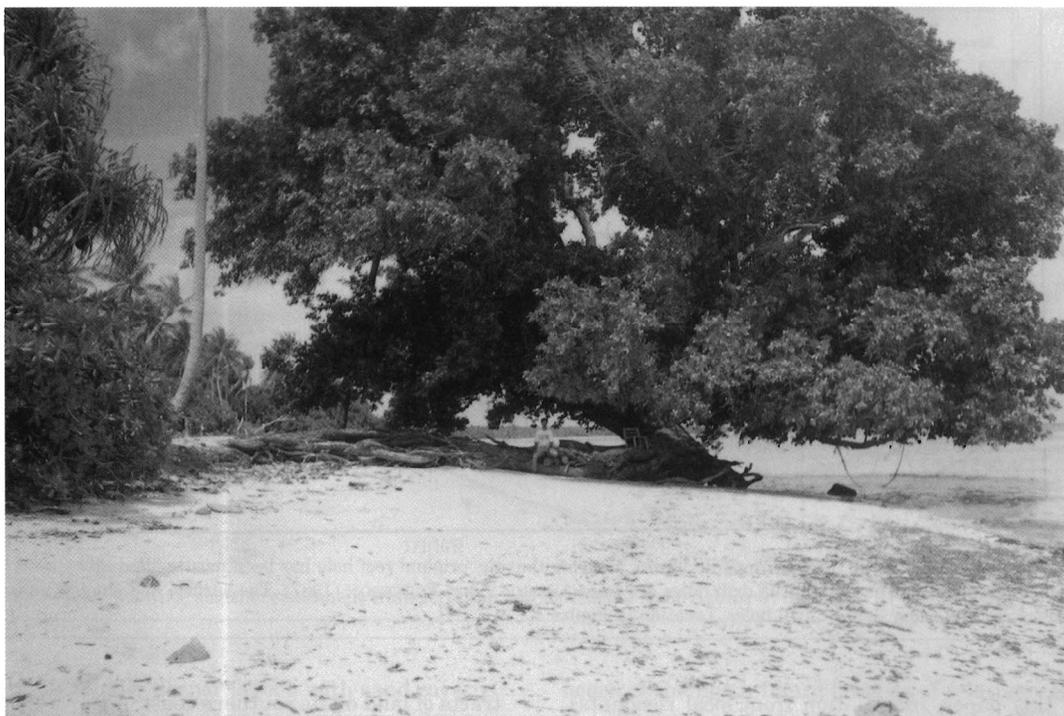
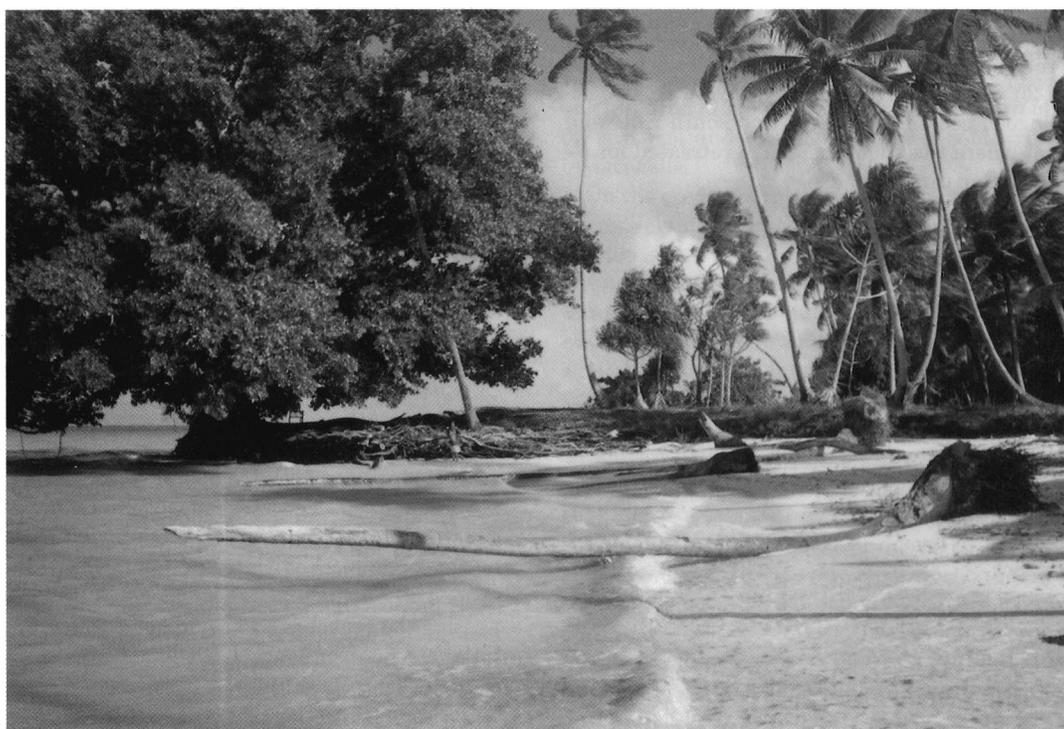
Figure 3. A surviving large tree *Calophyllum inophyllum*, indicating that the shoreline has retreated at least 14 m on the southeast updrift side (upper photo, view from 140°) and 22 m on the northwest downdrift side (lower photo, view from 290°), at average of 18 m, and northwest longshore sediment transport. Lagoon side, the west section of south rim. Location in Figure 1.

The lagoon coasts are eroded even more severely than the ocean coast, except the stable or prograding coasts in limited areas. A large land tree *Callophyllum inophyllum* indicates that the shoreline on the south section of east rim has retreated at least 4 m. However, based on the information from an elder resident, the shoreline of the south Uliga has retreated about 17 m since the end of the Second World War. On the west part of Rairok a surviving large tree, *Callophyllum inophyllum* indicates that the shoreline has retreated at least 17 m. The old road east to the airport has mostly disappeared and the present shoreline reaches the trees on south side of the road. It is estimated that the shoreline has receded more than 10 m. On the west section of south rim, surviving large trees *Callophyllum inophyllum* indicate that the shoreline has retreated at least 18 m in some places (Figure 3.). This recession occurred in the last 25 years (counting
