Another Look at the Impact of Hurricane Hugo on the Shelf and Coastal Resources of Puerto Rico, U.S.A.

RODRIGUEZ, R.W., WEBB, R.M.T., and BUSH, D.M., 1994. Another look at the impact of Hurricane Hugo on the shelf and coastal resources of Puerto Rico, U.S.A. *Journal of Coastal Research*, 10(2), 278-296. Fort Lauderdale (Florida), ISSN 0749-0208.

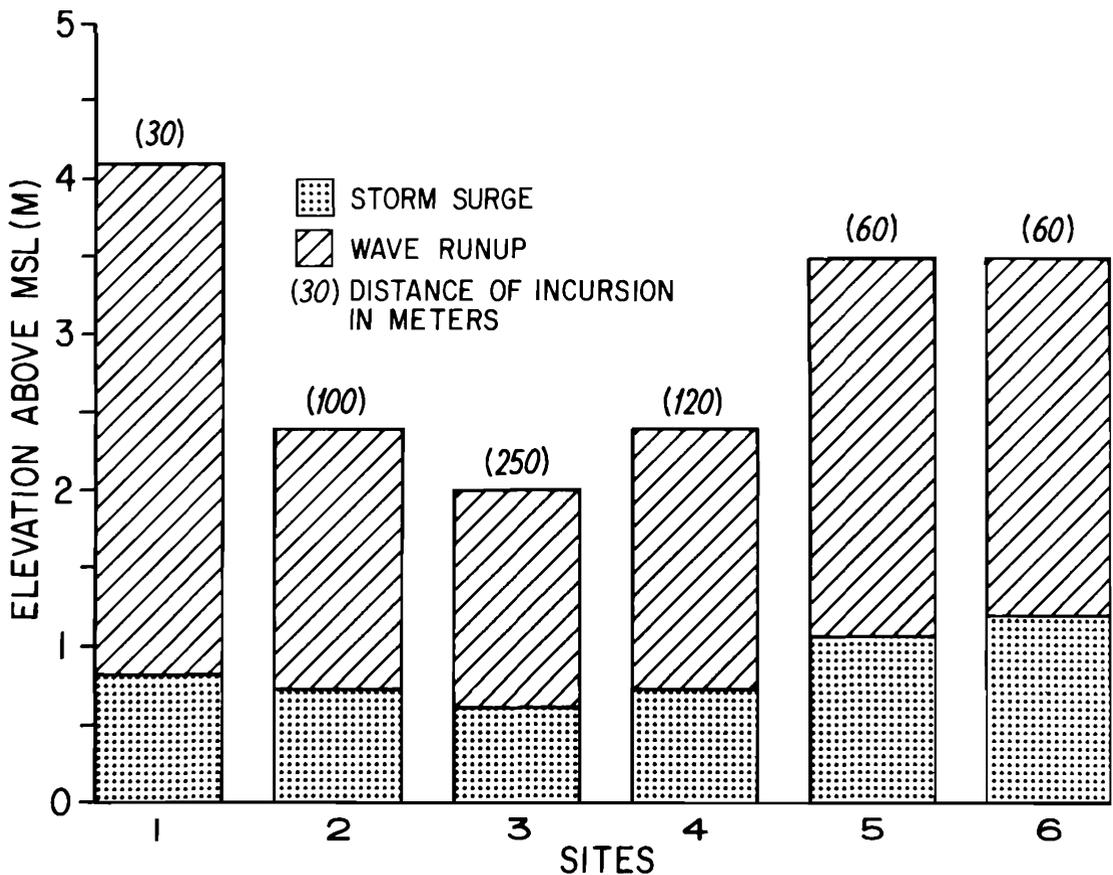
Figure 7. Storm-wave swash for six sites in Puerto Rico. Site location numbers are shown on Figure 1. Storm-wave swash is a combination of storm surge and wave runup. Storm surge was similar for the six sites, but wave runup varied as a function of coastal profile. Landward incursion of storm water is given by the values in parentheses at the top of each column. Coastal flooding was severe in low lying areas (sites 2, 3, 4). Although storm wave swash was greater in steeper profile areas (sites 1, 5, 6), overall incursion was less.

surveying techniques. Coastal flooding around the island was augmented by hurricane-generated waves that reached maximum heights of about 4 m. The combination of storm surge and the wave runup caused severe coastal flooding in low-lying areas (Figure 7).
