Mechanisms of Coastal Cliff Retreat and Hazard Zone Delineation in Soft Flysch Deposits

Vicki G. Moon and Terry Healy

MOON, V.G. and HEALY, T., 1994. Mechanisms of coastal cliff retreat and hazard zone delineation in soft flysch deposits. *Journal of Coastal Research*, 10(3), 663-680. Fort Lauderdale (Florida), ISSN 0749-0208.

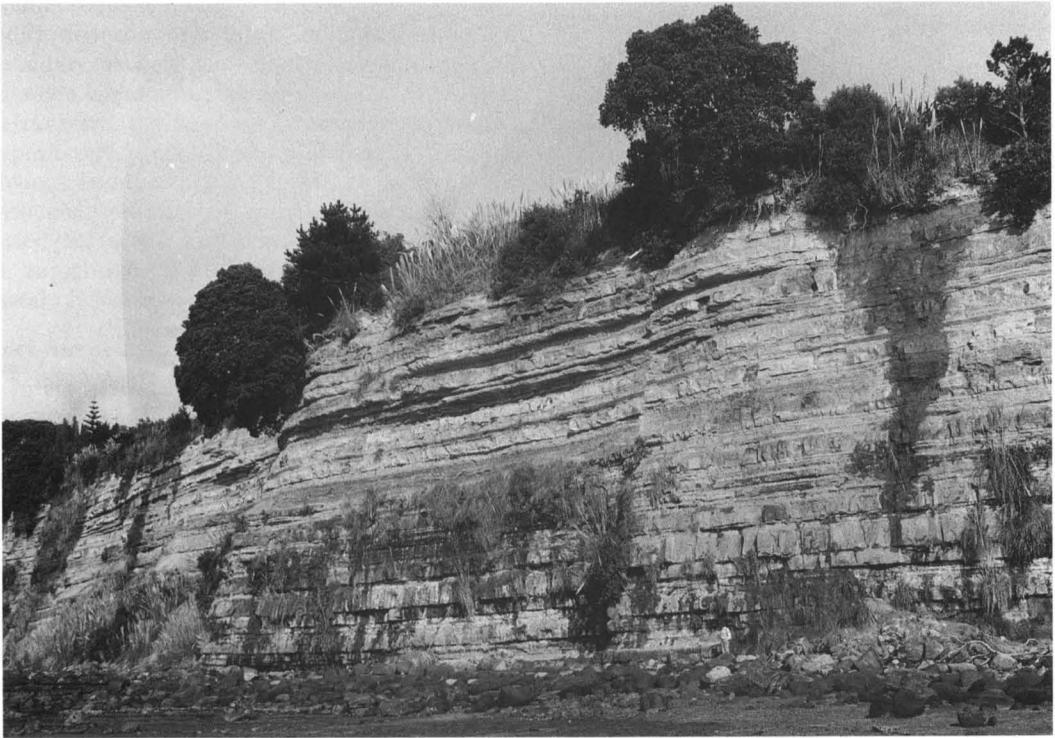
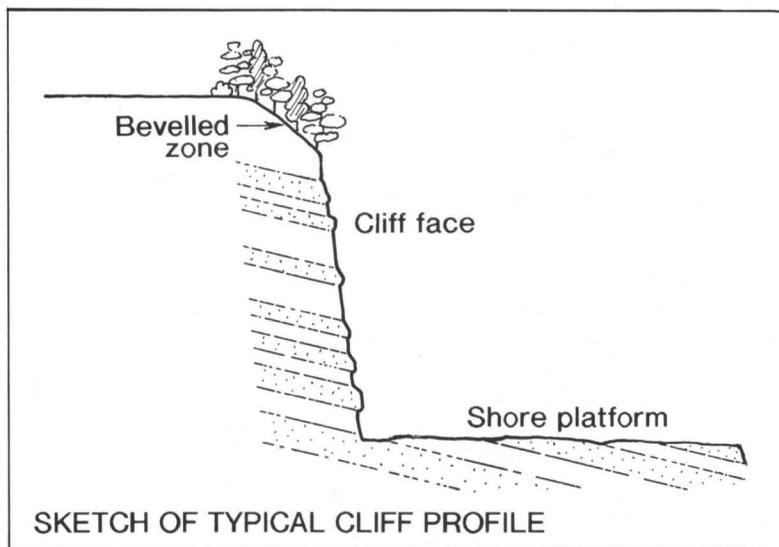
Figure 2. Steep cliffs up to 30 m in height are typical of the region. Alternating sandstone and siltstone layers with gentle dips to seaward make up the bulk of the rock faces. At the top of the profile, there is commonly a "bevelled zone" of lower slope representing the stable angle of the weathered soils.

The cliffs throughout the Auckland area are consistently very steep (Figure 2), forming angles of 10–20° to the vertical in general. Their height varies from approximately 5 m to 30 m with a typical cliff height of approximately 20 m.

At the top of the cliffs, it is common to see an area across which the slope decreases markedly behind the edge (Figure 2). This "bevelled zone" is believed to be the result of past failure of the overburden, and thus represents an equilibrium configuration in which the weathered regolith has established a stable angle. In the context used here, "bevelled" applies to the area of low slope developed specifically in the weathered soil material at the top of the cliff; however, the terminology is consistent with that used by YOUNG (1972) and TRENHAILE (1987).

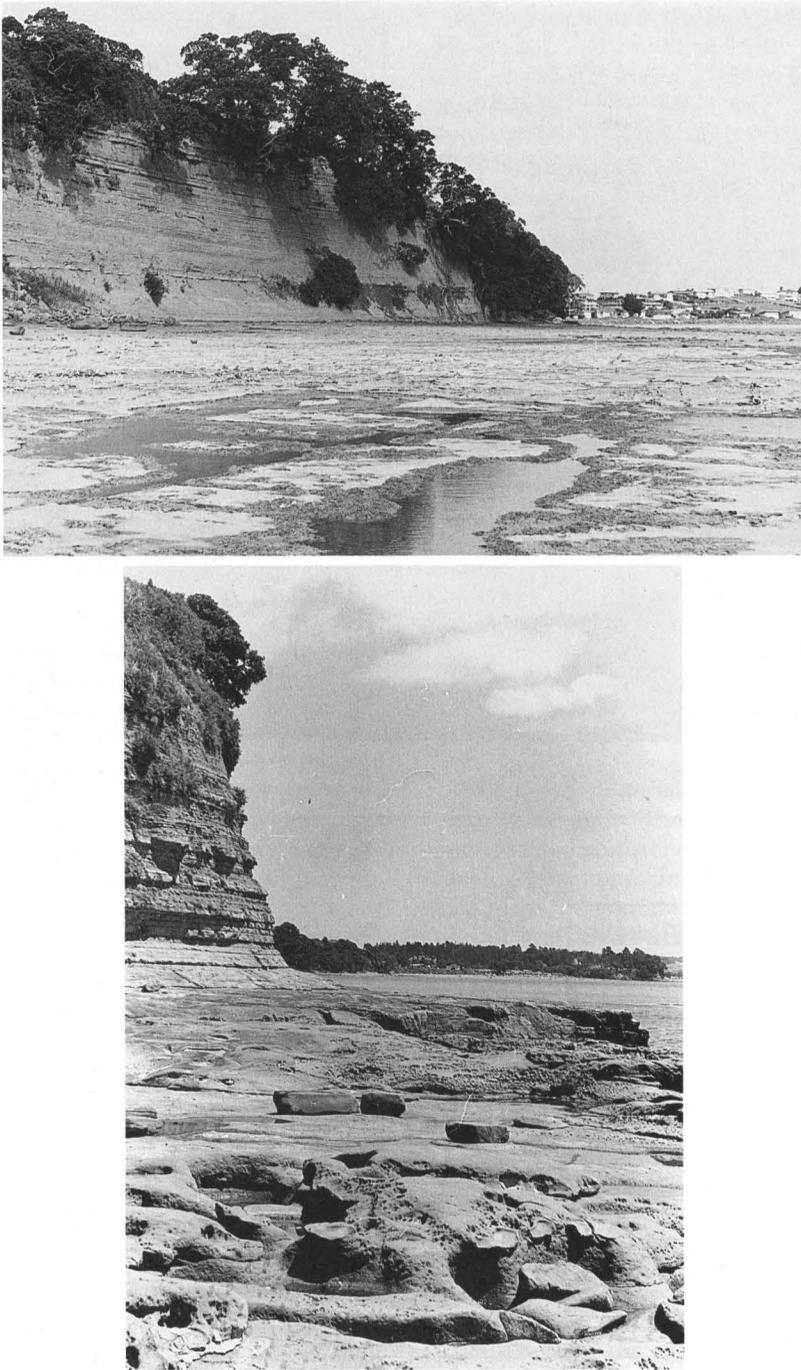
Figure 3. Shore platforms eroded into the flysch deposits: (Top, A) The common intertidal platform, which usually forms a 40–200 m wide shelf. (Bottom, B) The high-tide platform which is typically a narrow bench 2–3 m above the low-tide platform level and planed to the high tide level.

this consists of a broad, gently sloping surface extending some 40–200 m seaward of the cliff face (Figure 3a), and ending abruptly in a bioeroded sea cliff (HEALY, 1967a,b, 1968). In some sectors of the shoreline, a higher level platform exists some 2–3 m above the low tide level (Figure 3b). Such high tide platforms, or high level benches (HEALY, 1967a), are generally only a few metres wide.

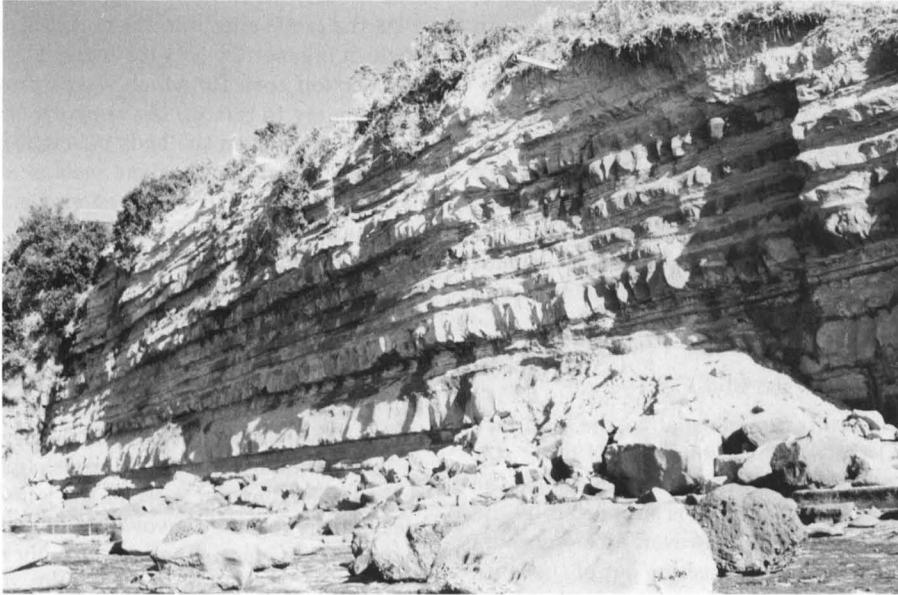
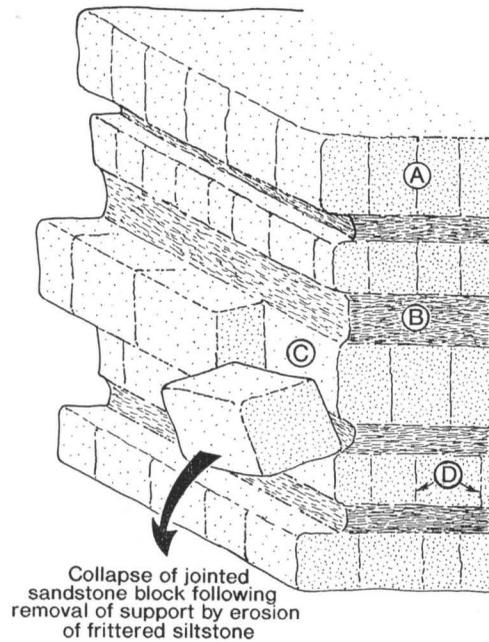
A: Sandstone C: Exposed joint plane
 B: Siltstone D: Jointing in sandstones

Figure 4. Stretch of cliffs actively eroding by falling joint blocks. Note the tendency for the siltstone beds to be preferentially eroded leaving the sandstone layers protruding. Continuous vertical joints through the sandstones break this material into regular blocks. Loss of support for these blocks results in simple gravitational collapse. The diagram shows the simplest case of a single displaced block; commonly a number of blocks will fall together, removing the support for a sizeable body of material above.

Collapse of jointed sandstone blocks is the most common form of instability of these cliffs. Figure 4 shows a typical stretch of coastal cliffs which is actively retreating by this mechanism. The actual failure itself is the result of simple gravitational collapse of the regularly shaped joint blocks described previously. Initially, the sandstone beds are supported by the underlying siltstone. However, the tendency of the siltstone to fragment by slaking results in loose, frittered material which is easily removed by surface water, waves, and even wind (reports of blowing silt are common from householders on the cliff tops). Once the sandstone blocks are undercut, there is very little support for them, as the joint planes tend to be continuous and open. The blocks can, therefore, fall readily from the face. This process is exacerbated by water flowing down the joint planes, as shown by wet surfaces and extensive ironstaining on newly exposed joint faces.

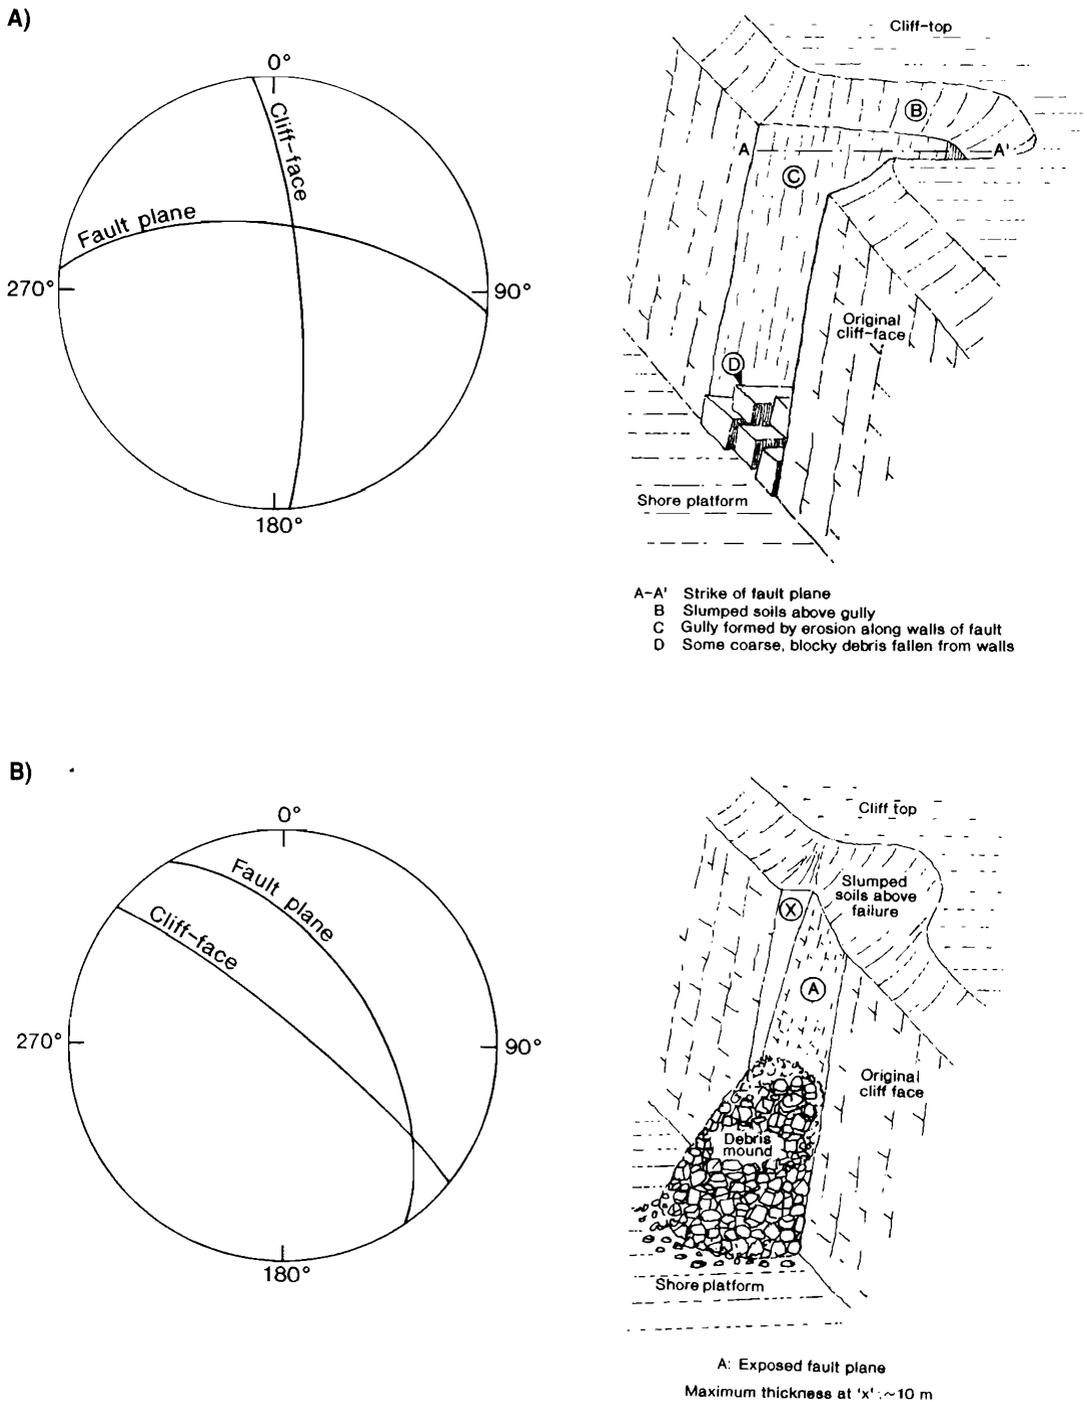
Figure 5. (A) Stereonet analysis showing the fault planes striking normal to the strike of the cliffs. In this situation a narrow gully is incised along the fault plane. (B) Stereonet analysis of fault planes striking sub-parallel to the cliff face. In this case, the capacity exists for planar failure of the material in the acute intersection zone between the fault and the cliff face.

When the faults run normal to the cliff face (Figure 5A) the situation is inherently quite stable, with no real capacity for sliding along the fault plane as the weak zone is supported by the rock mass on each side. However, erosion occurs by means of preferential washing out of the loose material along the fault plane with some localised joint block fall along the walls of the fault as support for the sandstone blocks is removed. This results in a narrow gully developing along the fault plane (Figure 6), similar to the erosion of weak, vertically dipping rocks described by TRENHAILE (1987). Unfortunately, associated soil failure above such natural gullies tends to produce a topographic feature which is seen as a prime site for disposal of stormwater. This enhances the gully erosion significantly, as it is mainly flowing surface water which is the cause of removal of the fault gouge initially.

When the fault planes run approximately parallel to the cliff face (Figure 5B), the situation is much less stable. In particular, the cliffs are susceptible to planar failure along the fault plane. TERZAGHI (1962) describes such a situation where the fault intersects the cliff face at an acute angle, and shows that the wedge-shaped body of rock between the slope and the fault may drop out. As many of the faults in the Auckland area are nearly vertical, they do not daylight from the slope, so the cliffs are buttressed by the rock at the base of the cliff. Unfortunately, in the coastal environment, waves provide a ready mechanism for transporting away loose material at the base of the slope, thus removing support for the overlying rock mass. As this support is lost, planar failure

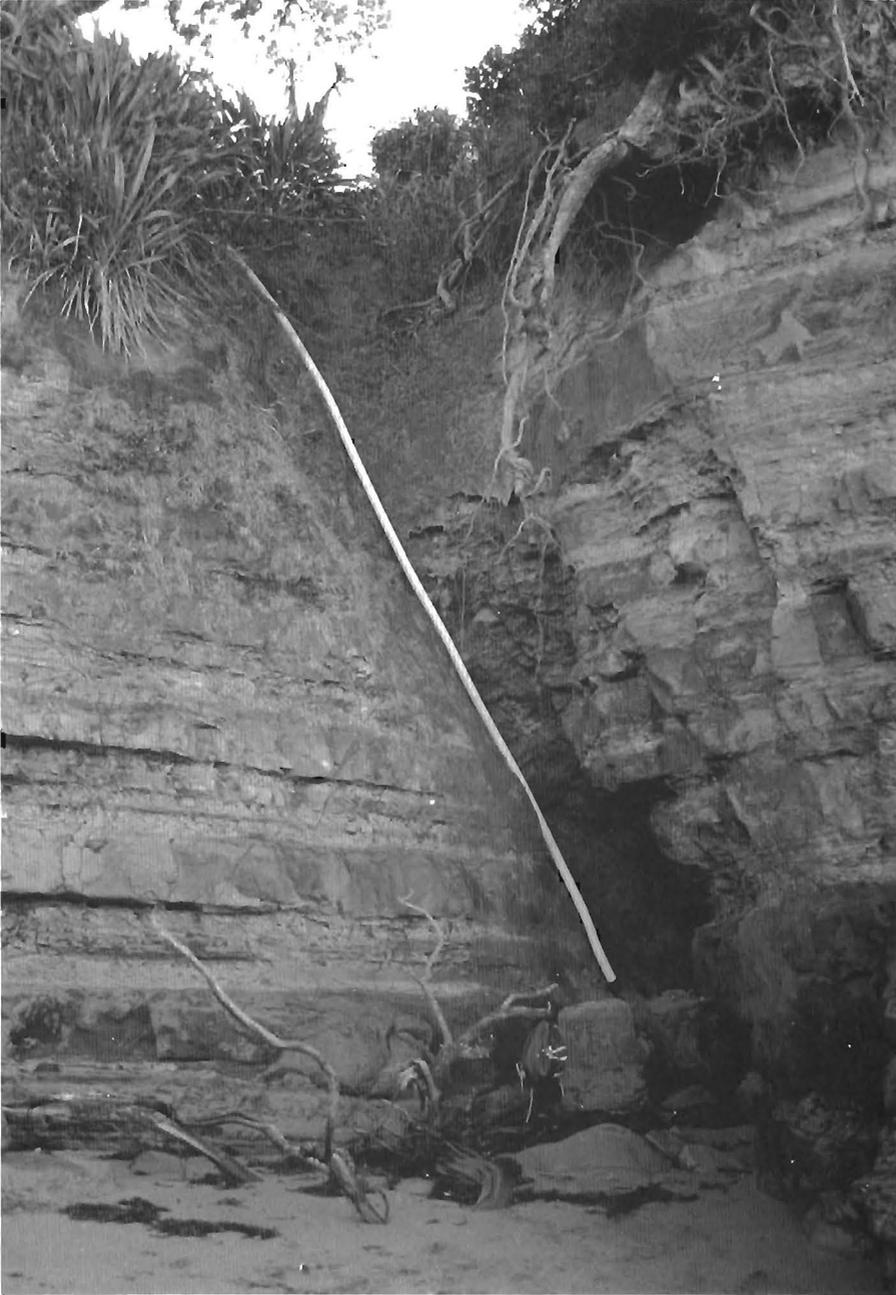
Figure 6. Gully development along a small fault striking normal to the cliff face. Note the recent extension of the stormwater discharge pipe to the base of the cliffs—in 1983 this discharge occurred at the cliff top, a significant cause of enhanced erosion along this plane.

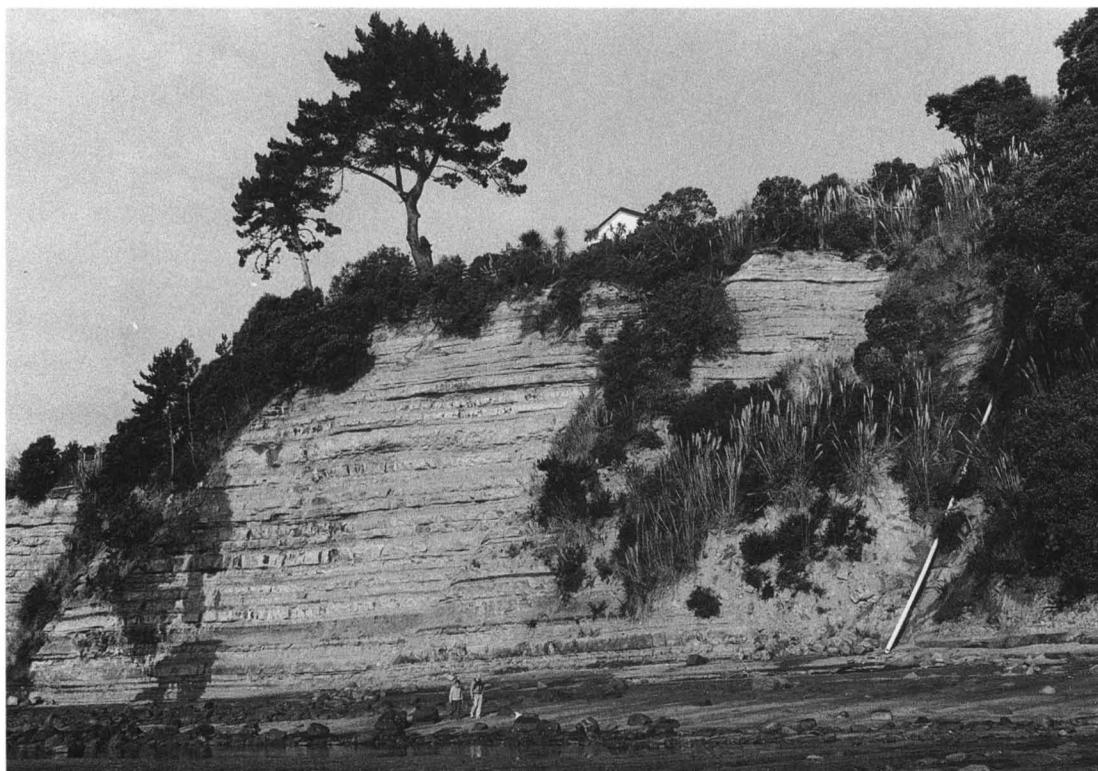
Figure 7. Planar failure along fault planes striking sub-parallel to the cliff face. The recent mass movement has been along the fault in the foreground, but similar movements have occurred along parallel faults slightly seaward of this one in the past. These are now forming the cliff face over short lengths of the cliff, but each one has only eroded to a depth of approximately 10 m before the mass of material seaward of the fault plane is sufficient to maintain stability.

of the material seaward of the fault plane becomes a possibility, as shown in Figure 7.

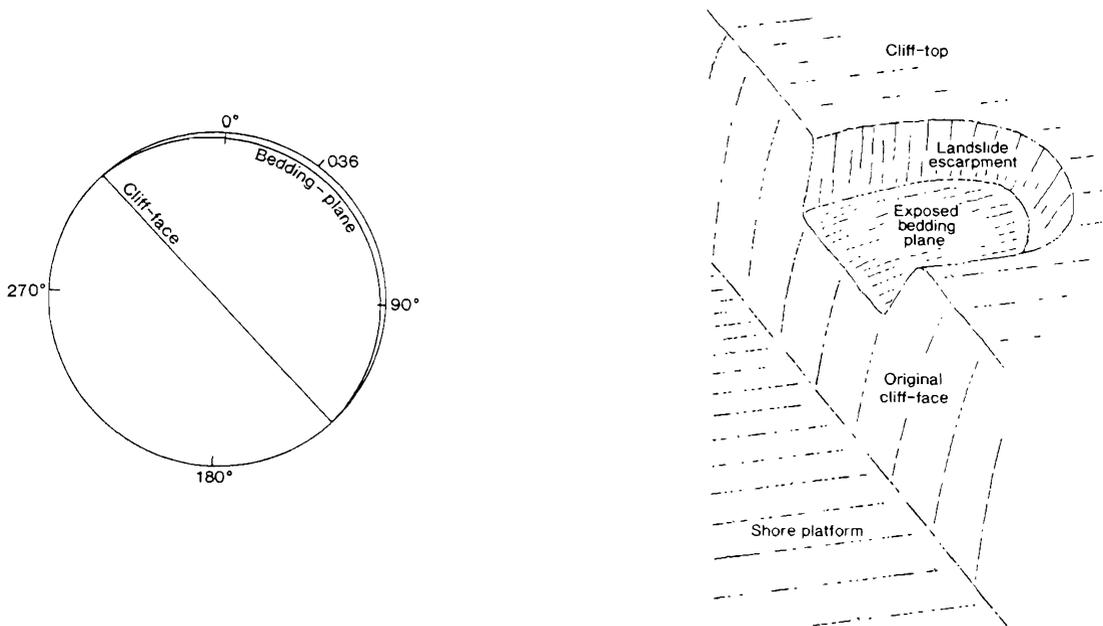
Figure 8. Stereonet analysis of the bedding plane failure mechanism at Churchill Reserve in the East Coast Bays area (see Figure 9). A very shallow seaward dip on the beds is normally sufficient to maintain stability, but loss of frictional resistance along this plane due to high cleft water pressures may result in a very large mass of material becoming unstable.

The mechanism for planar failure along the bedding planes is shown in Figure 8: large volumes of material lying above an unstable bedding plane seem to be rafted seaward out of the face. Fortunately, the dip angle of the bedding is generally very low, so the frictional resistance across the bedding planes is sufficient to maintain stability under normal circumstances. However, water entering these bedding plane surfaces would evidently reduce the stability immensely. Water along joint planes has the capacity to develop a cleft water pressure (TERZAGHI, 1962; WHALLEY, 1984) which effectively separates the two surfaces, and, hence, reduces the frictional resistance between them. The overlying material will thus fail when

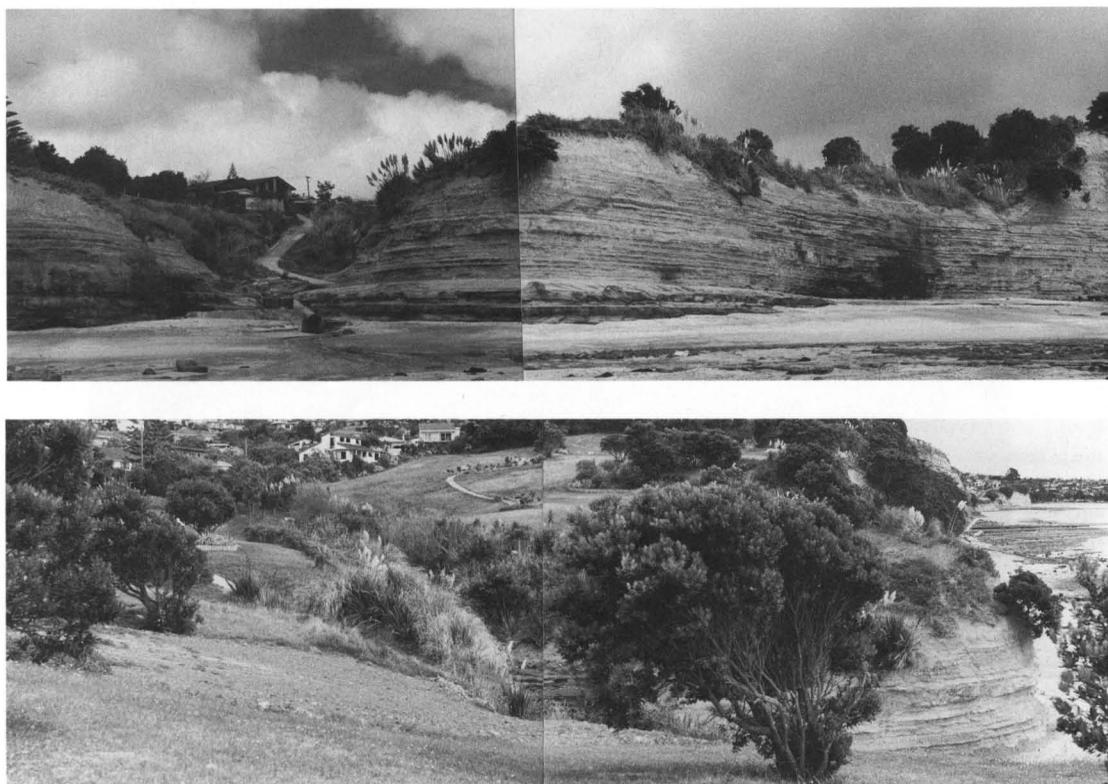
Figure 9. The Churchill Reserve, East Coast Bays, landslide. (Top, A) The sudden lowering of the cliff height at the right of the photograph represents the boundary of the landslide; the boundary on the left is beyond the edge of the photograph. Above the lowered patch of cliffs a thickness of some 10–15 m of material has been rafted off along a gently dipping bedding plane. The stream, which has been piped for a short distance, has not incised a course through the shore platform, suggesting that this landslide occurred after the post-glacial sea level rise. (Bottom, B) The grassed area follows approximately the base of the failure and is surrounded by a typical scarp face on which the houses are built. Evidence of continued movement exists in this area, particularly the hummocky nature of the grassed area, disruption to house foundations, and movement of survey pegs.

Large failures of this type have demonstrably occurred in the East Coast Bays area in at least three instances. The largest one (Figure 9) has clearly occurred since the rise in sea level following the last glacial, as the stream discharging from the slumped area has not incised through the present shore platform. This failure covers a basal failure plane area of some 500 m², and the total area directly affected by the slump is some 900 m². Instability of the slopes around this failure is still very evident, with cracking and slumping of the soils, disruption to house foundations, and movement of survey pegs being recorded.

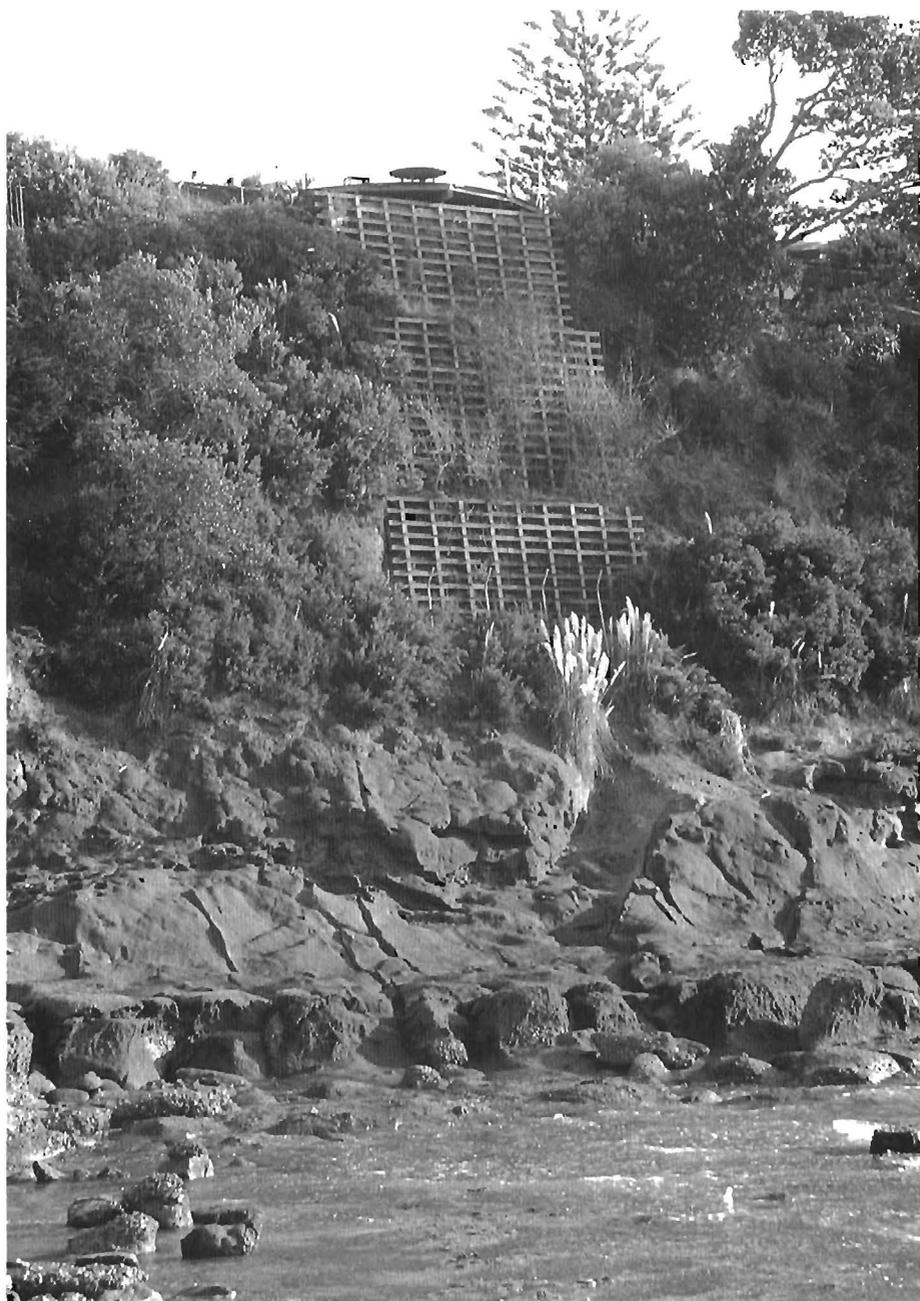
Figure 10. Translational failures in the Parnell Grit soils result in very steep (60–70°), unstable faces which undergo frequent, shallow failures. Extensive revetment wall construction has occurred in this area in an attempt to stabilise such failures.

Geomorphically, the Parnell Grit soils appear far more prone to mass movement than those formed on the flysch material. This is attributed to the more open structure and slightly higher activity of the Parnell Grit soils. Individual failures are comparatively small, but occur very often, resulting in continual retreat of the upper cliff zones. Extensive revetment wall construction has been necessary in one area of Parnell Grit soils in order to attempt to maintain stability on these steep failures (Figure 10).
