Hillsboro Inlet and the Lighthouse: One Hundred and Fifteen Years of Change

David F. Butler and Raymond McAllister

Hillsboro Inlet is one of many natural inlets along the Florida Atlantic Coast. The first documented map of Hillsboro Inlet in its present location was made in 1884. The inlet changed in 1890 with completion of the Florida East Coast Canal. The Hillsboro Lighthouse was constructed in 1905-1907. Early maps, photo records and written documentation have been used to describe the changes in 115 years. Gradual stabilization of the inlet by manmade structures from 1925 to 1966 are described. Dredging since 1983 has provided 100 percent sand bypassing. Future planned changes to deepen the inlet channel from 8 feet to 20 feet are described.

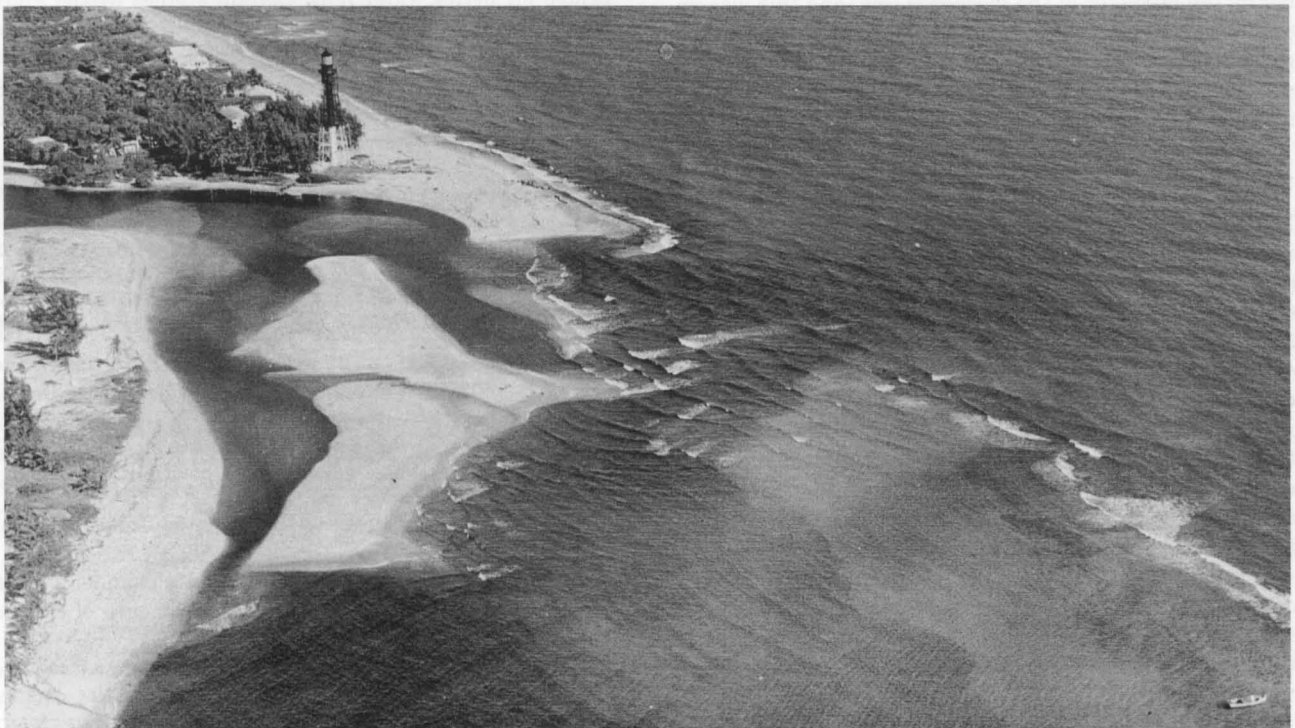
Figure 7. Pompano Beach Historical Society Archives.

1930–1945 period is shown in Figure 7. The inlet was characterized by:
