Rain Garden Installation: Site and Soil Conditions

ALEX BOLQUES^{1,*}, SARAHKEITH VALENTINE², JENNIFER CHERRIER²,
AND MICHAEL ABAZINGE²

¹Florida A&M University, CESTA, Gadsden County Extension, 2140 W. Jefferson Street,
Quincy, FL 32351-1905

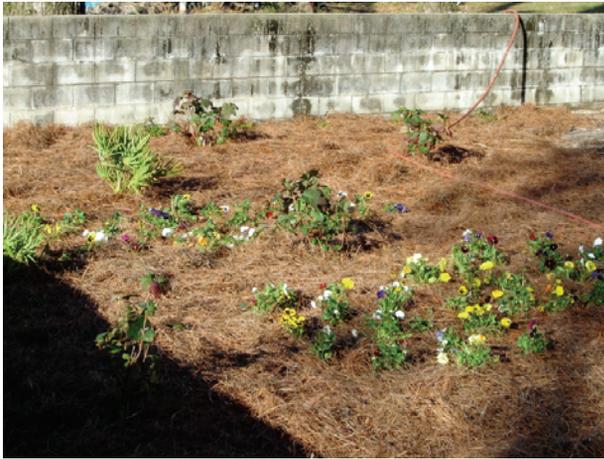
Fig. 1. Plants in the rain garden were mulched with pine straw.

In preparation for the rain garden installation, the drainage area was measured and a design was conceptualized. The design plan depicted the location of the rain garden, an area that is ~2100 square ft, and the layout of the plant materials to be used. Table 1 contains a list of plants used in the rain garden. Creeping fig was planted on the northern and western walls to provide vegetative cover and annual pansies were used for a show of color. Site preparation consisted of weed removal, amending the soil with mushroom compost (Quincy Farms, Quincy, FL), and placing a weed barrier (WeedBlock, Easy Garden Product Ltd., Waco, TX) for weed suppression. Plants were installed and mulched with pine straw (Fig. 1). The plants were watered initially and then as needed to get them established. The site receives partial sunlight since trees on the north and east side of the rain garden site partially shade it.
