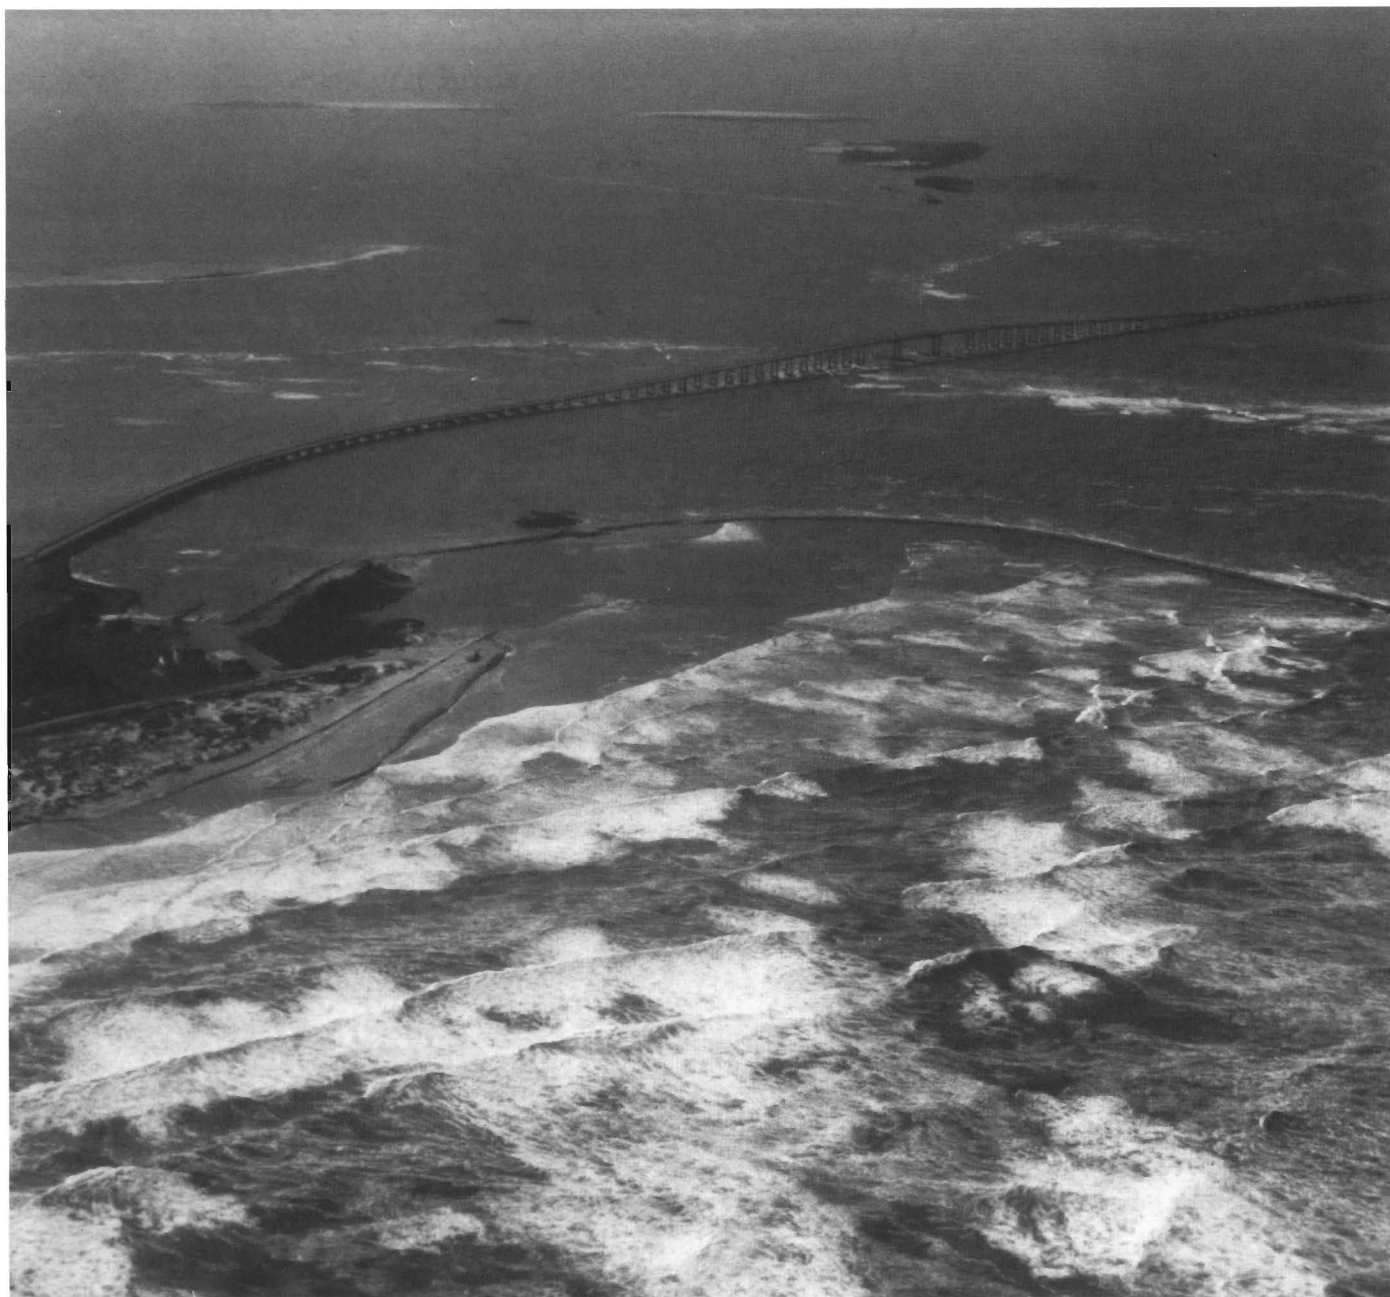
Terminal Groin at Oregon Inlet, North Carolina. View looking west on 31 October, 1991 during the height of the "Halloween" storm when the significant wave height was 5 m with associated periods of 22 sec. The Terminal Groin (foreground) was constructed by the NC Dept. of Transportation as an emergency measure to protect the Bonner Bridge and its abutment to the north end of Pea Island. The structure met the challenge of a barrage of extremely severe storms during the Fall of '91 and Winter of '92. (Photograph by Carl Miller, WES/CERC Field Research Facility, Duck, North Carolina).
